Asbestos Report

YARRIAMBIACK SHIRE COUNCIL

PROPERTY ADDRESS:
LB79 PUBLIC HALL
6 BOSCHERT STREET
TEMPY VIC 3489

INSPECTION DATE: 11 FEBRUARY 2021
REFERENCE NUMBER: 62121

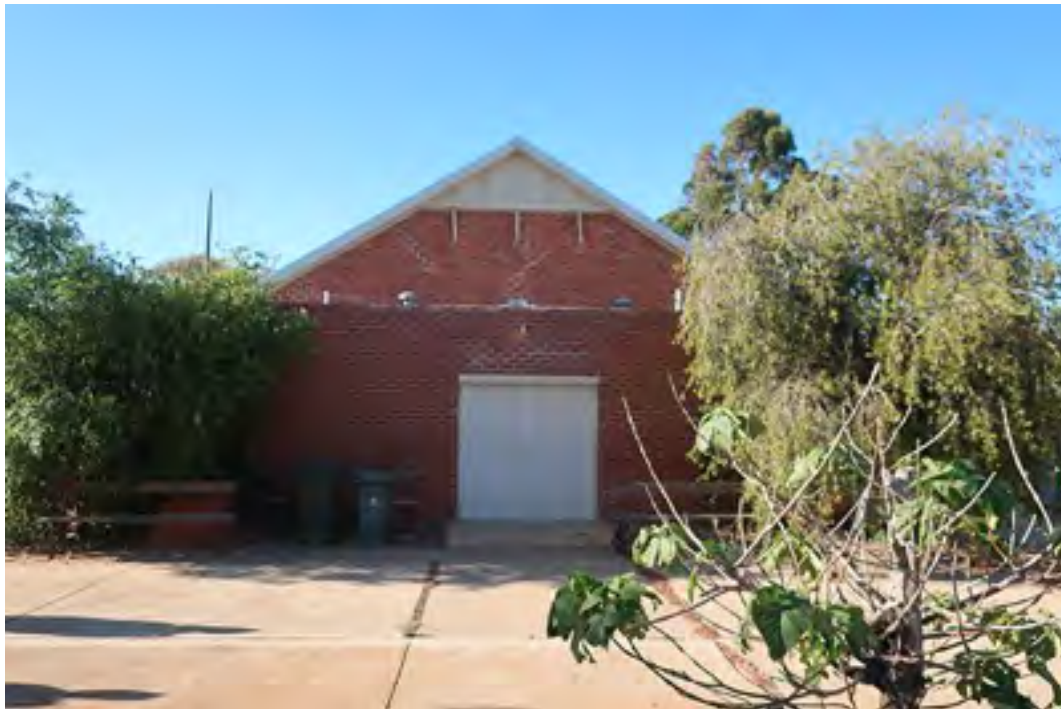
Area 6

RISK ASSESSMENT					
Type of Asbestos or Hazardous Material	No sample taken - Visual ID	Condition	GOOD	Likelihood of Damage	L (Low) – possible
		Activity	Moderate		
		Sealed	Yes	Friability	Bonded (non-friable)
		Labelled	Y	Exposure Risk	Low - Negligible or low risk
		Quantity
