**Global
Asbestos
Audits**

Asbestos Report

YARRIAMBIACK SHIRE COUNCIL

PROPERTY ADDRESS:
LB8 AERODROME
4936 HENTY HIGHWAY
WARRACKNABEAL VIC 3393

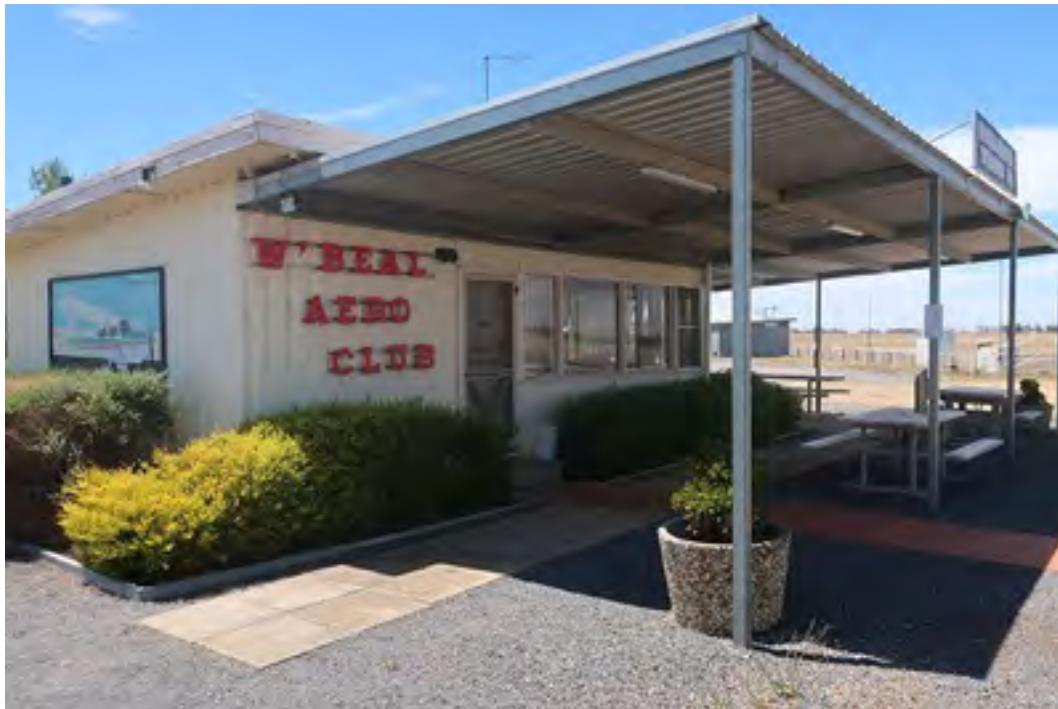
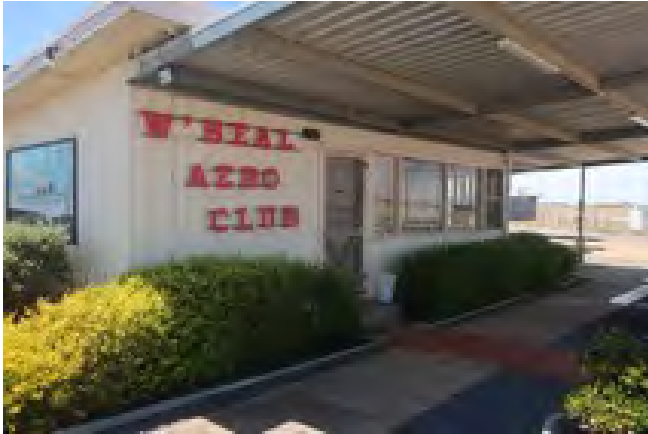
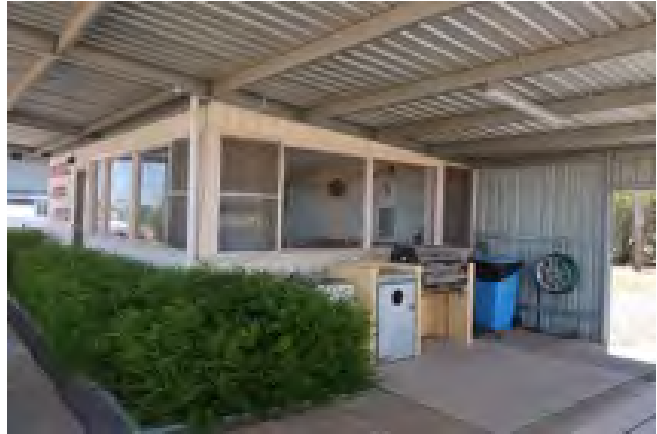
Area 5

Type of Asbestos or Hazardous Material	No sample taken - Visual ID	Condition	AVERAGE	Likelihood of Damage	L (Low) – possible	
		Activity	Moderate			
		Sealed	Yes	Friability		Exposed Fibres
		Labelled	Y	Exposure Risk		Medium - Moderate risk
		Quantity

Broken sections

Priority	HIGH	Label Required	Yes	Re- Audit Date	16 Feb 2022
Action	Remedial repairs required - seal exposed edges or replace or laminate over damaged material				
Recommendation	Broken sections - The damaged area requires immediate remedial repairs. It is recommended the asbestos sheeting be replaced (preferred) or edges sealed with approved sealant and then the area be concealed by laminating (sheeting).				
Legislative Requirements Victorian Regulation 2007	Damaged ACM visible in area. Requires IMMEDIATE ATTENTION. WARNING labels should be affixed. Avoid mechanical damage and abrasion. Remove if refurbishment, structural alteration or demolition is to be carried out in this area. Re-inspect every 12 months or earlier if disturbed or removed in accordance with the Victorian OH&S Regulation 2017. All remedial/removal repairs require a Clearance Inspection & Certificate to be recorded by an approved and competent assessor.

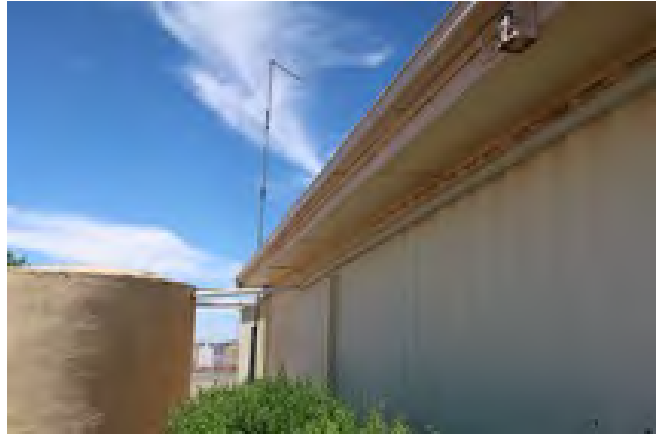
RISK ASSESSMENT					
Type of Asbestos or Hazardous Material	No sample taken - Visual ID	Condition	GOOD	Likelihood of Damage	L (Low) – possible
		Activity	Moderate		
		Sealed	Yes	Friability	Bonded (non-friable)
		Labelled	No	Exposure Risk	Low - Negligible or low risk
		Quantity

Priority	MEDIUM	Label Required	Yes	Re- Audit Date	16 Feb 2022
Action	No remedial action required, unless disturbed				
Recommendation	Maintain paint or sealant to ACM surfaces. Particular attention should be given to side edges, ensure paint/sealant covers ALL exposed ACM surfaces.				
Legislative Requirements Victorian Regulation 2007	Warning labels should be affixed. Avoid mechanical damage and abrasion. Remove if refurbishment, structural alteration or demolition is to be carried out in this area. Re-inspect every 12 months or earlier if disturbed or removed in accordance with the Victorian OH&S Regulation 2017. All remedial/removal repairs require a Clearance Inspection & Certificate to be recorded by an approved and competent assessor.

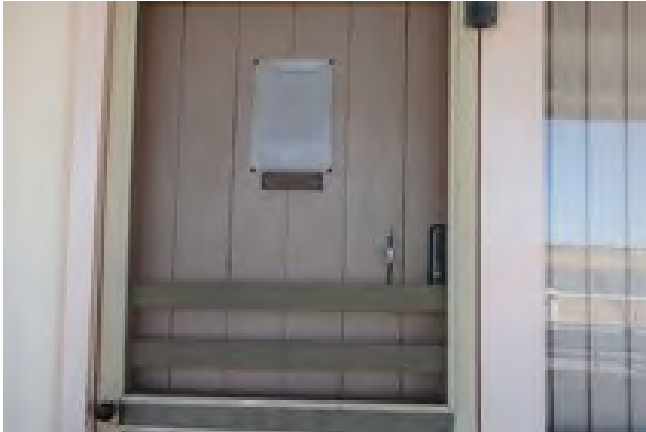
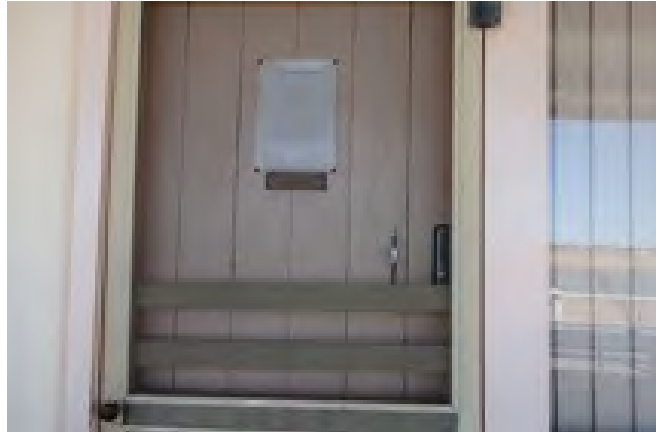
Type of Asbestos or Hazardous Material	No sample taken - No Access	Condition		Likelihood of Damage	
		Activity			
		Sealed		Friability	
		Labelled	No	Exposure Risk	
		Quantity

Priority	HIGH	Label Required	Yes	Re- Audit Date	16 Feb 2022
Action					
Recommendation					
Legislative Requirements Victorian Regulation 2007	Unable to Gain Access. Assume asbestos in area and provide monitoring if work undertaken in these areas. If access is made available, contact Global Asbestos Audits for re-inspection

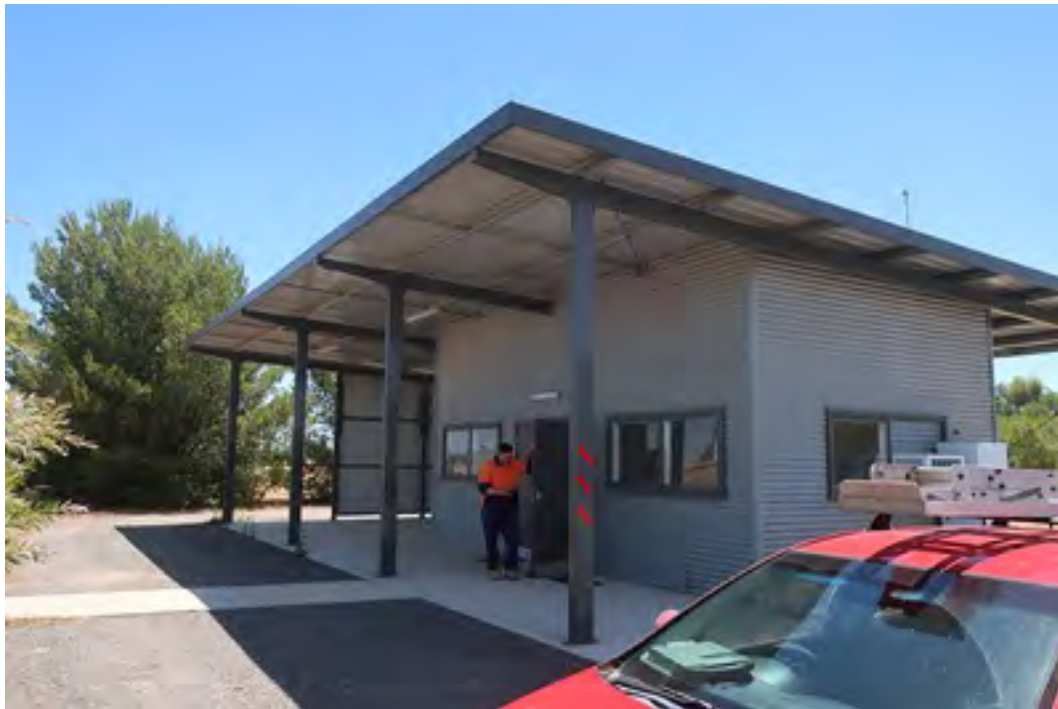
Area 3

RISK ASSESSMENT					
Type of Asbestos or Hazardous Material	No sample taken - Visual ID	Condition	AVERAGE	Likelihood of Damage	L (Low) – possible
		Activity	Moderate		
		Sealed	No	Friability	Bonded (non-friable)
		Labelled	No	Exposure Risk	Medium - Moderate risk
		Quantity

RISK CONTROL					
Priority	HIGH	Label Required	Yes	Re- Audit Date	16 Feb 2022
Action	Remedial repairs required - seal raw material / edges				
Recommendation	Raw material sheeting - The area requires immediate remedial repairs. It is recommended the asbestos material be sealed with an approved membrane.				
Legislative Requirements Victorian Regulation 2007	Damaged ACM visible in area. Requires IMMEDIATE ATTENTION. WARNING labels should be affixed. Avoid mechanical damage and abrasion. Remove if refurbishment, structural alteration or demolition is to be carried out in this area. Re-inspect every 12 months or earlier if disturbed or removed in accordance with the Victorian OH&S Regulation 2017. All remedial/removal repairs require a Clearance Inspection & Certificate to be recorded by an approved and competent assessor.

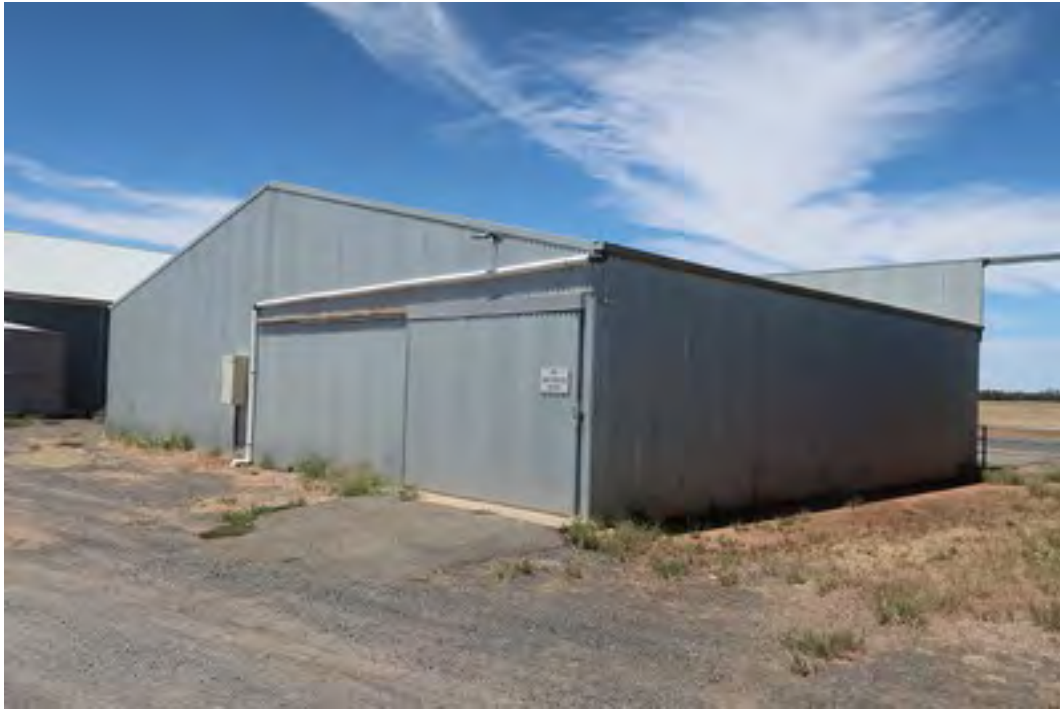
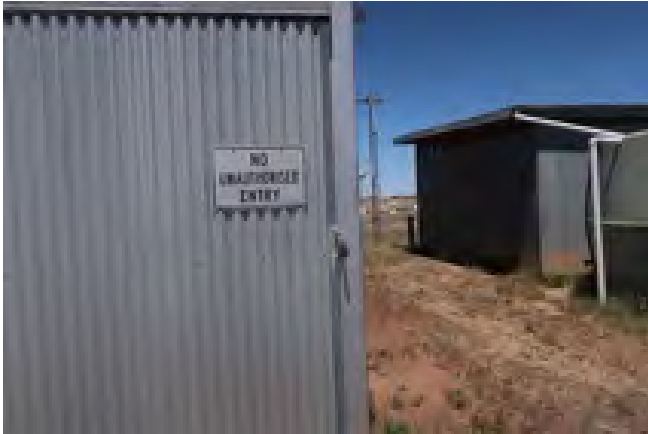
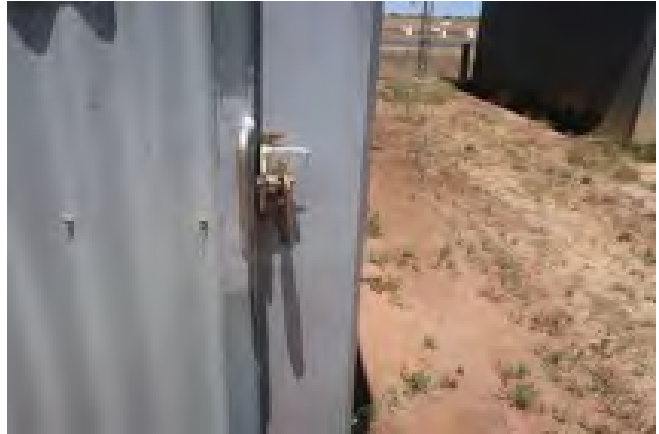
Area 2

Shed: . Until the area is inspected, it should be managed as if it Asbestos Containing Material (ACM) is present.

RISK ASSESSMENT					
Type of Asbestos or Hazardous Material	No sample taken - No Access	Condition		Likelihood of Damage	
		Activity			
		Sealed		Friability	
		Labelled	No	Exposure Risk	
		Quantity

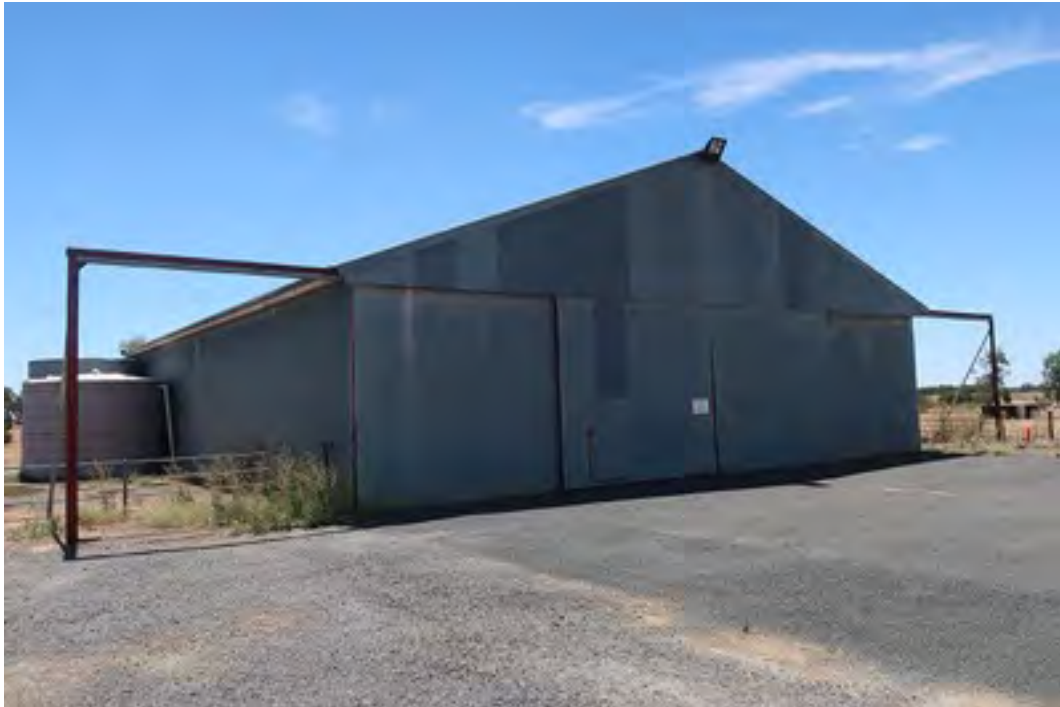
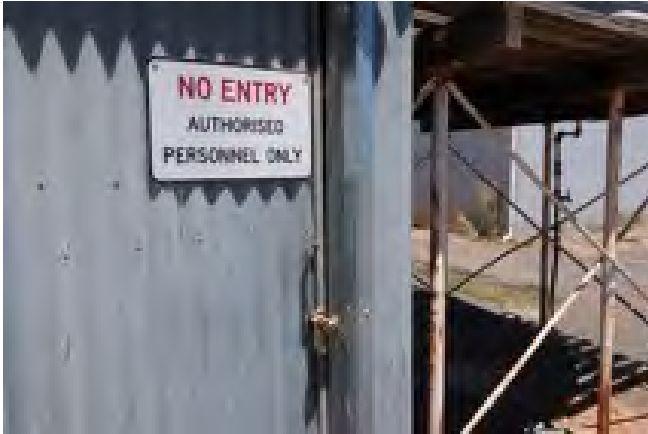
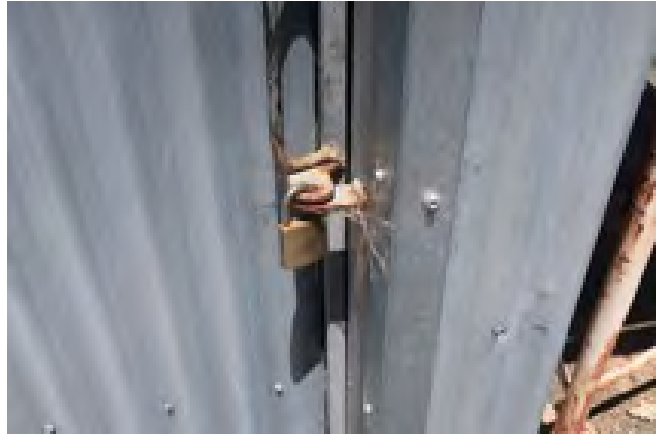
Area 1

Hanger: . Until the area is inspected, it should be managed as if it Asbestos Containing Material (ACM) is present.

RISK ASSESSMENT					
Type of Asbestos or Hazardous Material	No sample taken - No Access	Condition		Likelihood of Damage	
		Activity		Friability	
		Sealed		Exposure Risk	
		Labelled	No		
		Quantity

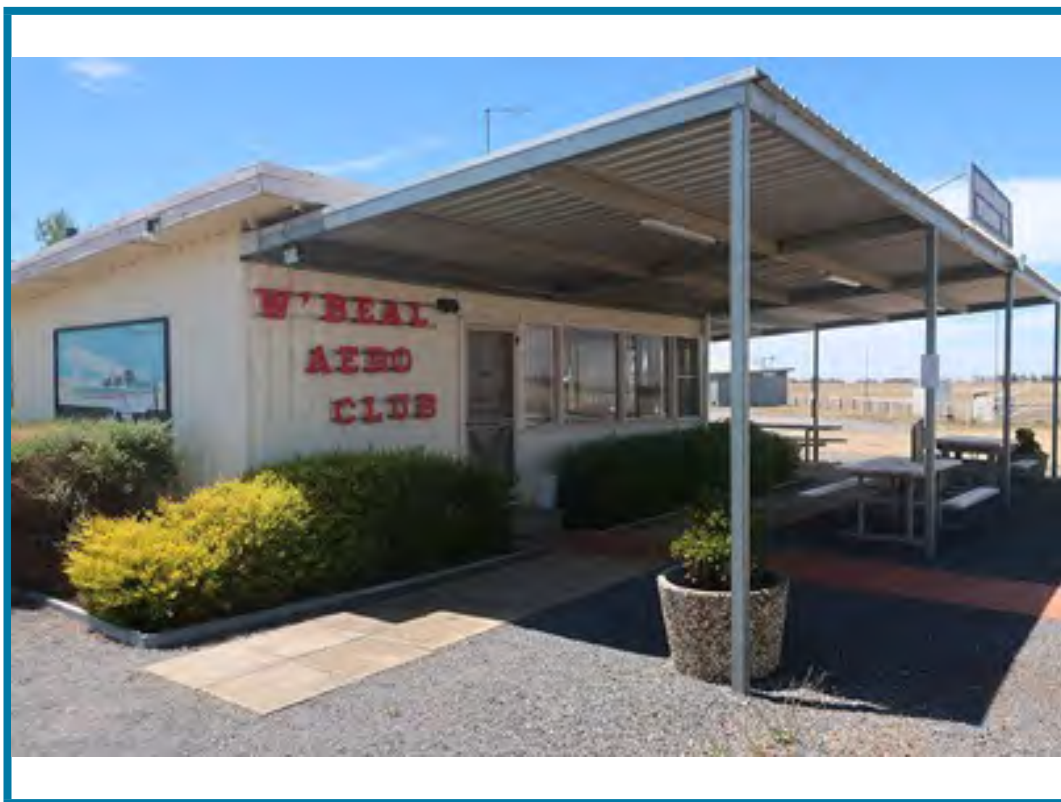
Location	Area	Component Materials	ACM Identified	Type Asbestos Assessment	Condition	Priority	Signage Required
W' Beal Aero Club LB8 Aerodrome - entire perimeter of building.	Walls	F C Sheeting	Yes	No sample taken - Visual ID	AVERAGE HIGH		Yes
					Refer to the Abestos Register for more information.		
W' Beal Aero Club LB8 Aerodrome - entire perimeter of building.	Soffit	F C Sheeting	Yes	No sample taken - Visual ID	GOOD MEDIUM		Yes
					Refer to the Abestos Register for more information.		
W' Beal Aero Club LB8 Aerodrome - .		No Asbestos Materials	Yes	No sample taken - No Access	HIGH		Yes
					Refer to the Abestos Register for more information.		
			Image not available		No Access Locked Door
