Asbestos Report

YARRIAMBIACK SHIRE COUNCIL

PROPERTY ADDRESS:
LR47 CARAVAN PARK
2A LYLE STREET
WARRACKNABEAL VIC 3393

INSPECTION DATE: 16 FEBRUARY 2021
REFERENCE NUMBER: 62126

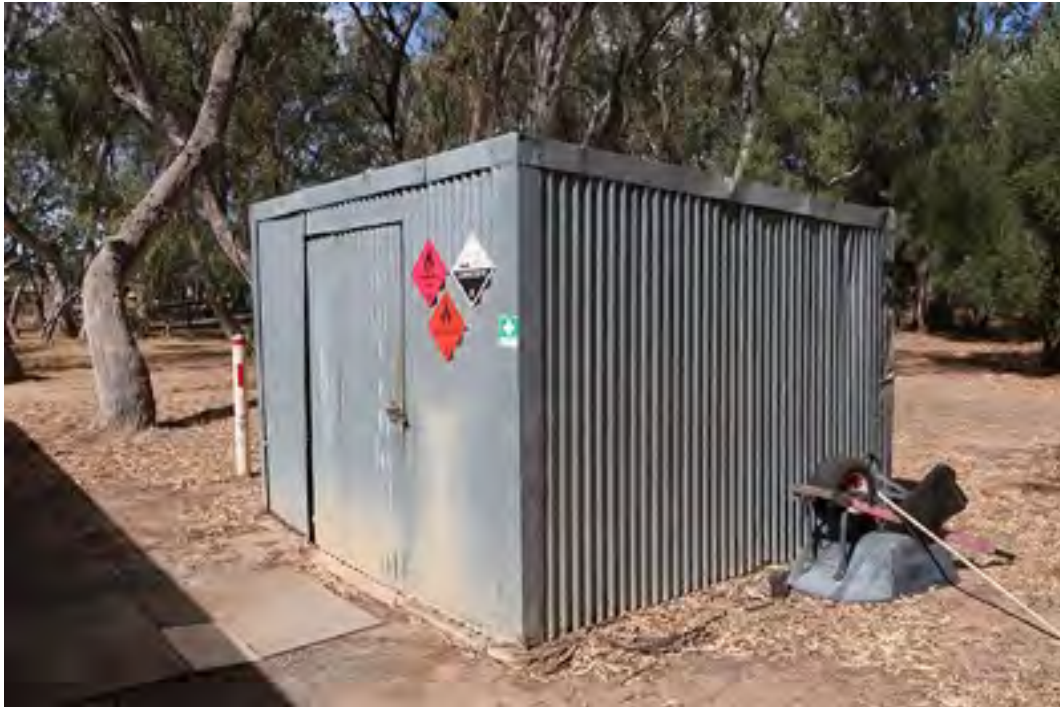
Area 5

RISK ASSESSMENT					
Type of Asbestos or Hazardous Material	No sample taken - No Access	Condition		Likelihood of Damage	
		Activity			
		Sealed		Friability	
		Labelled	No	Exposure Risk	
		Quantity

RISK CONTROL					
Priority	HIGH	Label Required	Yes	Re- Audit Date	16 Feb 2022
Action					
Recommendation					
Legislative Requirements Victorian Regulation 2007	Unable to Gain Access. Assume asbestos in area and provide monitoring if work undertaken in these areas. If access is made available, contact Global Asbestos Audits for re-inspection

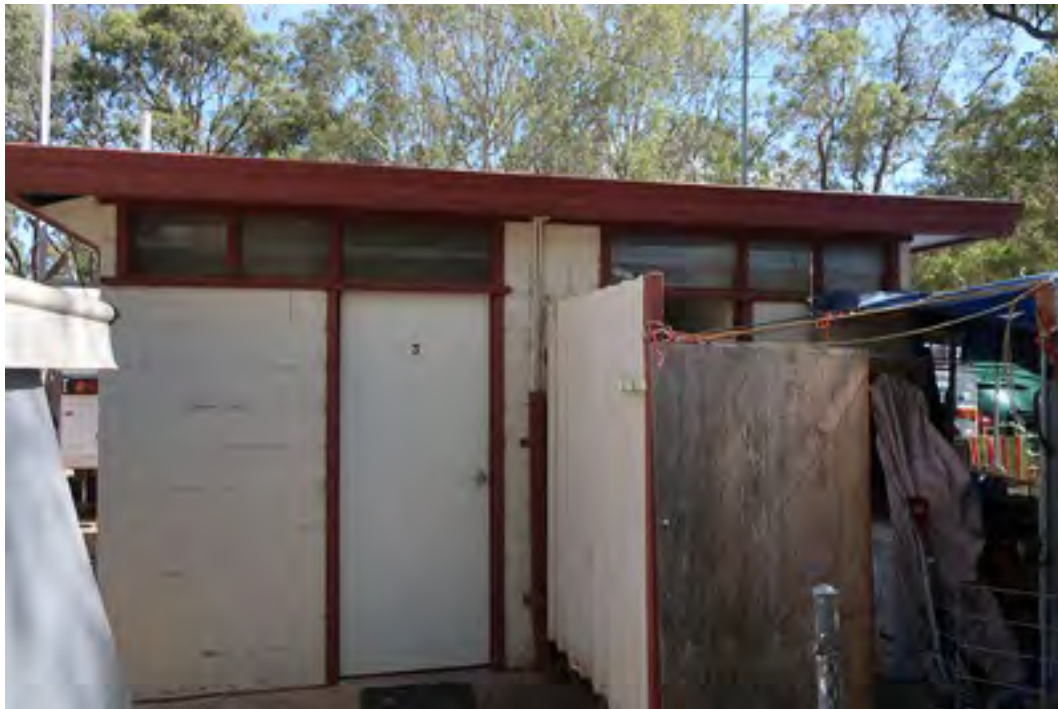
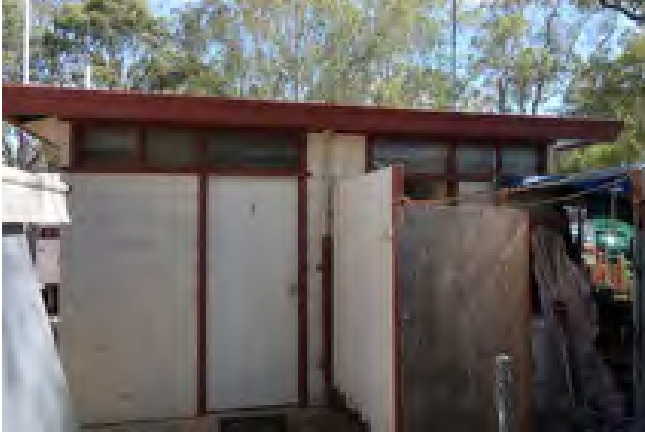
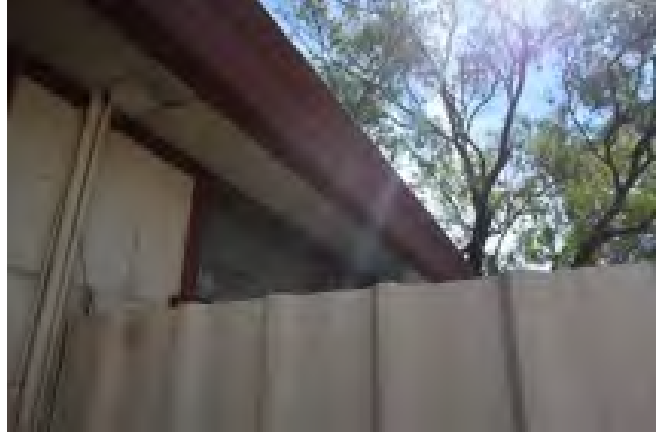
Area 1**Ensuites 1-4: entire perimeter of building. The Soffit (F C Sheeting) has Asbestos Containing Material (ACM) present.****RISK ASSESSMENT**

Type of Asbestos or Hazardous Material	Chrysotile	Condition	AVERAGE	Likelihood of Damage	L (Low) – possible
	Same as Sample - 62126 -005	Activity	Moderate		
		Sealed	Yes	Friability	Exposed Fibres
		Labelled	Y	Exposure Risk	Medium - Moderate risk
		Quantity

Priority	HIGH	Label Required	Yes	Re- Audit Date	16 Feb 2022
Action	Remedial repairs required - seal exposed edges or replace or laminate over damaged material				
Recommendation	Broken sections - The damaged area requires immediate remedial repairs. It is recommended the asbestos sheeting be replaced (preferred) or edges sealed with approved sealant and then the area be concealed by laminating (sheeting).				
Legislative Requirements Victorian Regulation 2007	<p>Damaged ACM visible in area. Requires IMMEDIATE ATTENTION. WARNING labels should be affixed. Avoid mechanical damage and abrasion. Remove if refurbishment, structural alteration or demolition is to be carried out in this area. Re-inspect every 12 months or earlier if disturbed or removed in accordance with the Victorian OH&S Regulation 2017.</p> <p>All remedial/removal repairs require a Clearance Inspection & Certificate to be recorded by an approved and competent assessor.</p>

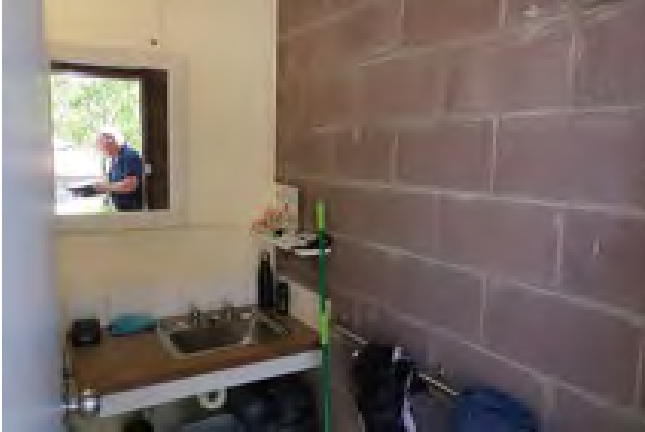
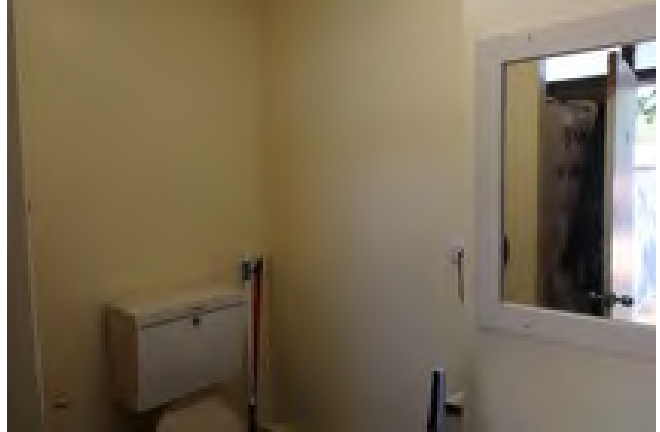
Area 7**Ensuites 1-4: Ensuite 3 1. The Walls and Ceiling (F C Sheeting) has Asbestos Containing Material (ACM) present.****RISK ASSESSMENT**

Type of Asbestos or Hazardous Material	Chrysotile	Condition	GOOD	Likelihood of Damage	L (Low) – possible
	Same as Sample - 62126-006	Activity	Moderate		
		Sealed	Yes	Friability	Bonded (non-friable)
		Labelled	Y	Exposure Risk	Low - Negligible or low risk
		Quantity

Priority	MEDIUM	Label Required	Yes	Re- Audit Date	16 Feb 2022
Action	No remedial action required, unless disturbed				
Recommendation	Maintain paint or sealant to ACM surfaces. Particular attention should be given to side edges, ensure paint/sealant covers ALL exposed ACM surfaces.				
Legislative Requirements Victorian Regulation 2007	Warning labels should be affixed. Avoid mechanical damage and abrasion. Remove if refurbishment, structural alteration or demolition is to be carried out in this area. Re-inspect every 12 months or earlier if disturbed or removed in accordance with the Victorian OH&S Regulation 2017. All remedial/removal repairs require a Clearance Inspection & Certificate to be recorded by an approved and competent assessor.

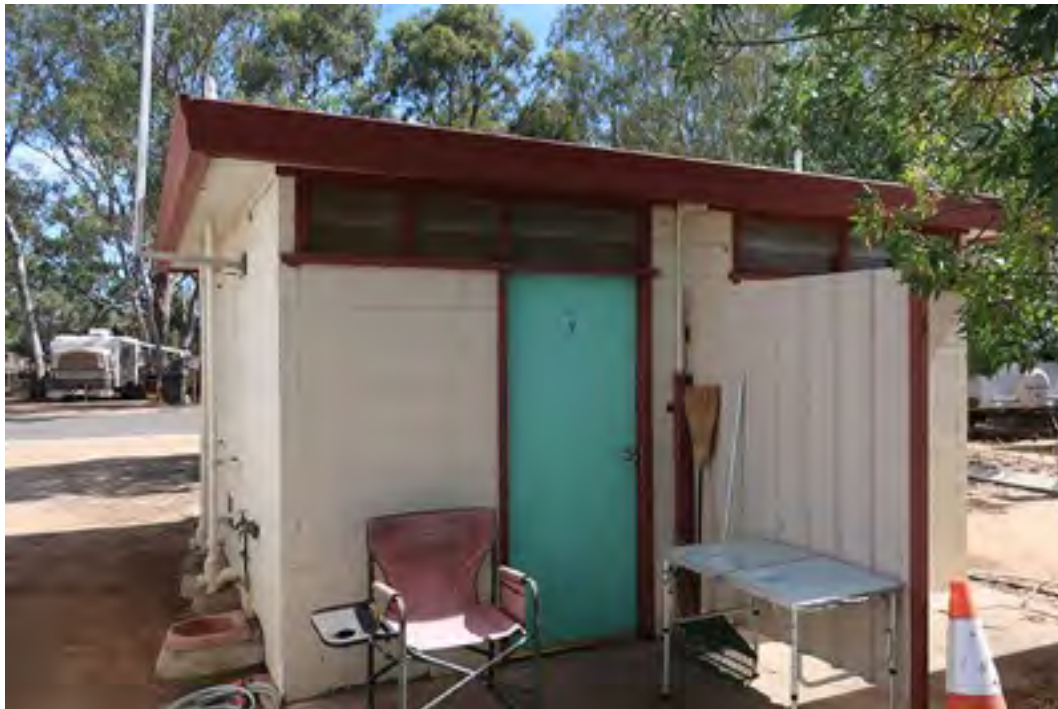
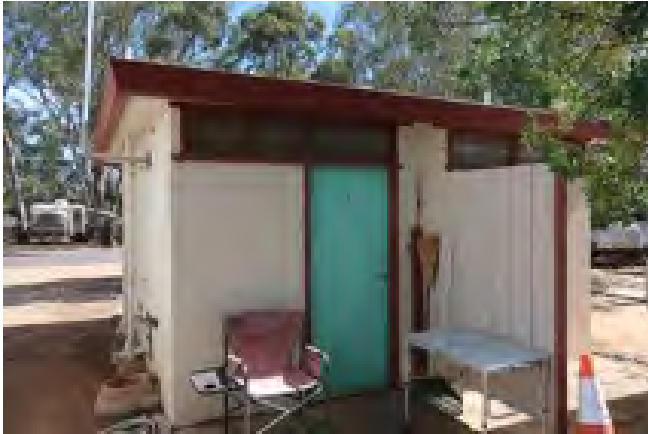
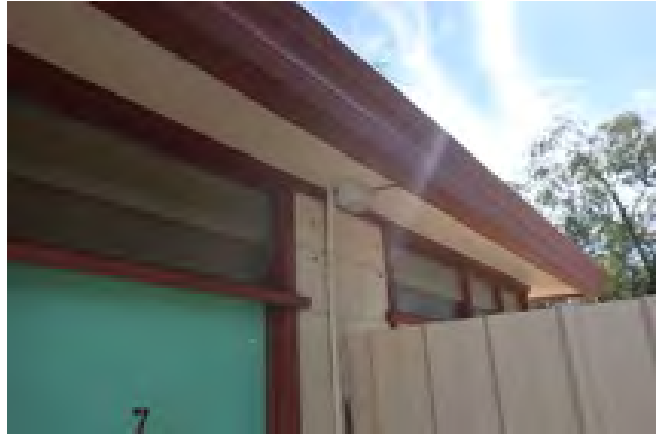
Area 9

Ensuites 5-8: entire perimeter of building. The Soffit (F C Sheeting) has Asbestos Containing Material (ACM) present.

RISK ASSESSMENT					
Type of Asbestos or Hazardous Material	Chrysotile	Condition	GOOD	Likelihood of Damage	L (Low) – possible
	Same as Sample - 62126 -005	Activity	Moderate		
		Sealed	Yes	Friability	Bonded (non-friable)
		Labelled	Y	Exposure Risk	Low - Negligible or low risk
		Quantity

Priority	MEDIUM	Label Required	Yes	Re- Audit Date	16 Feb 2022
Action	No remedial action required, unless disturbed				
Recommendation	Maintain paint or sealant to ACM surfaces. Particular attention should be given to side edges, ensure paint/sealant covers ALL exposed ACM surfaces.				
Legislative Requirements Victorian Regulation 2007	Warning labels should be affixed. Avoid mechanical damage and abrasion. Remove if refurbishment, structural alteration or demolition is to be carried out in this area. Re-inspect every 12 months or earlier if disturbed or removed in accordance with the Victorian OH&S Regulation 2017. All remedial/removal repairs require a Clearance Inspection & Certificate to be recorded by an approved and competent assessor.

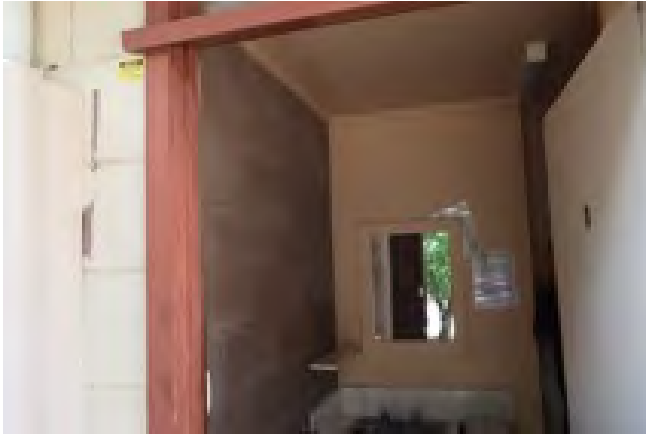
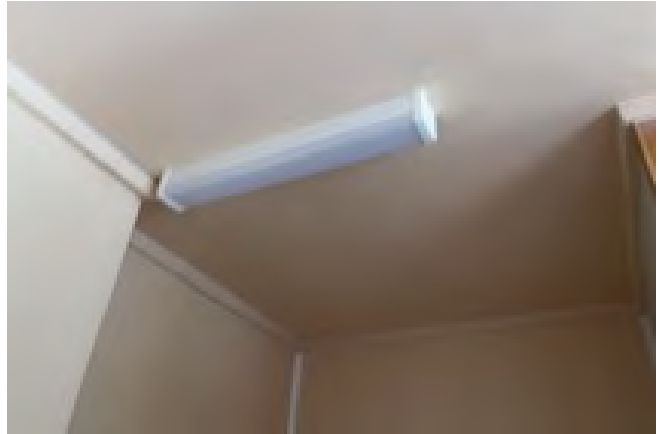
Area 3**Ensuites 5-8: Ensuite 8 1. The Walls and Ceiling (F C Sheeting) has Asbestos Containing Material (ACM) present.****RISK ASSESSMENT**

Type of Asbestos or Hazardous Material	Chrysotile	Condition	AVERAGE	Likelihood of Damage	L (Low) – possible
	Sample taken 62126-006	Activity	Moderate		
		Sealed	No	Friability	Bonded (non-friable)
		Labelled	Y	Exposure Risk	Medium - Moderate risk
		Quantity

Priority	HIGH	Label Required	Yes	Re- Audit Date	16 Feb 2022
Action	Remedial repairs required - seal raw material / edges				
Recommendation	Raw material sheeting - The area requires immediate remedial repairs. It is recommended the asbestos material be sealed with an approved membrane.				
Legislative Requirements Victorian Regulation 2007	<p>Damaged ACM visible in area. Requires IMMEDIATE ATTENTION. WARNING labels should be affixed. Avoid mechanical damage and abrasion. Remove if refurbishment, structural alteration or demolition is to be carried out in this area. Re-inspect every 12 months or earlier if disturbed or removed in accordance with the Victorian OH&S Regulation 2017.</p> <p>All remedial/removal repairs require a Clearance Inspection & Certificate to be recorded by an approved and competent assessor.</p>

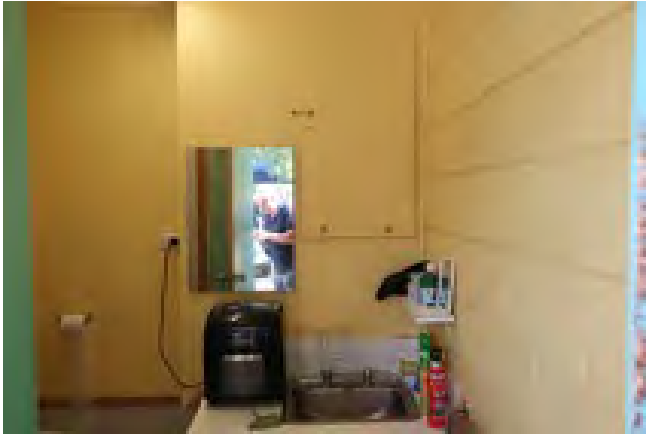
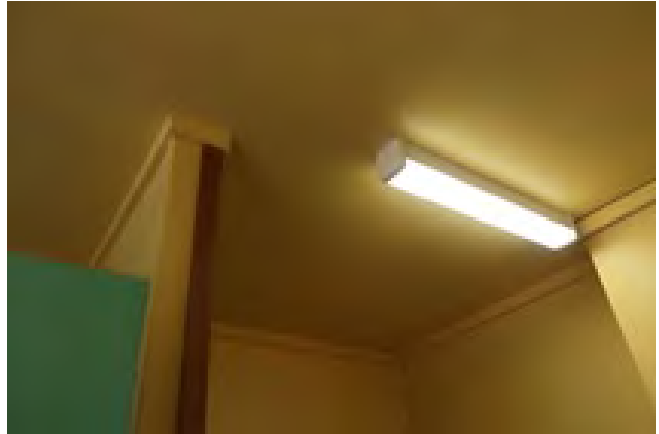
Ensuites 5-8: Ensuite 7 2. The Walls and Ceiling (F C Sheeting) has Asbestos Containing Material (ACM) present.

RISK ASSESSMENT					
Type of Asbestos or Hazardous Material	Chrysotile	Condition	AVERAGE	Likelihood of Damage	L (Low) – possible
	Same as Sample - 62126-006	Activity	Moderate		
		Sealed	No	Friability	Bonded (non-friable)
		Labelled	Y	Exposure Risk	Medium - Moderate risk
		Quantity

RISK CONTROL					
Priority	HIGH	Label Required	Yes	Re- Audit Date	16 Feb 2022
Action	Remedial repairs required - seal raw material / edges				
Recommendation	Raw material sheeting - The area requires immediate remedial repairs. It is recommended the asbestos material be sealed with an approved membrane.				
Legislative Requirements Victorian Regulation 2007	Damaged ACM visible in area. Requires IMMEDIATE ATTENTION. WARNING labels should be affixed. Avoid mechanical damage and abrasion. Remove if refurbishment, structural alteration or demolition is to be carried out in this area. Re-inspect every 12 months or earlier if disturbed or removed in accordance with the Victorian OH&S Regulation 2017. All remedial/removal repairs require a Clearance Inspection & Certificate to be recorded by an approved and competent assessor.

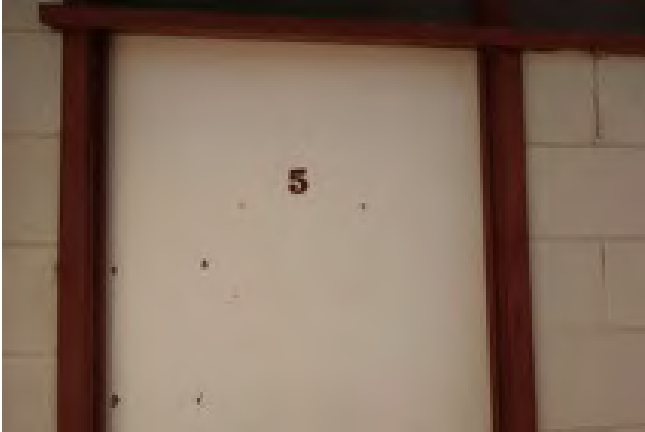
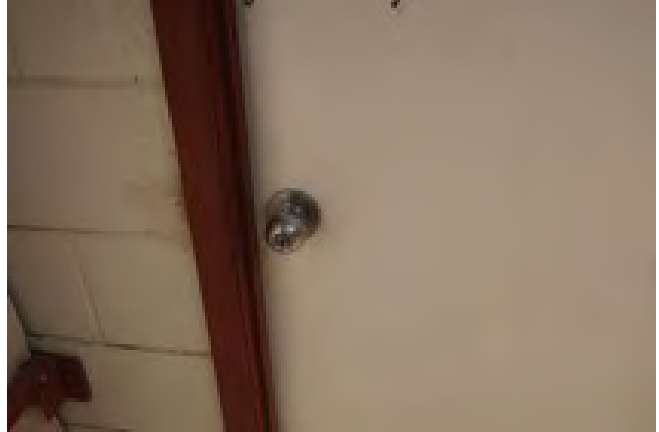
Area 8**Ensuites 5-8: Ensuite 5 & 6. The Walls and Ceiling (F C Sheeting) has Asbestos Containing Material (ACM) present.****RISK ASSESSMENT**

Type of Asbestos or Hazardous Material	Chrysotile	Condition	GOOD	Likelihood of Damage	L (Low) – possible
	Same as Sample - 62126-006	Activity	Moderate		
		Sealed	Yes	Friability	Bonded (non-friable)
		Labelled	No	Exposure Risk	Low - Negligible or low risk
		Quantity

Priority	MEDIUM	Label Required	Yes	Re- Audit Date	16 Feb 2022
Action	No remedial action required, unless disturbed				
Recommendation	Maintain paint or sealant to ACM surfaces. Particular attention should be given to side edges, ensure paint/sealant covers ALL exposed ACM surfaces.				
Legislative Requirements Victorian Regulation 2007	Warning labels should be affixed. Avoid mechanical damage and abrasion. Remove if refurbishment, structural alteration or demolition is to be carried out in this area. Re-inspect every 12 months or earlier if disturbed or removed in accordance with the Victorian OH&S Regulation 2017. All remedial/removal repairs require a Clearance Inspection & Certificate to be recorded by an approved and competent assessor.

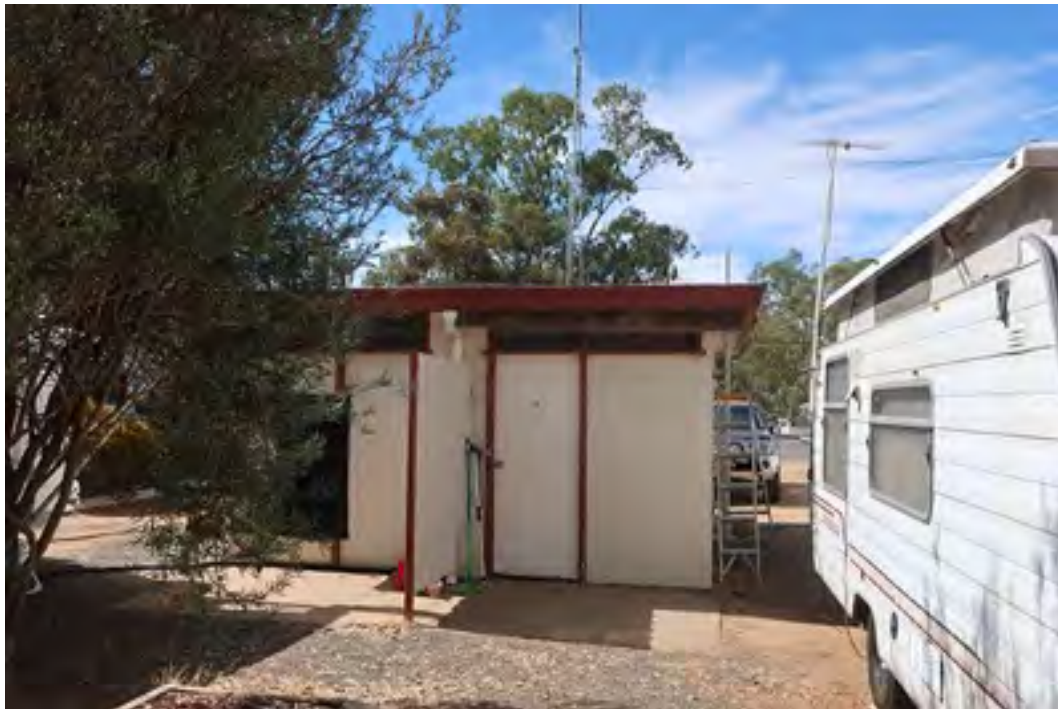
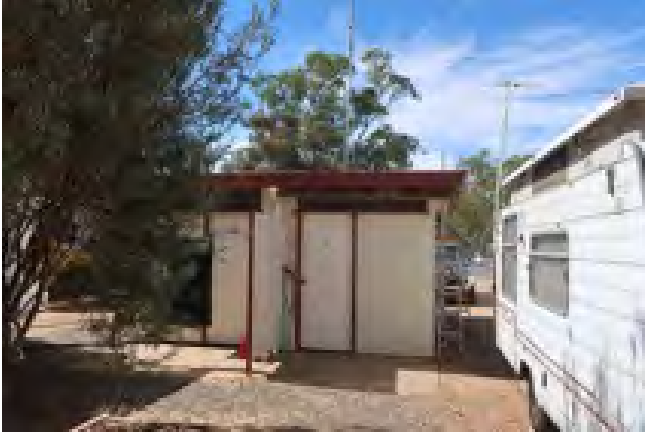
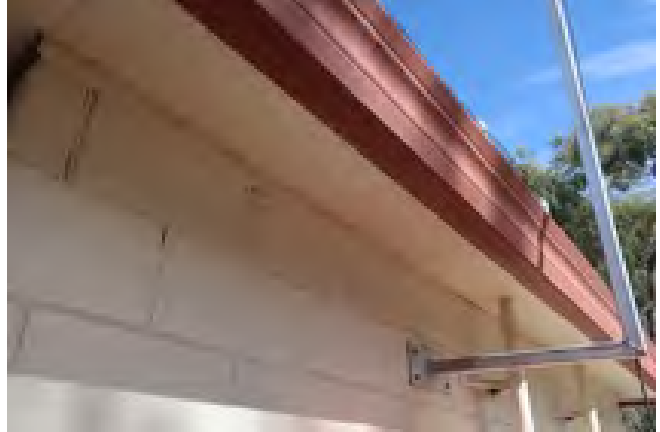
Area 4**Ensuites 9-12: entire perimeter of building. The Soffit (F C Sheeting) has Asbestos Containing Material (ACM) present.****RISK ASSESSMENT**

Type of Asbestos or Hazardous Material	Chrysotile	Condition	POOR	Likelihood of Damage	L (Low) – possible
	Sample taken 62126-005	Activity	Moderate		
		Sealed	Yes	Friability	Exposed Fibres
		Labelled	Y	Exposure Risk	Medium - Moderate risk
		Quantity
