Asbestos Report

YARRIAMBIACK SHIRE COUNCIL

PROPERTY ADDRESS:
LB15 HISTORICAL CENTRE
81 SCOTT STREET
WARRACKNABEAL VIC 3393

INSPECTION DATE: 16 FEBRUARY 2021
REFERENCE NUMBER: 62128

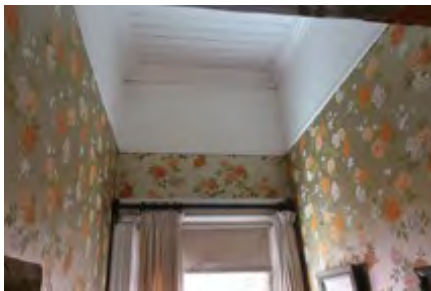
Maintain paint or sealant
