Asbestos Report

YARRIAMBIACK SHIRE COUNCIL

PROPERTY ADDRESS:
LR15B LIBRARY
36 LYLE STREET
WARRACKNABEAL VIC 3393

INSPECTION DATE: 16 FEBRUARY 2021
REFERENCE NUMBER: 62131

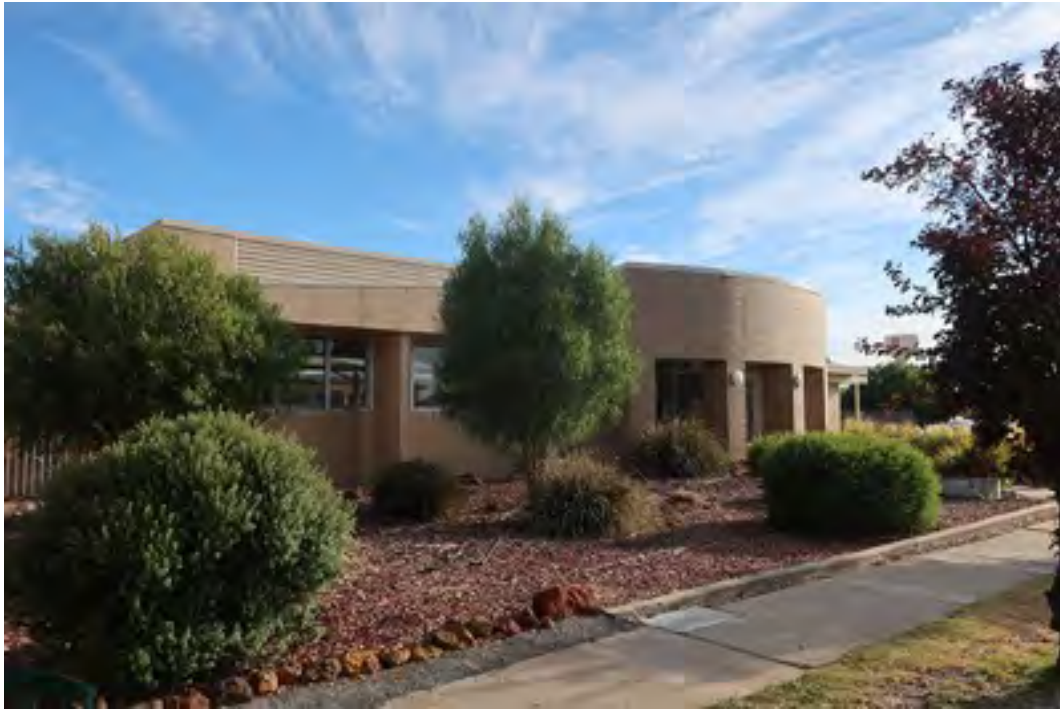
Area 3

- 3 LR15B Library: left side of building. The Soffit (F C Sheeting) has Asbestos Containing Material (ACM) present.
- 2 LR15B Library: Entry 1. The Ceiling - old soffit (F C Sheeting) has Asbestos Containing Material (ACM) present.
- 1 LR15B Library: Reception 3. The Electrical Cabinet (F C Sheeting) has Asbestos Containing Material (ACM) present.

Raw material sheeting - The area requires immediate remedial repairs. It is recommended the asbestos material be sealed with an approved membrane.
