Asbestos Report

YARRIAMBIACK SHIRE COUNCIL

PROPERTY ADDRESS:
LR16 LIONS FLORA & FAUNA PARK BBQ AREA
CRAIG AVENUE
WARRACKNABEAL VIC 3393

INSPECTION DATE: 16 FEBRUARY 2021
REFERENCE NUMBER: 62132

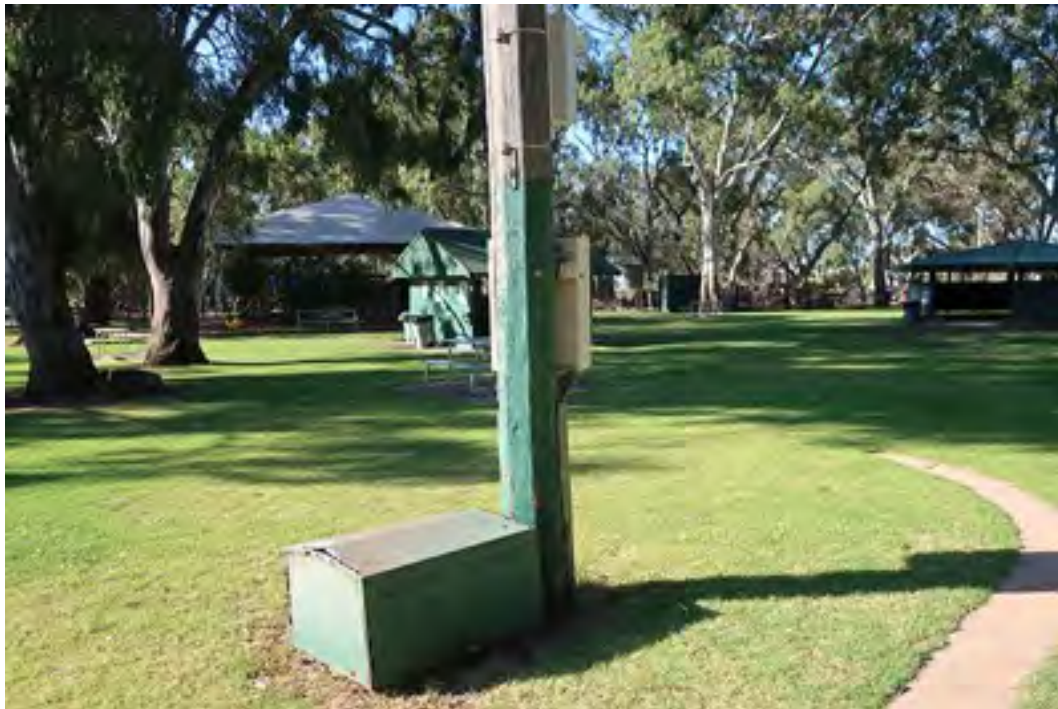
ASBESTOS REGISTER: LR16 Lions Flora & Fauna Park BBQ Area, Craig Avenue, Warracknabeal VIC 3393

Area 1**Grounds: Until the area is inspected, it should be managed as if it Asbestos Containing Material (ACM) is present.****RISK ASSESSMENT**
