Asbestos Report

YARRIAMBIACK SHIRE COUNCIL

PROPERTY ADDRESS:
LB6 MUSEUM WHEAT
34 HENTY HIGHWAY
WARRACKNABEAL VIC 3393

INSPECTION DATE: 16 FEBRUARY 2021
REFERENCE NUMBER: 62133

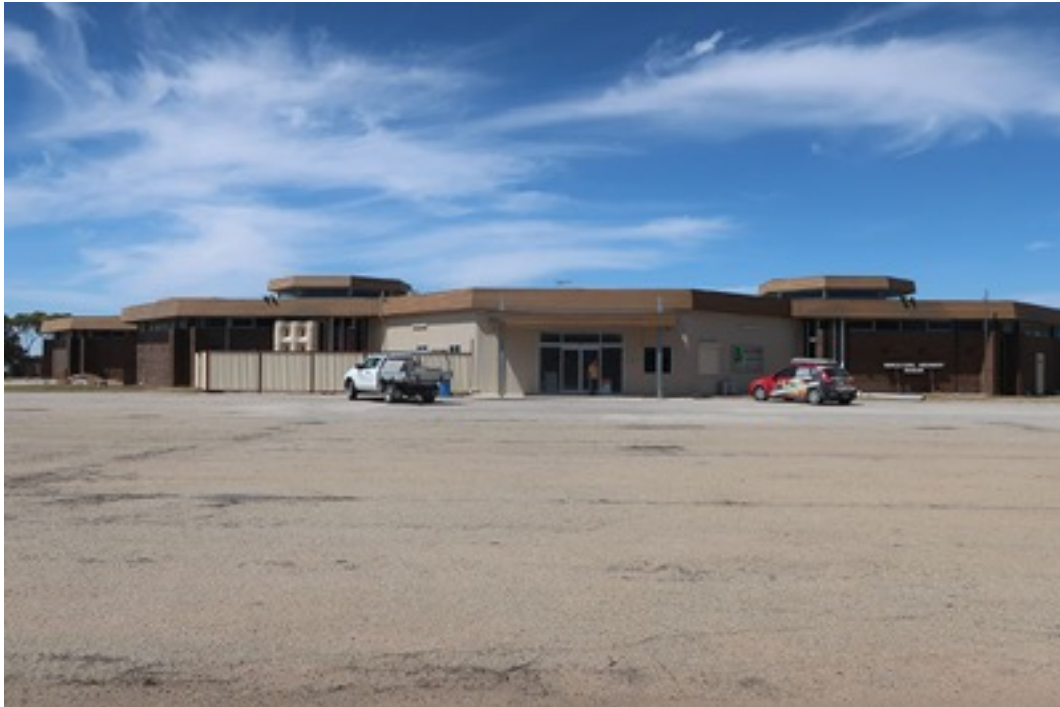
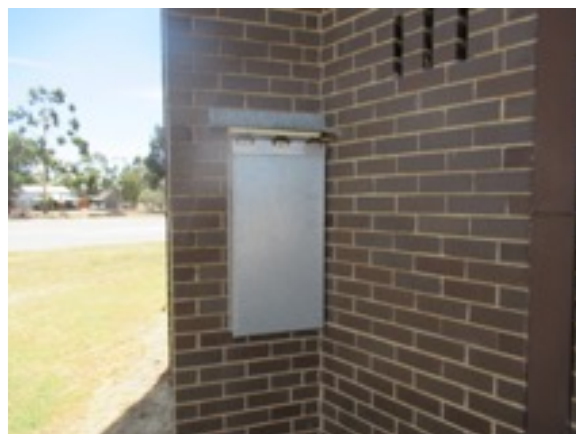
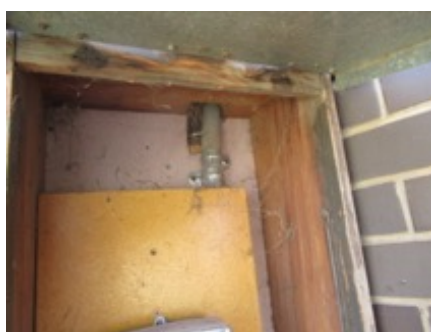
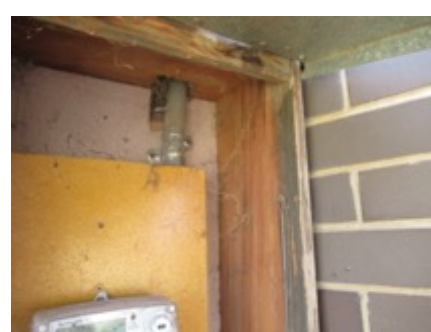
Area 19**Museum: right side of building. The Electrical board (F C Sheeting) has Asbestos Containing Material (ACM) present.****RISK ASSESSMENT**

Raw Material

- 19 Museum: right side of building. The Electrical board (F C Sheeting) has Asbestos Containing Material (ACM) present.**
- Raw material sheeting - The area requires immediate remedial repairs. It is recommended the asbestos material be sealed with an approved membrane.

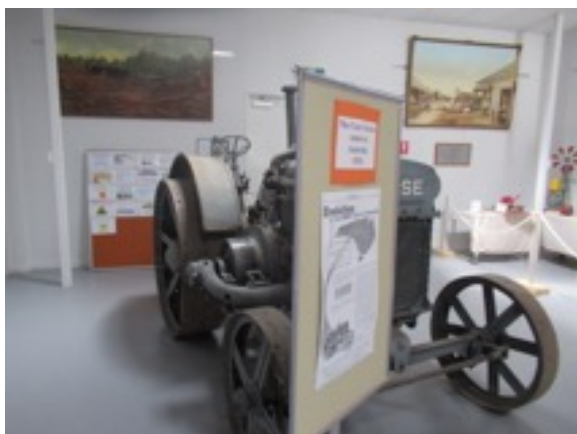
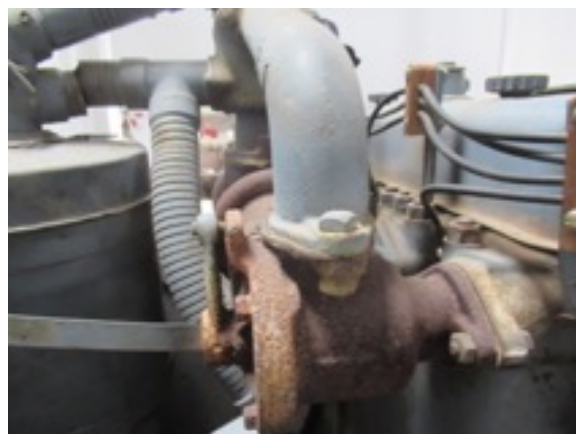
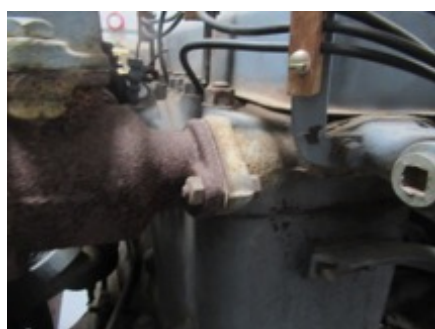
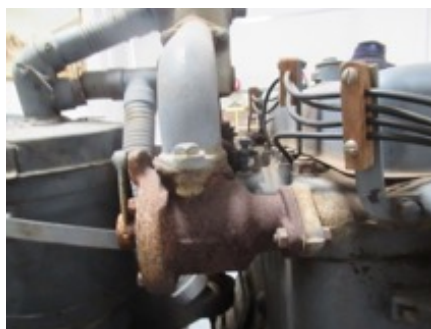
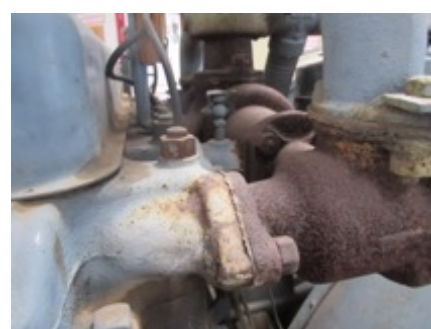
Area 18**Museum: Foyer - Display: Case Tractor. The Exhaust flange - gasket (Compound Material) has Asbestos Containing Material (ACM) present.****RISK ASSESSMENT**

Type of Asbestos or Hazardous Material	Chrysotile	Condition	POOR	Likelihood of Damage	M (Medium) - likely
	Sample taken 62133-008	Activity	Moderate		
		Sealed	No	Friability	Exposed Fibres
		Labelled	No	Exposure Risk	High - Short term exposure risk
		Quantity

Unbonded surface

- 18 Museum: Foyer - Display: Case Tractor. The Exhaust flange - gasket (Compound Material) has Asbestos Containing Material (ACM) present.**
- Unbonded surface - The area requires immediate remedial repairs. It is recommended the asbestos material be replaced (preferred) or the material be sealed with an approved membrane.

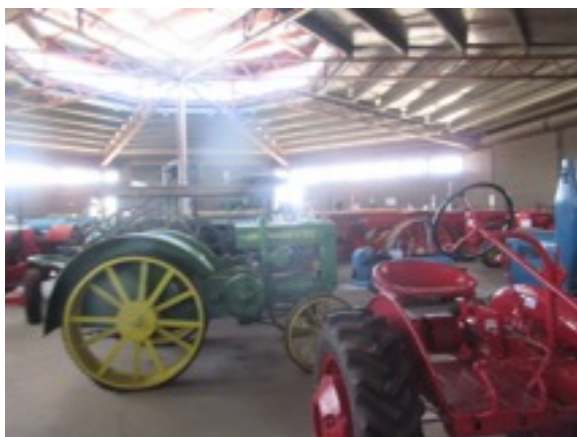
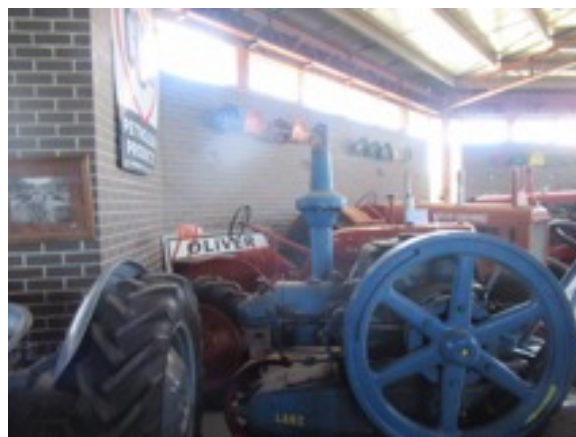
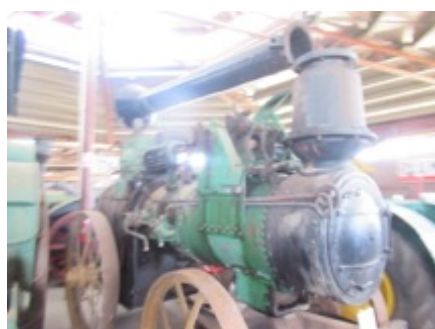
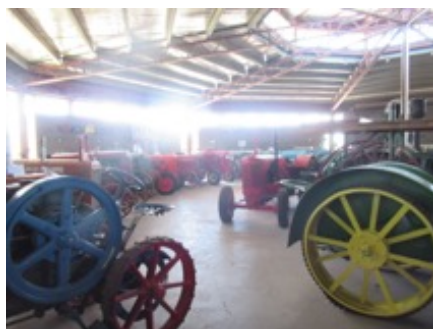
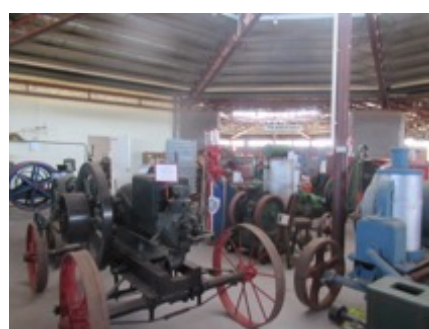
Area 21**Museum: Tractor Display. The Exhaust Gaskets & Lagging & Brakes (Compound Material) has Asbestos Containing Material (ACM) present.****RISK ASSESSMENT**

Type of Asbestos or Hazardous Material	No sample taken - Visual ID	Condition	POOR	Likelihood of Damage	M (Medium) - likely
		Activity	Moderate		
		Sealed	No	Friability	Exposed Fibres
		Labelled	No	Exposure Risk	Medium - Moderate risk
		Quantity

Unbonded surface

- 21 Museum: Tractor Display. The Exhaust Gaskets & Lagging & Brakes (Compound Material) has Asbestos Containing Material (ACM) present.**
- Unbonded surface - The area requires immediate remedial repairs. It is recommended the asbestos material be replaced (preferred) or the material be sealed with an approved membrane.

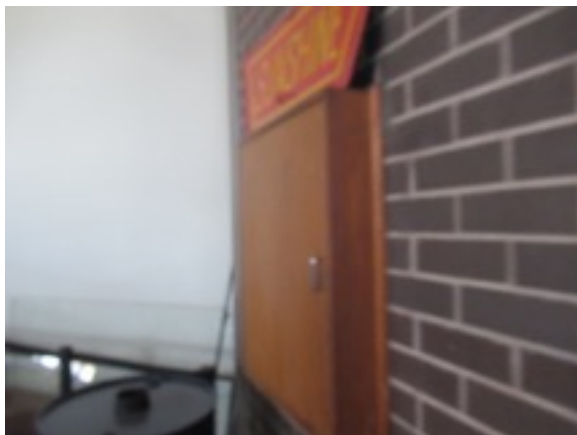
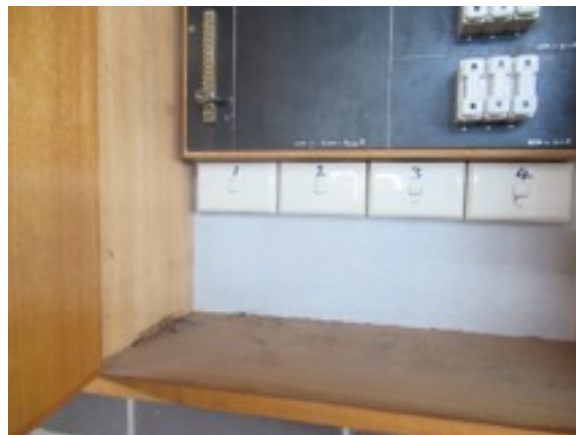
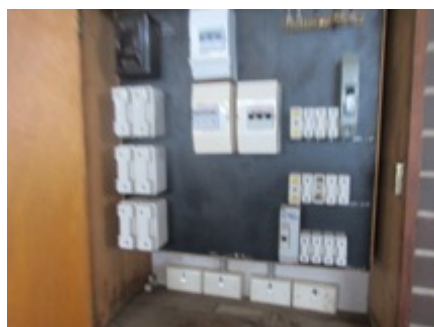
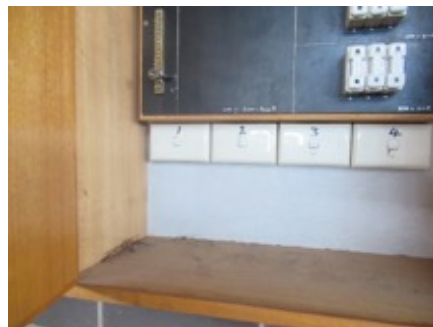
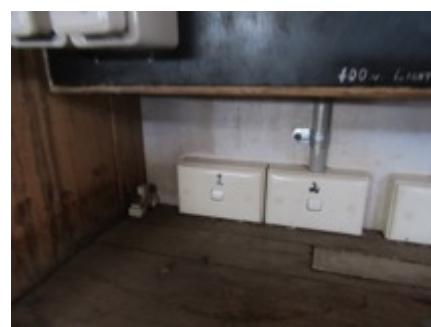
Area 17**Museum: Display areas (x3). The Electrical Cabinet - lining (F C Sheeting) has Asbestos Containing Material (ACM) present.****RISK ASSESSMENT**

Type of Asbestos or Hazardous Material	Chrysotile	Condition	AVERAGE	Likelihood of Damage	L (Low) – possible
	Same as Sample - 62133 -007	Activity	Moderate		
		Sealed	No	Friability	Bonded (non-friable)
		Labelled	Y	Exposure Risk	Medium - Moderate risk
		Quantity

Raw Material

- 17 Museum: Display areas (x3). The Electrical Cabinet - lining (F C Sheeting) has Asbestos Containing Material (ACM) present.**
- Raw material sheeting - The area requires immediate remedial repairs. It is recommended the asbestos material be sealed with an approved membrane.

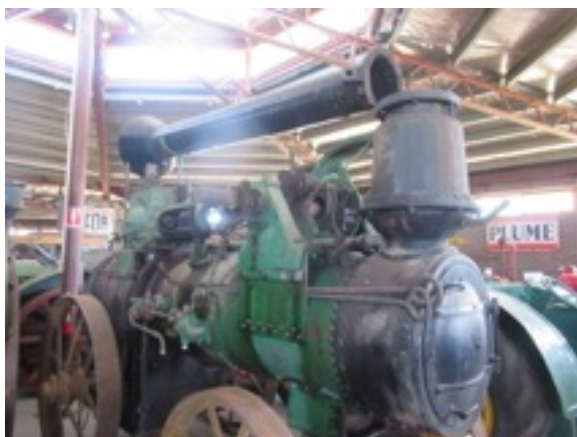
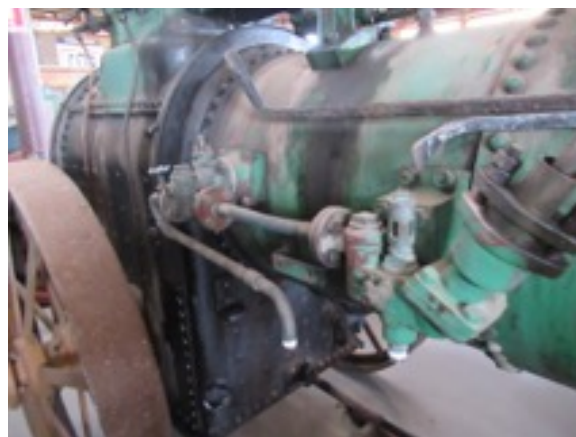
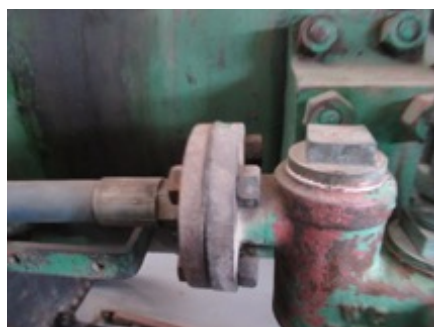
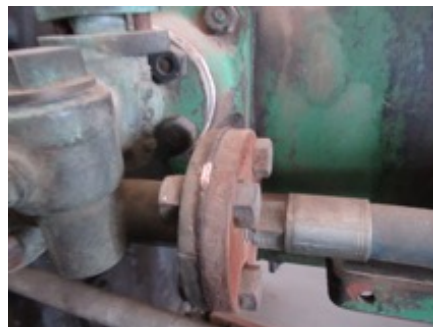
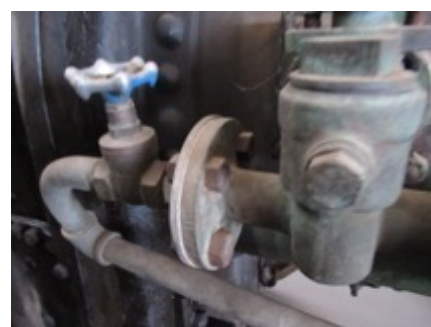
Area 20**Museum: Steam Tractor. The Exhaust flange - gasket (Compound Material) has Asbestos Containing Material (ACM) present.****RISK ASSESSMENT**

Type of Asbestos or Hazardous Material	Chrysotile	Condition	POOR	Likelihood of Damage	M (Medium) - likely
	Sample taken 62133-012	Activity	Moderate		
		Sealed	No	Friability	Exposed Fibres
		Labelled	Y	Exposure Risk	Medium - Moderate risk
		Quantity

Unbonded surface

- 20 Museum: Steam Tractor. The Exhaust flange - gasket (Compound Material) has Asbestos Containing Material (ACM) present.**
- Unbonded surface - The area requires immediate remedial repairs. It is recommended the asbestos material be replaced (preferred) or the material be sealed with an approved membrane.
Reuse/installation of asbestos products is illegal

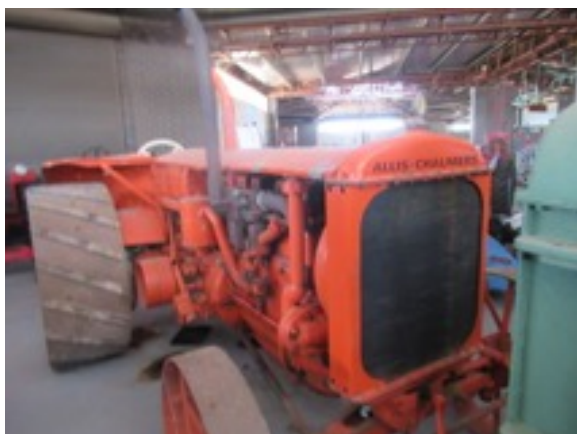
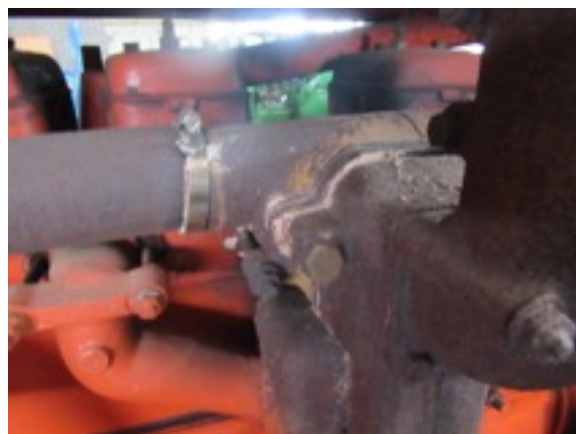
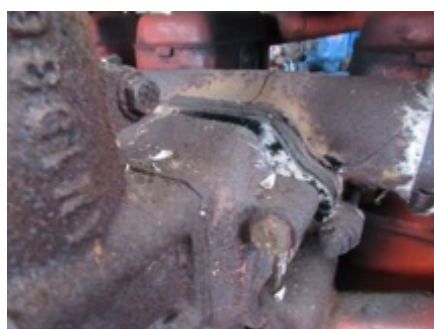
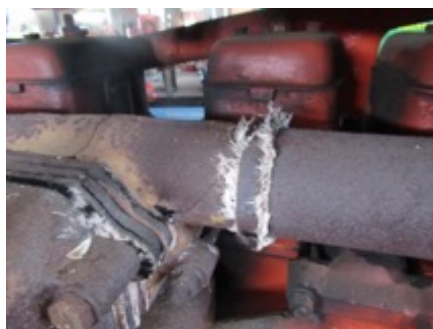
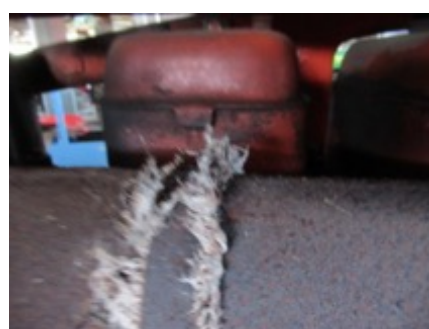
Area 3**Museum: Tractor - Allis Chalmers. The Exhaust Pipe - lagging (Cloth) has Asbestos Containing Material (ACM) present.****RISK ASSESSMENT**

Type of Asbestos or Hazardous Material	Chrysotile	Condition	POOR	Likelihood of Damage	H (High) - almost certain
	Sample taken 62133-013	Activity	Moderate		
		Sealed	No	Friability	Friable
		Labelled	Y	Exposure Risk	High - Short term exposure risk
		Quantity

Unbonded surface

- 3 Museum: Tractor - Allis Chalmers. The Exhaust Pipe - lagging (Cloth) has Asbestos Containing Material (ACM) present.**
- Friable Unbonded surface - The area requires immediate remedial repairs. It is recommended the asbestos material be removed.
Reuse/installation of asbestos products is illegal

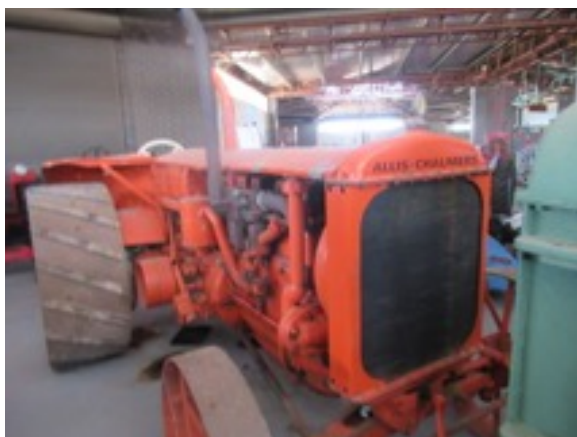
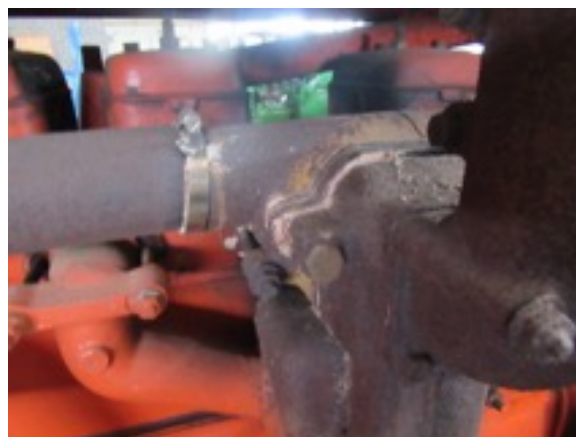
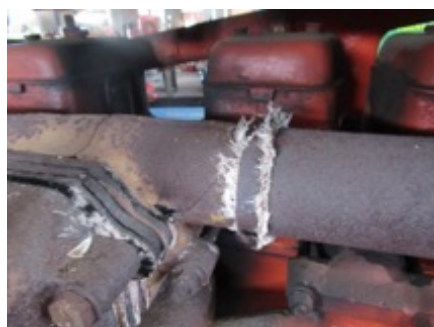
Type of Asbestos or Hazardous Material	Chrysotile	Condition	POOR	Likelihood of Damage	M (Medium) - likely
	Sample taken 62133-014	Activity	Moderate		
		Sealed	No	Friability	Exposed Fibres
		Labelled	Y	Exposure Risk	High - Short term exposure risk
		Quantity

Unbonded surface

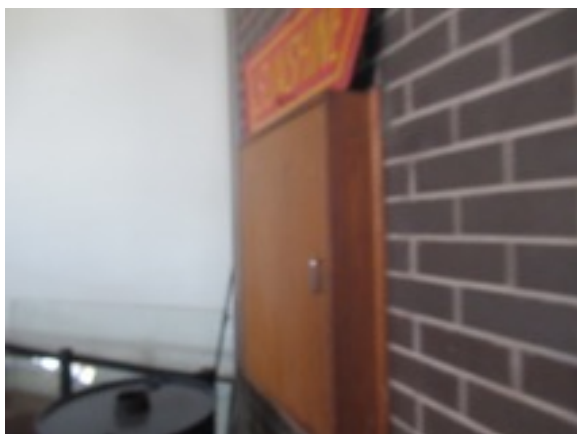
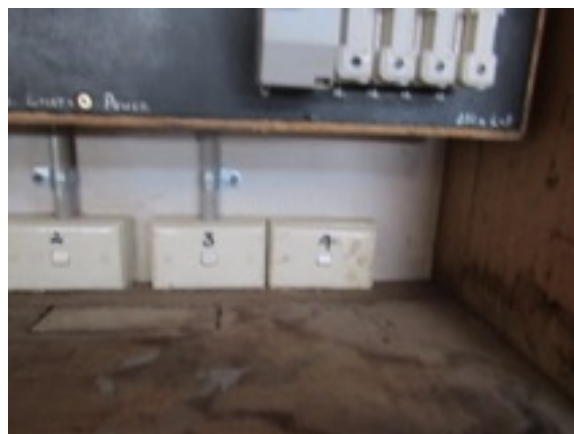
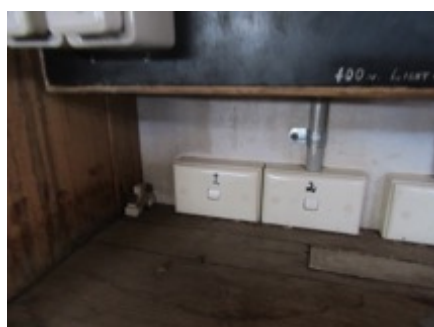
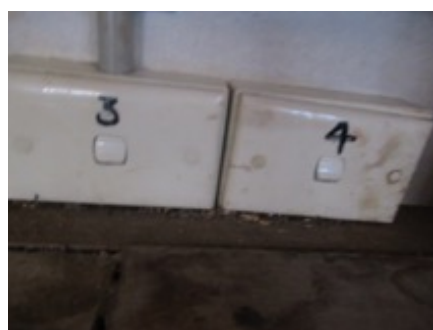
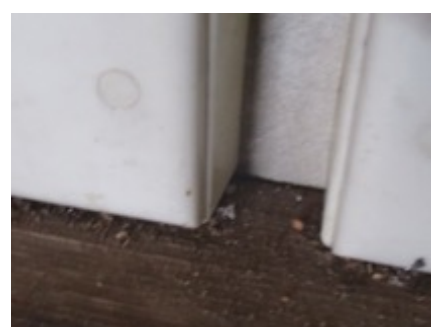
Area 1**Museum: Display areas (x3). The Electrical Cabinet (Debris) has Asbestos Containing Material (ACM) present.****RISK ASSESSMENT**

Type of Asbestos or Hazardous Material	No sample taken - Visual ID	Condition	POOR	Likelihood of Damage	H (High) - almost certain
		Activity	Low		
		Sealed	No	Friability	Exposed Fibres
		Labelled	Y	Exposure Risk	High - Short term exposure risk
		Quantity

Debris on Surface

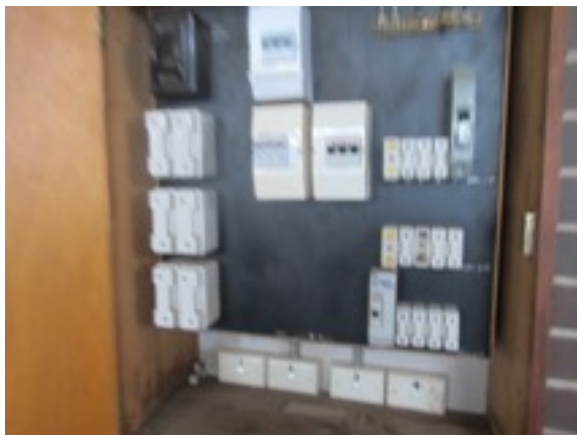
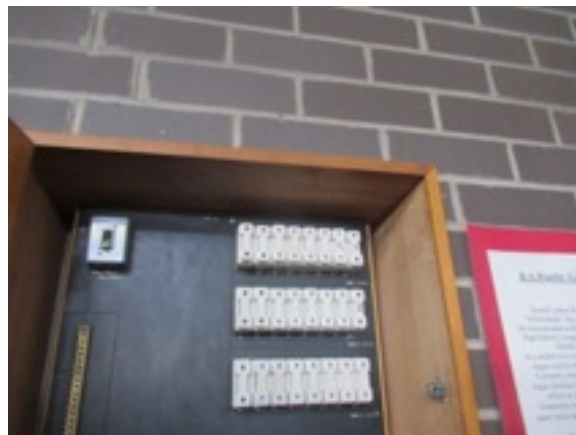
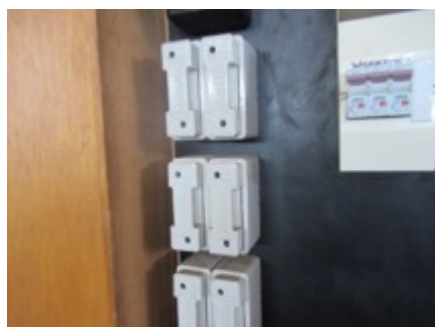
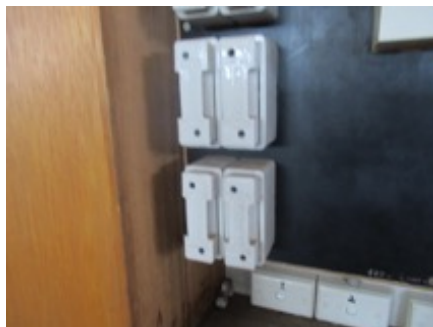
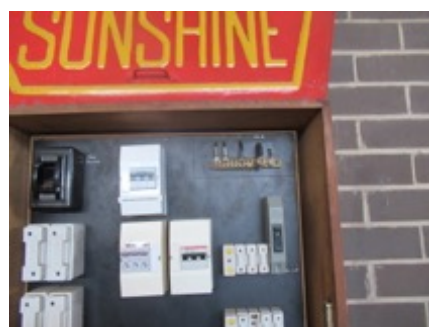
Area 16**Museum: Display areas (x3). The A: Electrical board; B: Ceramic Fuses (A: Zelemite; B: Cloth Inserts) has Asbestos Containing Material (ACM) present.****RISK ASSESSMENT**

Type of Asbestos or Hazardous Material	No sample taken - Visual ID	Condition	AVERAGE	Likelihood of Damage	L (Low) – possible
		Activity	Moderate		
		Sealed	No	Friability	Bonded (non-friable)
		Labelled	Y	Exposure Risk	Medium - Moderate risk
		Quantity

Raw Material

Priority	HIGH	Label Required	Yes	Re- Audit Date	16 Feb 2022
Action	Remedial repairs required - seal raw material / edges				
Recommendation	Raw material sheeting - The area requires immediate remedial repairs. It is recommended the asbestos material be sealed with an approved membrane. Do not remove the fuses without asbestos controls - test for cloth inserts				
Legislative Requirements Victorian Regulation 2007	Damaged ACM visible in area. Requires IMMEDIATE ATTENTION. WARNING labels should be affixed. Avoid mechanical damage and abrasion. Remove if refurbishment, structural alteration or demolition is to be carried out in this area. Re-inspect every 12 months or earlier if disturbed or removed in accordance with the Victorian OH&S Regulation 2017. All remedial/removal repairs require a Clearance Inspection & Certificate to be recorded by an approved and competent assessor.

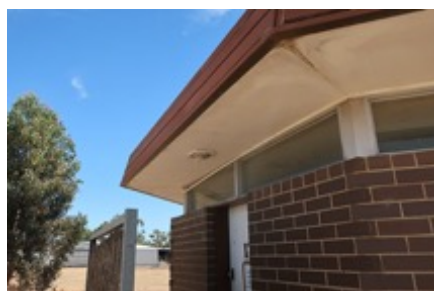
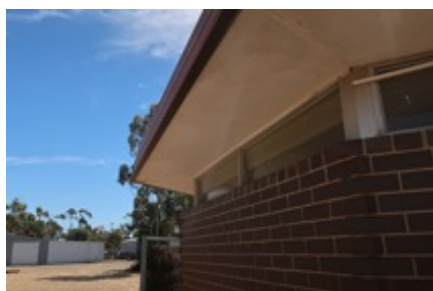
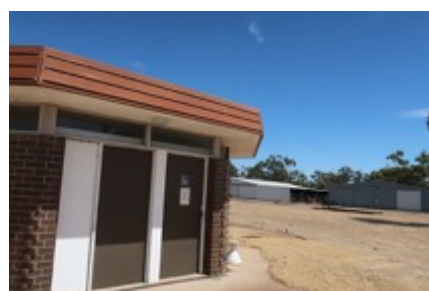
Area 25**Toilets: entire perimeter of building. The Soffit (F C Sheeting) has Asbestos Containing Material (ACM) present.****RISK ASSESSMENT**

Type of Asbestos or Hazardous Material	No sample taken - Visual ID	Condition	GOOD	Likelihood of Damage	L (Low) – possible
		Activity	Moderate		
		Sealed	Yes	Friability	Bonded (non-friable)
		Labelled	Y	Exposure Risk	Low - Negligible or low risk
		Quantity

Maintain paint or sealant

Priority	MEDIUM	Label Required	Yes	Re- Audit Date	16 Feb 2022
Action	No remedial action required, unless disturbed				
Recommendation	Maintain paint or sealant to ACM surfaces. Particular attention should be given to side edges, ensure paint/sealant covers ALL exposed ACM surfaces.				
Legislative Requirements Victorian Regulation 2007	Warning labels should be affixed. Avoid mechanical damage and abrasion. Remove if refurbishment, structural alteration or demolition is to be carried out in this area. Re-inspect every 12 months or earlier if disturbed or removed in accordance with the Victorian OH&S Regulation 2017. All remedial/removal repairs require a Clearance Inspection & Certificate to be recorded by an approved and competent assessor.

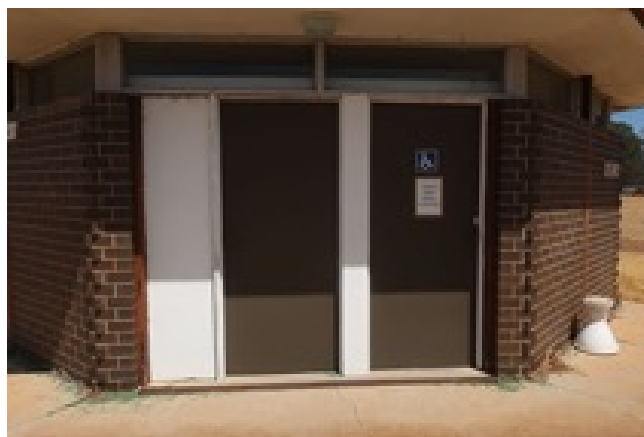
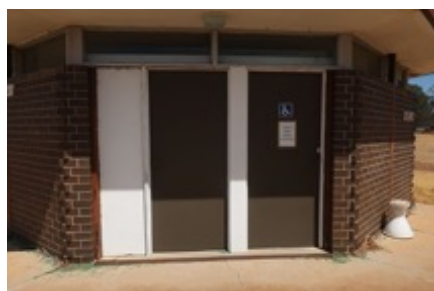
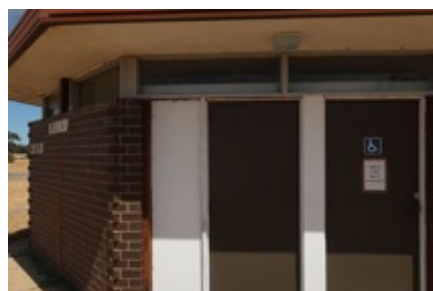
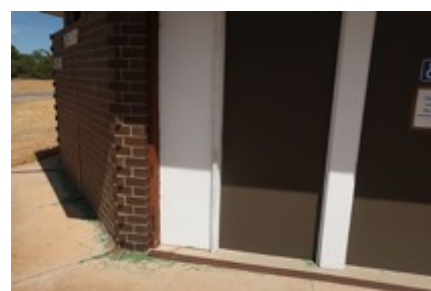
Type of Asbestos or Hazardous Material	No sample taken - Visual ID	Condition	GOOD	Likelihood of Damage	L (Low) – possible
		Activity	Moderate		
		Sealed	Yes	Friability	Bonded (non-friable)
		Labelled	Y	Exposure Risk	Low - Negligible or low risk
		Quantity

Maintain paint or sealant

Priority	MEDIUM	Label Required	Yes	Re- Audit Date	16 Feb 2022
Action	No remedial action required, unless disturbed				
Recommendation	Maintain paint or sealant to ACM surfaces. Particular attention should be given to side edges, ensure paint/sealant covers ALL exposed ACM surfaces.				
Legislative Requirements Victorian Regulation 2007	Warning labels should be affixed. Avoid mechanical damage and abrasion. Remove if refurbishment, structural alteration or demolition is to be carried out in this area. Re-inspect every 12 months or earlier if disturbed or removed in accordance with the Victorian OH&S Regulation 2017. All remedial/removal repairs require a Clearance Inspection & Certificate to be recorded by an approved and competent assessor.

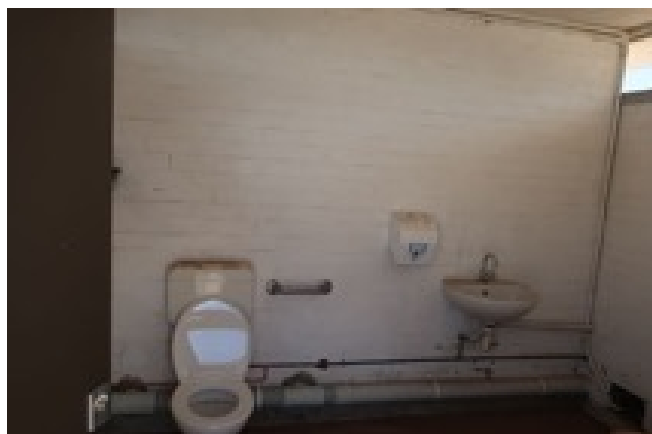
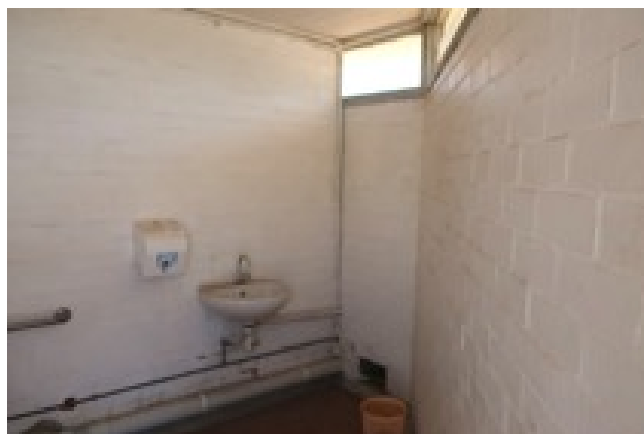
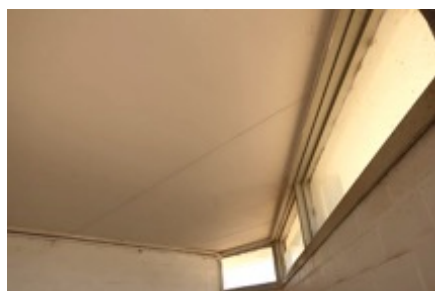
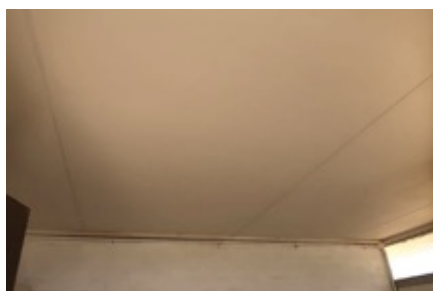
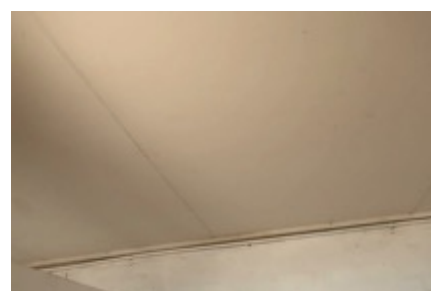
Area 24**Toilets: Disabled bathroom 1. The Ceiling (F C Sheeting) has Asbestos Containing Material (ACM) present.****RISK ASSESSMENT**

Type of Asbestos or Hazardous Material	No sample taken - Visual ID	Condition	GOOD	Likelihood of Damage	L (Low) – possible
		Activity	Moderate		
		Sealed	Yes	Friability	Bonded (non-friable)
		Labelled	Y	Exposure Risk	Low - Negligible or low risk
		Quantity

Maintain paint or sealant

Priority	MEDIUM	Label Required	Yes	Re- Audit Date	16 Feb 2022
Action	No remedial action required, unless disturbed				
Recommendation	Maintain paint or sealant to ACM surfaces. Particular attention should be given to side edges, ensure paint/sealant covers ALL exposed ACM surfaces.				
Legislative Requirements Victorian Regulation 2007	Warning labels should be affixed. Avoid mechanical damage and abrasion. Remove if refurbishment, structural alteration or demolition is to be carried out in this area. Re-inspect every 12 months or earlier if disturbed or removed in accordance with the Victorian OH&S Regulation 2017. All remedial/removal repairs require a Clearance Inspection & Certificate to be recorded by an approved and competent assessor.

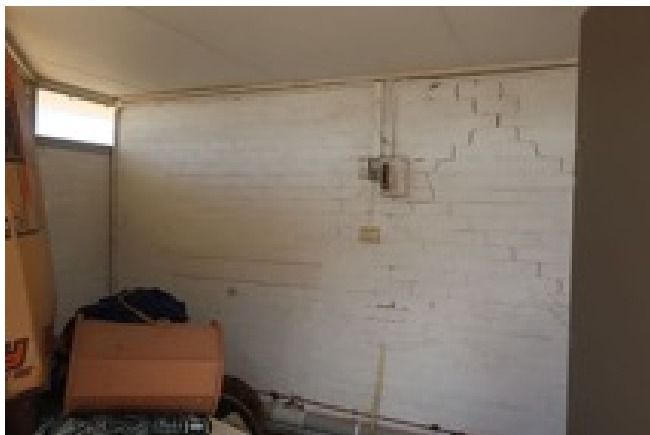
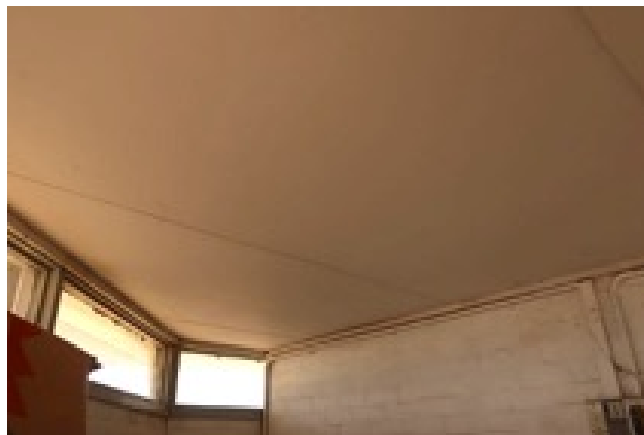
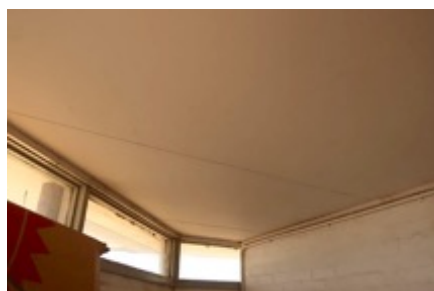
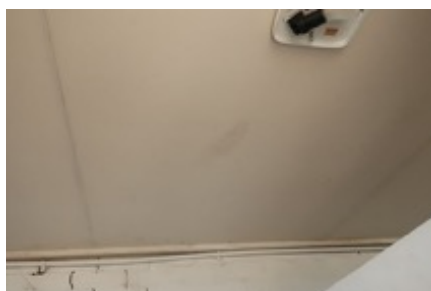
Area 29**Toilets: Storage 2. The Ceiling (F C Sheeting) has Asbestos Containing Material (ACM) present.****RISK ASSESSMENT**

Type of Asbestos or Hazardous Material	No sample taken - Visual ID	Condition	GOOD	Likelihood of Damage	L (Low) – possible
		Activity	Moderate		
		Sealed	Yes	Friability	Bonded (non-friable)
		Labelled	Y	Exposure Risk	Low - Negligible or low risk
		Quantity

Maintain paint or sealant

Priority	MEDIUM	Label Required	Yes	Re- Audit Date	16 Feb 2022
Action	No remedial action required, unless disturbed				
Recommendation	Maintain paint or sealant to ACM surfaces. Particular attention should be given to side edges, ensure paint/sealant covers ALL exposed ACM surfaces.				
Legislative Requirements Victorian Regulation 2007	Warning labels should be affixed. Avoid mechanical damage and abrasion. Remove if refurbishment, structural alteration or demolition is to be carried out in this area. Re-inspect every 12 months or earlier if disturbed or removed in accordance with the Victorian OH&S Regulation 2017. All remedial/removal repairs require a Clearance Inspection & Certificate to be recorded by an approved and competent assessor.

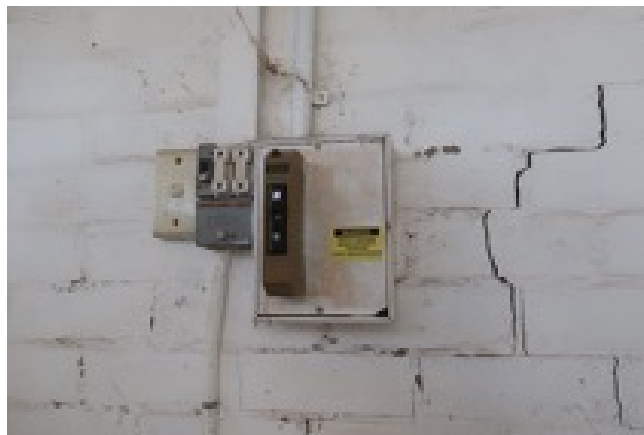
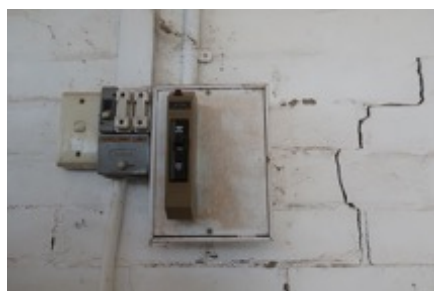
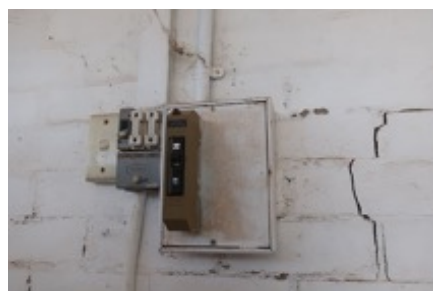
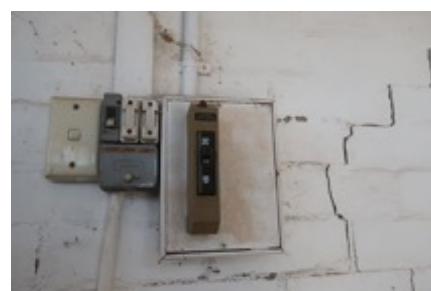
Type of Asbestos or Hazardous Material	Chrysotile Sample taken 62133-001	Condition	GOOD	Likelihood of Damage	L (Low) – possible
		Activity	Moderate		
		Sealed	Yes	Friability	Bonded (non-friable)
		Labelled	Y	Exposure Risk	Low - Negligible or low risk
		Quantity

Maintain paint or sealant

Priority	MEDIUM	Label Required	Yes	Re- Audit Date	16 Feb 2022
Action	No remedial action required, unless disturbed				
Recommendation	Maintain paint or sealant to ACM surfaces. Particular attention should be given to side edges, ensure paint/sealant covers ALL exposed ACM surfaces.				
Legislative Requirements Victorian Regulation 2007	Warning labels should be affixed. Avoid mechanical damage and abrasion. Remove if refurbishment, structural alteration or demolition is to be carried out in this area. Re-inspect every 12 months or earlier if disturbed or removed in accordance with the Victorian OH&S Regulation 2017. All remedial/removal repairs require a Clearance Inspection & Certificate to be recorded by an approved and competent assessor.

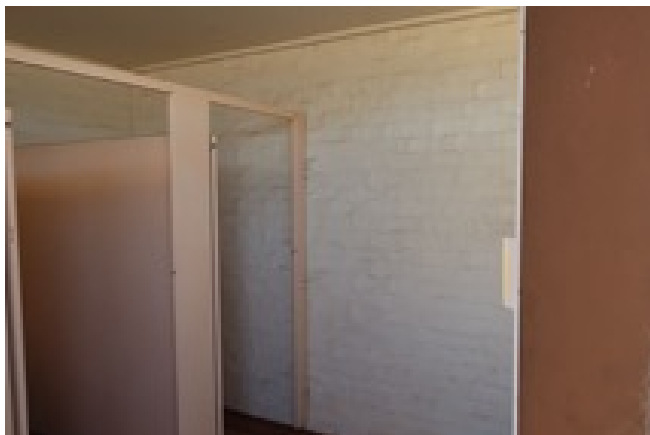
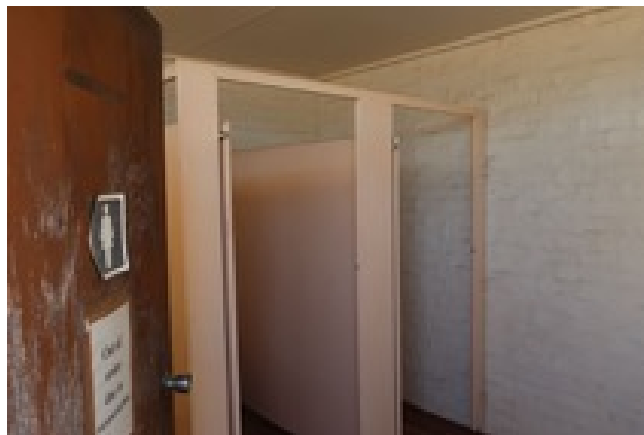
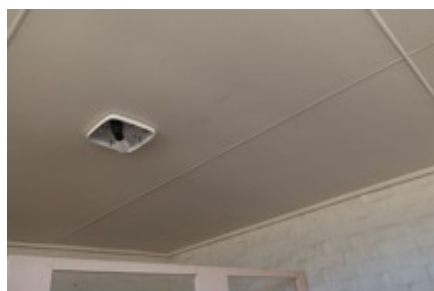
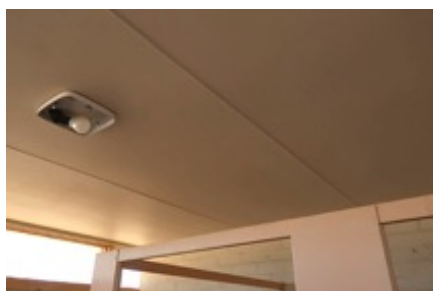
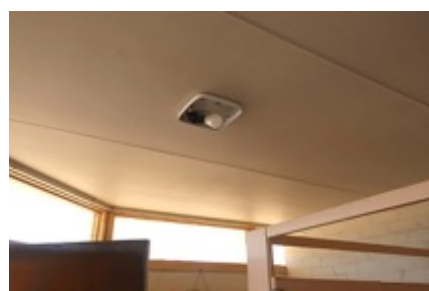
Area 26**Toilets: Female bathroom 3. The Ceiling (F C Sheeting) has Asbestos Containing Material (ACM) present.****RISK ASSESSMENT**

Type of Asbestos or Hazardous Material	No sample taken - Visual ID	Condition	GOOD	Likelihood of Damage	L (Low) – possible
		Activity	Moderate		
		Sealed	Yes	Friability	Bonded (non-friable)
		Labelled	Y	Exposure Risk	Low - Negligible or low risk
		Quantity

Maintain paint or sealant

Priority	MEDIUM	Label Required	Yes	Re- Audit Date	16 Feb 2022
Action	No remedial action required, unless disturbed				
Recommendation	Maintain paint or sealant to ACM surfaces. Particular attention should be given to side edges, ensure paint/sealant covers ALL exposed ACM surfaces.				
Legislative Requirements Victorian Regulation 2007	Warning labels should be affixed. Avoid mechanical damage and abrasion. Remove if refurbishment, structural alteration or demolition is to be carried out in this area. Re-inspect every 12 months or earlier if disturbed or removed in accordance with the Victorian OH&S Regulation 2017. All remedial/removal repairs require a Clearance Inspection & Certificate to be recorded by an approved and competent assessor.

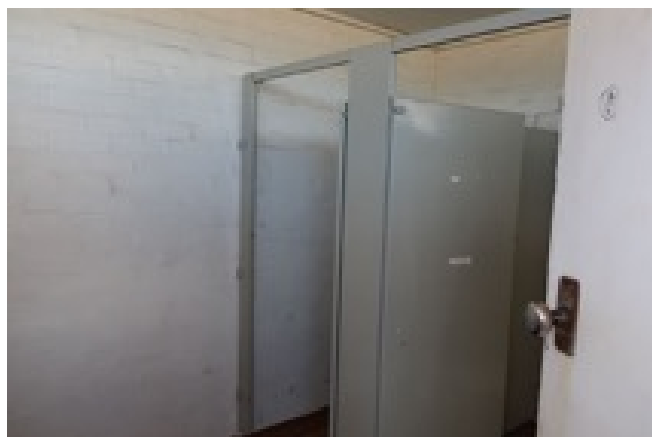
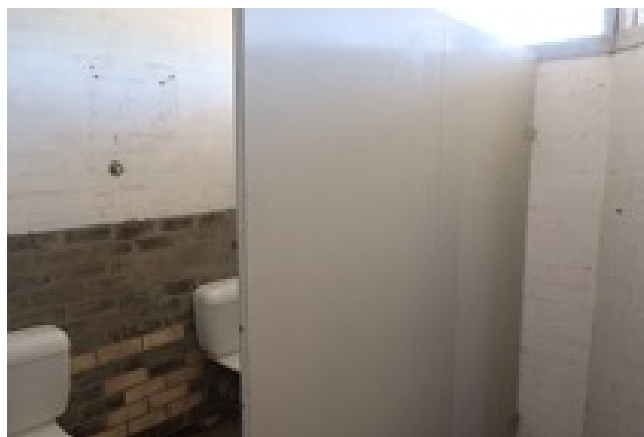
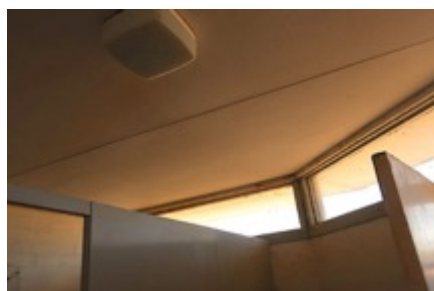
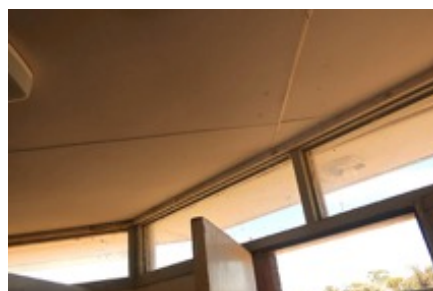
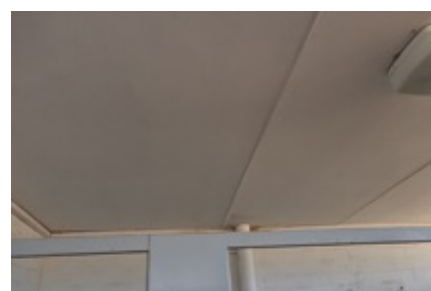
Area 28**Toilets: Male bathroom 4. The Ceiling (F C Sheeting) has Asbestos Containing Material (ACM) present.****RISK ASSESSMENT**

Type of Asbestos or Hazardous Material	No sample taken - Visual ID	Condition	GOOD	Likelihood of Damage	L (Low) – possible
		Activity	Moderate		
		Sealed	Yes	Friability	Bonded (non-friable)
		Labelled	Y	Exposure Risk	Low - Negligible or low risk
		Quantity

Maintain paint or sealant

Priority	MEDIUM	Label Required	Yes	Re- Audit Date	16 Feb 2022
Action	No remedial action required, unless disturbed				
Recommendation	Maintain paint or sealant to ACM surfaces. Particular attention should be given to side edges, ensure paint/sealant covers ALL exposed ACM surfaces.				
Legislative Requirements Victorian Regulation 2007	Warning labels should be affixed. Avoid mechanical damage and abrasion. Remove if refurbishment, structural alteration or demolition is to be carried out in this area. Re-inspect every 12 months or earlier if disturbed or removed in accordance with the Victorian OH&S Regulation 2017. All remedial/removal repairs require a Clearance Inspection & Certificate to be recorded by an approved and competent assessor.

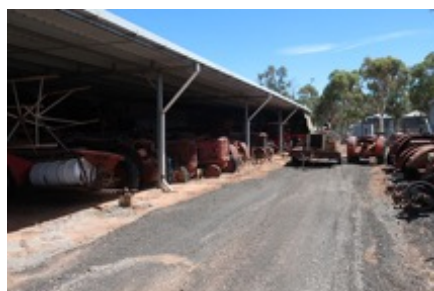
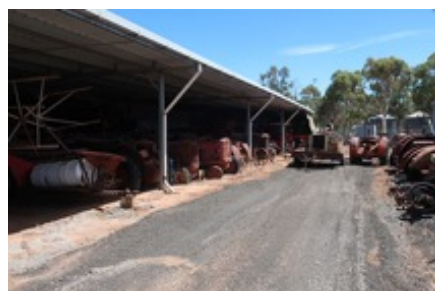
Area 14

Type of Asbestos or Hazardous Material	No sample taken - Visual ID	Condition	POOR	Likelihood of Damage	M (Medium) - likely
		Activity	Moderate		
		Sealed	No	Friability	Exposed Fibres
		Labelled	Y	Exposure Risk	Medium - Moderate risk
		Quantity

Unbonded surface

Priority	HIGH	Label Required	Yes	Re- Audit Date	16 Feb 2022
Action	Remove during normal maintenance or refurbishment				
Recommendation	Unbonded surface - The area requires immediate remedial repairs. It is recommended the asbestos material be replaced (preferred) or the material be sealed with an approved membrane. Reuse/installation of asbestos products is illegal				
Legislative Requirements Victorian Regulation 2007	Reuse/installation of asbestos products is illegal URGENT - ACM visible in area. Asbestos removal consultant are urgently required. Immediately cease any access to the area and affix warning signs to all entry points. Re-inspect every 12 months or earlier if disturbed or removed in accordance with the Victorian OH&S Regulation 2017. All remedial/removal repairs require a Clearance Inspection & Certificate to be recorded by an approved and competent assessor.

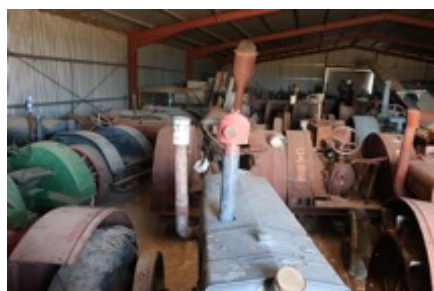
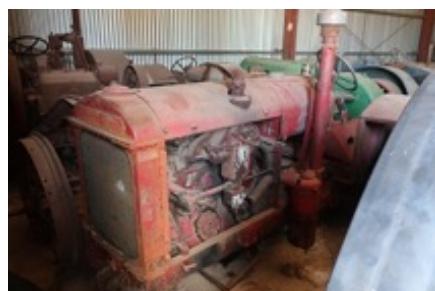
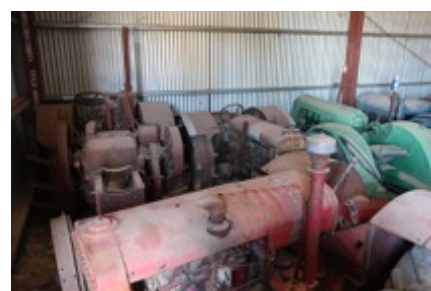
Area 15**John Roberts Land Building: Shed 1. The Tractors & Machinery (Various - Gaskets, Brake pads, Insulating Materials) has Asbestos Containing Material (ACM) present.****RISK ASSESSMENT**

Type of Asbestos or Hazardous Material	No sample taken - Visual ID	Condition	POOR	Likelihood of Damage	M (Medium) - likely
		Activity	Moderate		
		Sealed	No	Friability	Exposed Fibres
		Labelled	Y	Exposure Risk	Medium - Moderate risk
		Quantity

Unbonded surface

Priority	HIGH	Label Required	Yes	Re- Audit Date	16 Feb 2022
Action	Remove during normal maintenance or refurbishment				
Recommendation	Unbonded surface - The area requires immediate remedial repairs. It is recommended the asbestos material be replaced (preferred) or the material be sealed with an approved membrane. Reuse/installation of asbestos products is illegal				
Legislative Requirements Victorian Regulation 2007	Reuse/installation of asbestos products is illegal URGENT - ACM visible in area. Asbestos removal consultant are urgently required. Immediately cease any access to the area and affix warning signs to all entry points. Re-inspect every 12 months or earlier if disturbed or removed in accordance with the Victorian OH&S Regulation 2017. All remedial/removal repairs require a Clearance Inspection & Certificate to be recorded by an approved and competent assessor.

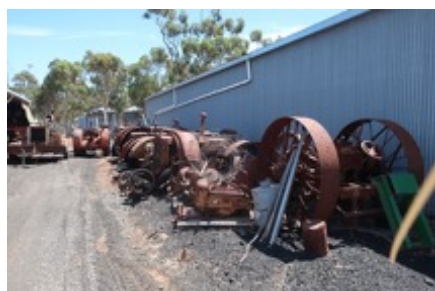
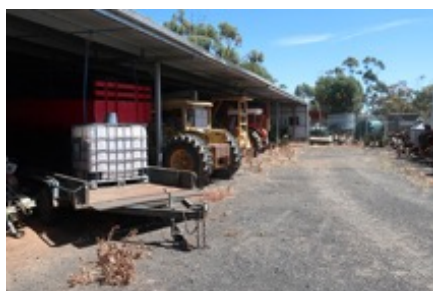
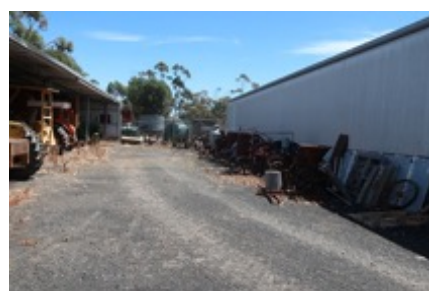
Area 12

Type of Asbestos or Hazardous Material	No sample taken - Visual ID	Condition	POOR	Likelihood of Damage	M (Medium) - likely
		Activity	Moderate		
		Sealed	No	Friability	Exposed Fibres
		Labelled	Y	Exposure Risk	Medium - Moderate risk
		Quantity

Unbonded surface

Priority	HIGH	Label Required	Yes	Re- Audit Date	16 Feb 2022
Action	Restrict access and enclose or encapsulate or seal				
Recommendation	Unbonded surface - The area requires immediate remedial repairs. It is recommended the asbestos material be replaced (preferred) or the material be sealed with an approved membrane. Reuse/installation of asbestos products is illegal				
Legislative Requirements Victorian Regulation 2007	Reuse/installation of asbestos products is illegal URGENT - ACM visible in area. Asbestos removal consultant are urgently required. Immediately cease any access to the area and affix warning signs to all entry points. Re-inspect every 12 months or earlier if disturbed or removed in accordance with the Victorian OH&S Regulation 2017. All remedial/removal repairs require a Clearance Inspection & Certificate to be recorded by an approved and competent assessor.

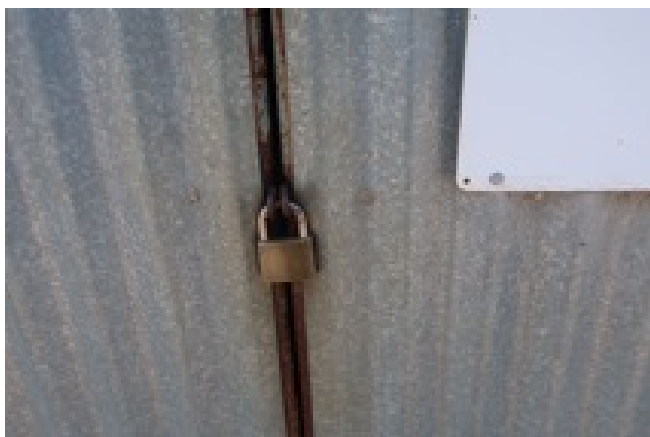
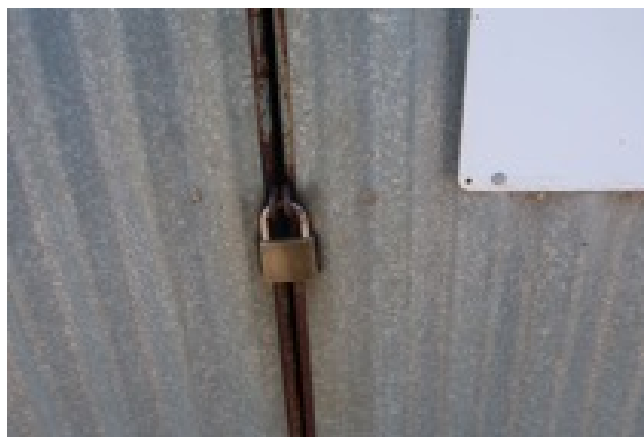
Area 11***B.P.Kelm Building: . Until the area is inspected, it should be managed as if it Asbestos Containing Material (ACM) is present.*****RISK ASSESSMENT**

Type of Asbestos or Hazardous Material	No sample taken - No Access	Condition		Likelihood of Damage	
		Activity			
		Sealed		Friability	
		Labelled	No	Exposure Risk	
		Quantity

Priority	HIGH	Label Required	Yes	Re- Audit Date	16 Feb 2022
Action					
Recommendation					
Legislative Requirements Victorian Regulation 2007	Unable to Gain Access. Assume asbestos in area and provide monitoring if work undertaken in these areas. If access is made available, contact Global Asbestos Audits for re-inspection

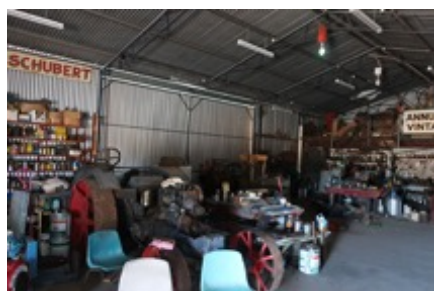
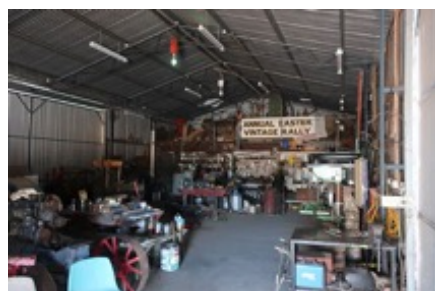
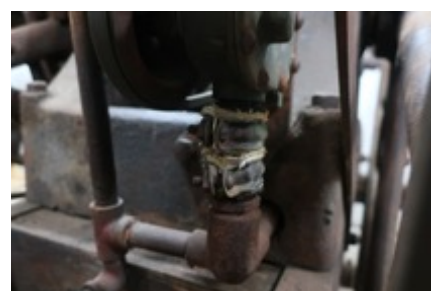
Area 23

Type of Asbestos or Hazardous Material	No sample taken - Visual ID	Condition	POOR	Likelihood of Damage	M (Medium) - likely
		Activity	Moderate		
		Sealed	No	Friability	Exposed Fibres
		Labelled	Y	Exposure Risk	Medium - Moderate risk
		Quantity

Unbonded surface

Priority	HIGH	Label Required	Yes	Re- Audit Date	16 Feb 2022
Action	Remove during normal maintenance or refurbishment				
Recommendation	Unbonded surface - The area requires immediate remedial repairs. It is recommended the asbestos material be replaced (preferred) or the material be sealed with an approved membrane. Reuse/installation of asbestos products is illegal				
Legislative Requirements Victorian Regulation 2007	Reuse/installation of asbestos products is illegal URGENT - ACM visible in area. Asbestos removal consultant are urgently required. Immediately cease any access to the area and affix warning signs to all entry points. Re-inspect every 12 months or earlier if disturbed or removed in accordance with the Victorian OH&S Regulation 2017. All remedial/removal repairs require a Clearance Inspection & Certificate to be recorded by an approved and competent assessor.

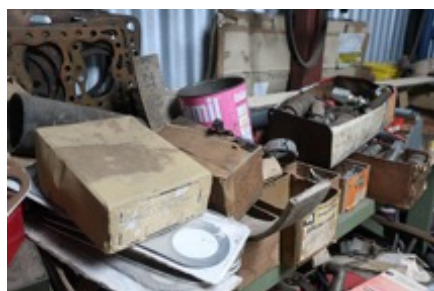
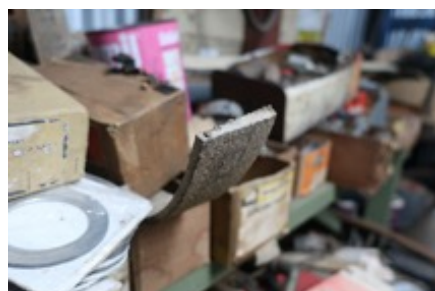
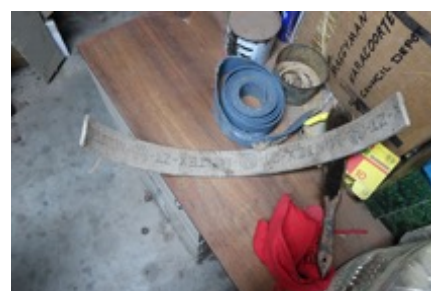
Area 6**Workshop: Ground Floor Storage 2. The Brake pads (Compound Material) has Asbestos Containing Material (ACM) present.****RISK ASSESSMENT**

Type of Asbestos or Hazardous Material	Chrysotile	Condition	POOR	Likelihood of Damage	H (High) - almost certain
	Sample taken 62133-002	Activity	Moderate		
		Sealed	No	Friability	Friable
		Labelled	Y	Exposure Risk	High - Short term exposure risk
		Quantity

Not in-situ

Priority	IMMEDIATE	Label Required	Yes	Re- Audit Date	16 Feb 2022
Action	Restrict access and target for imminent removal				
Recommendation	<p>Friction material - Stored & Unbonded asbestos materials - The area requires immediate remedial repairs. It is recommended the asbestos material be removed.</p> <p>Stored & Reuse/installation of asbestos products is illegal.</p> <p>The storage area will require full remediation</p>				
Legislative Requirements Victorian Regulation 2007	<p>URGENT - ACM visible in area. Asbestos removal consultant are urgently required. Immediately cease any access to the area and affix warning signs to all entry points. Avoid physical and mechanical damage. Re-inspect every 12 months or earlier if disturbed or removed in accordance with the Victorian OH&S Regulation 2017.</p> <p>All remedial/removal repairs require a Clearance Inspection & Certificate to be recorded by an approved and competent assessor.</p>
