Asbestos Report

YARRIAMBIACK SHIRE COUNCIL

PROPERTY ADDRESS:
LB6 MUSEUM WHEAT
34 HENTY HIGHWAY
WARRACKNABEAL VIC 3393

INSPECTION DATE: 16 FEBRUARY 2021
REFERENCE NUMBER: 62133

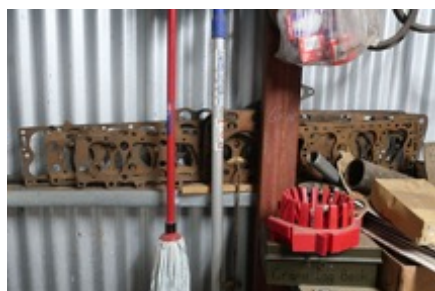
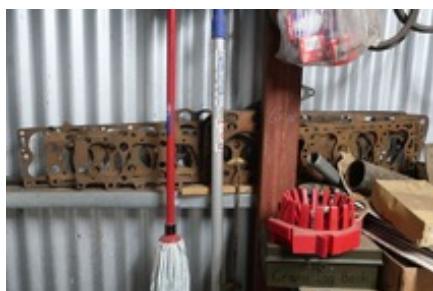
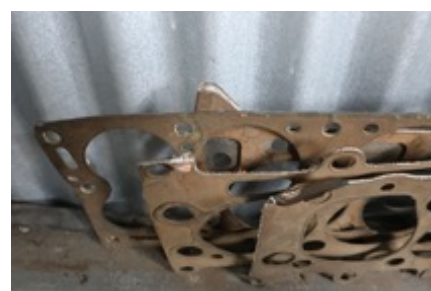
Area 7**Workshop: Ground Floor Storage 2. The Gaskets (Compound Material) has Asbestos Containing Material (ACM) present.****RISK ASSESSMENT**

Type of Asbestos or Hazardous Material	Chrysotile	Condition	POOR	Likelihood of Damage	H (High) - almost certain
	Sample taken 62133-003	Activity	Moderate		
		Sealed	No	Friability	Friable
		Labelled	Y	Exposure Risk	High - Short term exposure risk
		Quantity

Not in-situ

Priority	IMMEDIATE	Label Required	Yes	Re- Audit Date	16 Feb 2022
Action	Restrict access and target for imminent removal				
Recommendation	<p>Stored & Unbonded asbestos materials - The area requires immediate remedial repairs. It is recommended the asbestos material be removed.</p> <p>Stored & Reuse/installation of asbestos products is illegal.</p> <p>The storage area will require full remediation</p>				
Legislative Requirements Victorian Regulation 2007	<p>Reuse/installation of asbestos products is illegal</p> <p>URGENT - ACM visible in area. The ACM appears to be of a friable nature. The services of an "A" class Asbestos removal consultant are urgently required. Immediately cease any access to the area and affix warning signs to all entry points. Re-inspect every 12 months or earlier if disturbed or removed in accordance with the Victorian OH&S Regulation 2017.</p> <p>All remedial/removal repairs require a Clearance Inspection & Certificate to be recorded by an approved and competent assessor.</p>

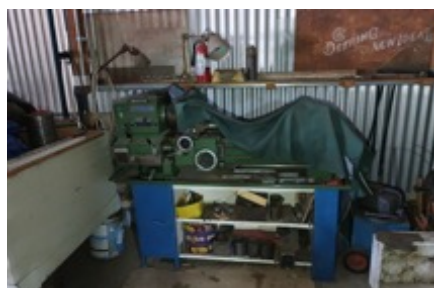
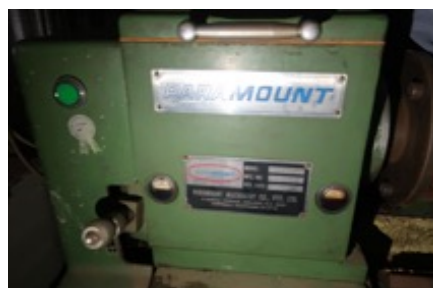
Type of Asbestos or Hazardous Material	No sample taken - Visual ID	Condition	AVERAGE	Likelihood of Damage	H (High) - almost certain
		Activity	Moderate		
		Sealed	Yes	Friability	Exposed Fibres
		Labelled	Y	Exposure Risk	Medium - Moderate risk
		Quantity

Maintain paint or sealant

Priority	IMMEDIATE	Label Required	Yes	Re- Audit Date	16 Feb 2022
Action	Restrict access and target for imminent removal				
Recommendation	Friction material - Unbonded surface - The area requires immediate remedial repairs. It is recommended the asbestos material be replaced Contamination dust will exist in the area. Testing of Brake pads/belts is recommended before removal - access to the area will be required.				
Legislative Requirements Victorian Regulation 2007	URGENT - ACM visible in area. Asbestos removal consultant are urgently required. Immediately cease any access to the area and affix warning signs to all entry points. Re-inspect every 12 months or earlier if disturbed or removed in accordance with the Victorian OH&S Regulation 2017. All remedial/removal repairs require a Clearance Inspection & Certificate to be recorded by an approved and competent assessor.

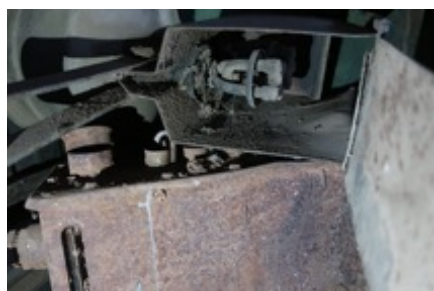
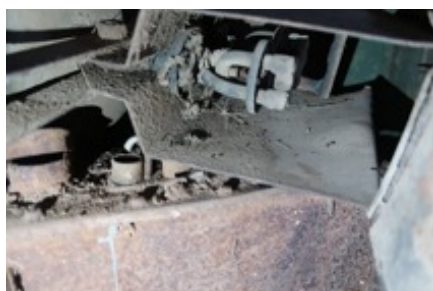
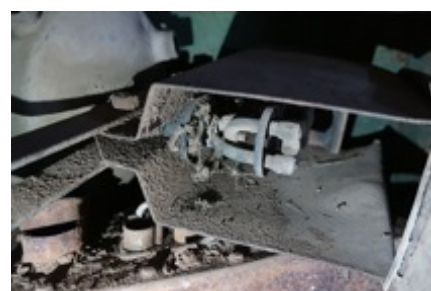
Area 9**Workshop: Mezzanine 1 Mezzanine 3. The Electrical wire (Fire Retardant cloth) has Asbestos Containing Material (ACM) present.****RISK ASSESSMENT**

Type of Asbestos or Hazardous Material	Chrysotile	Condition	POOR	Likelihood of Damage	H (High) - almost certain
	Sample taken 62133-005	Activity	Moderate		
		Sealed	No	Friability	Friable
		Labelled	Y	Exposure Risk	High - Short term exposure risk
		Quantity

Not in-situ

Priority	IMMEDIATE	Label Required	Yes	Re- Audit Date	16 Feb 2022
Action	Restrict access and target for imminent removal				
Recommendation	<p>Stored & Unbonded asbestos materials - The area requires immediate remedial repairs. It is recommended the asbestos material be removed.</p> <p>Stored & Reuse/installation of asbestos products is illegal.</p> <p>The storage area will require full remediation</p>				
Legislative Requirements Victorian Regulation 2007	<p>Reuse/installation of asbestos products is illegal</p> <p>URGENT - ACM visible in area. The ACM appears to be of a friable nature. The services of an "A" class Asbestos removal consultant are urgently required. Immediately cease any access to the area and affix warning signs to all entry points. Re-inspect every 12 months or earlier if disturbed or removed in accordance with the Victorian OH&S Regulation 2017.</p> <p>All remedial/removal repairs require a Clearance Inspection & Certificate to be recorded by an approved and competent assessor.</p>

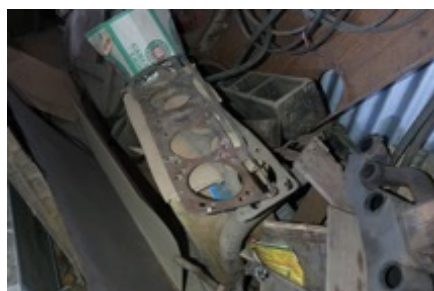
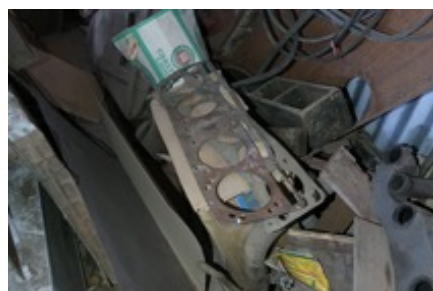
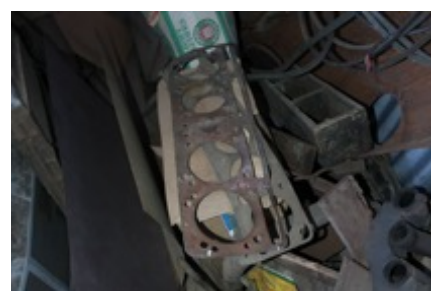
Type of Asbestos or Hazardous Material	Chrysotile	Condition	POOR	Likelihood of Damage	H (High) - almost certain
	Same as Sample - 62133 -003	Activity	Moderate		
		Sealed	No	Friability	Exposed Fibres
		Labelled	Y	Exposure Risk	High - Short term exposure risk
		Quantity

Not in-situ

Unbonded surface

Priority	IMMEDIATE	Label Required	Yes	Re- Audit Date	16 Feb 2022
Action	Restrict access and target for imminent removal				
Recommendation	<p>Stored & Unbonded asbestos materials - The area requires immediate remedial repairs. It is recommended the asbestos material be removed.</p> <p>Stored & Reuse/installation of asbestos products is illegal.</p> <p>The storage area will require full remediation</p>				
Legislative Requirements Victorian Regulation 2007	<p>Reuse/installation of asbestos products is illegal</p> <p>URGENT - ACM visible in area. The ACM appears to be of a friable nature. The services of an "A" class Asbestos removal consultant are urgently required. Immediately cease any access to the area and affix warning signs to all entry points. Re-inspect every 12 months or earlier if disturbed or removed in accordance with the Victorian OH&S Regulation 2017.</p> <p>All remedial/removal repairs require a Clearance Inspection & Certificate to be recorded by an approved and competent assessor.</p>

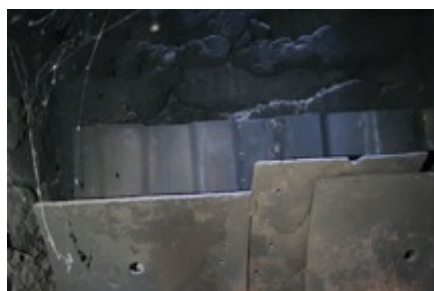
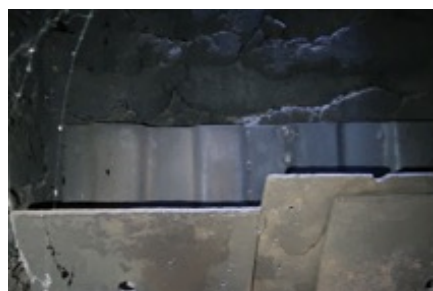
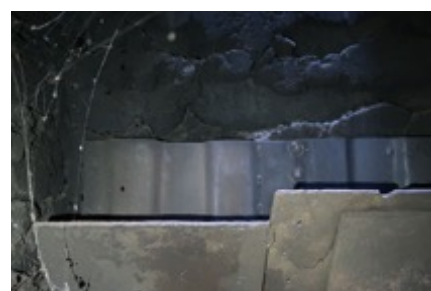
Type of Asbestos or Hazardous Material	No sample taken - Visual ID	Condition	POOR	Likelihood of Damage	H (High) - almost certain
		Activity	High		
		Sealed	No	Friability	Exposed Fibres
		Labelled	Y	Exposure Risk	High - Short term exposure risk
		Quantity

Unbonded surface

Priority	IMMEDIATE	Label Required	Yes	Re- Audit Date	16 Feb 2022
Action	Restrict access and enclose or encapsulate or seal				
Recommendation	Material is breaking down from use - Unbonded surface - The area requires immediate remedial repairs. It is recommended the asbestos sheeting be replaced (preferred) or the material be sealed with an approved membrane.				
Legislative Requirements Victorian Regulation 2007	URGENT - ACM visible in area. Asbestos removal consultant are urgently required. Immediately cease any access to the area and affix warning signs to all entry points. Re-inspect every 12 months or earlier if disturbed or removed in accordance with the Victorian OH&S Regulation 2017. All remedial/removal repairs require a Clearance Inspection & Certificate to be recorded by an approved and competent assessor.

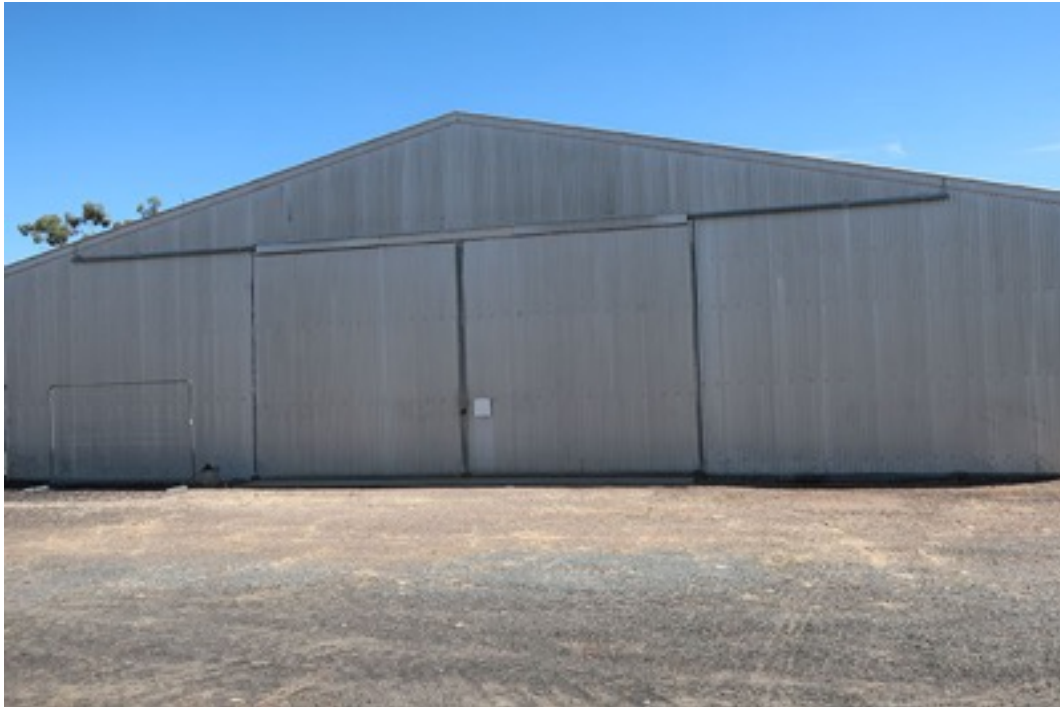
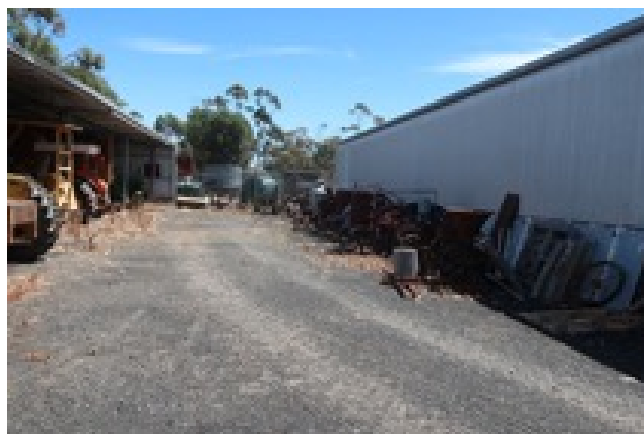
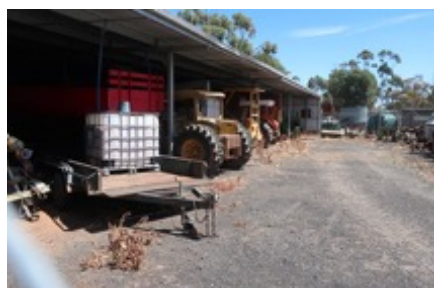
Tractor storage shed

Area 5**Tractor storage shed: left side of building. The Tractors & Machinery (Various - Gaskets, Brake pads, Insulating Materials) has Asbestos Containing Material (ACM) present.****RISK ASSESSMENT**

Type of Asbestos or Hazardous Material	No sample taken - Visual ID	Condition	POOR	Likelihood of Damage	M (Medium) - likely
		Activity	Moderate		
		Sealed	No	Friability	Exposed Fibres
		Labelled	Y	Exposure Risk	High - Short term exposure risk
		Quantity

Unbonded surface

Priority	IMMEDIATE	Label Required	Yes	Re- Audit Date	16 Feb 2022
Action	Restrict access and enclose or encapsulate or seal				
Recommendation	Unbonded surface - The area requires immediate remedial repairs. It is recommended the asbestos material be replaced (preferred) or the material be sealed with an approved membrane. Reuse/installation of asbestos products is illegal				
Legislative Requirements Victorian Regulation 2007	URGENT - ACM visible in area. Asbestos removal consultant are urgently required. Immediately cease any access to the area and affix warning signs to all entry points. Re-inspect every 12 months or earlier if disturbed or removed in accordance with the Victorian OH&S Regulation 2017. All remedial/removal repairs require a Clearance Inspection & Certificate to be recorded by an approved and competent assessor.

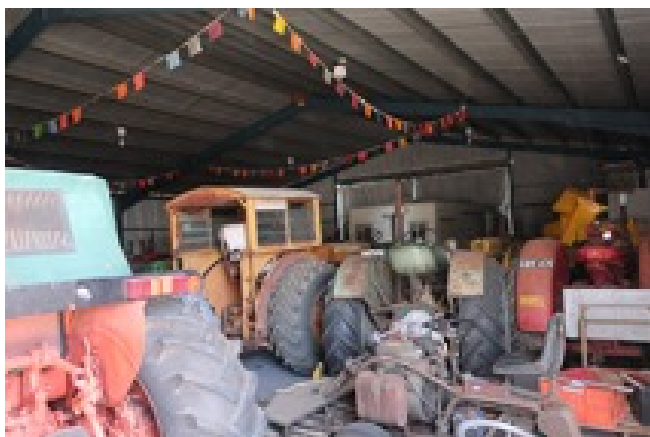
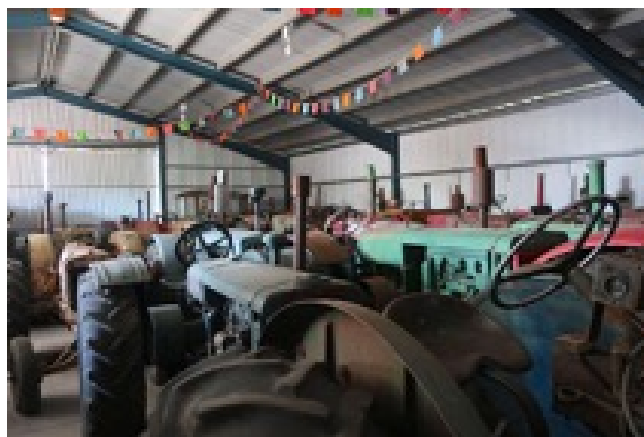
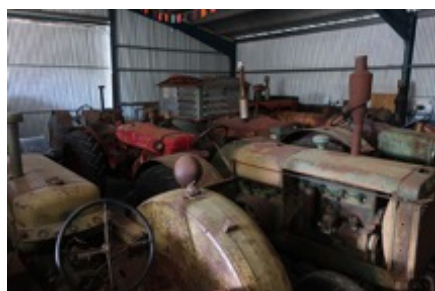
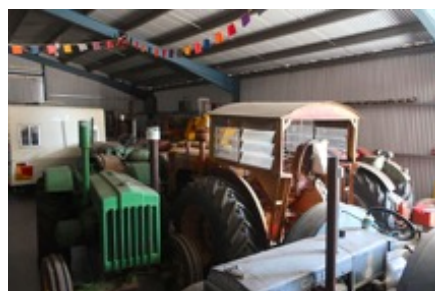
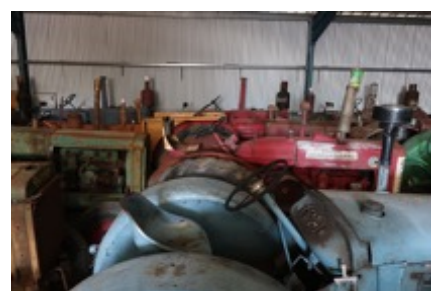
Area 22**Tractor storage shed: Shed 1. The Tractors & Machinery (Various - Gaskets, Brake pads, Insulating Materials) has Asbestos Containing Material (ACM) present.****RISK ASSESSMENT**

Type of Asbestos or Hazardous Material	No sample taken - Visual ID	Condition	POOR	Likelihood of Damage	M (Medium) - likely
		Activity	Moderate		
		Sealed	No	Friability	Exposed Fibres
		Labelled	Y	Exposure Risk	High - Short term exposure risk
		Quantity

Unbonded surface

Priority	HIGH	Label Required	Yes	Re- Audit Date	16 Feb 2022
Action	Restrict access and enclose or encapsulate or seal				
Recommendation	Unbonded surface - The area requires immediate remedial repairs. It is recommended the asbestos material be replaced (preferred) or the material be sealed with an approved membrane. Reuse/installation of asbestos products is illegal				
Legislative Requirements Victorian Regulation 2007	Reuse/installation of asbestos products is illegal URGENT - ACM visible in area. Asbestos removal consultant are urgently required. Immediately cease any access to the area and affix warning signs to all entry points. Re-inspect every 12 months or earlier if disturbed or removed in accordance with the Victorian OH&S Regulation 2017. All remedial/removal repairs require a Clearance Inspection & Certificate to be recorded by an approved and competent assessor.

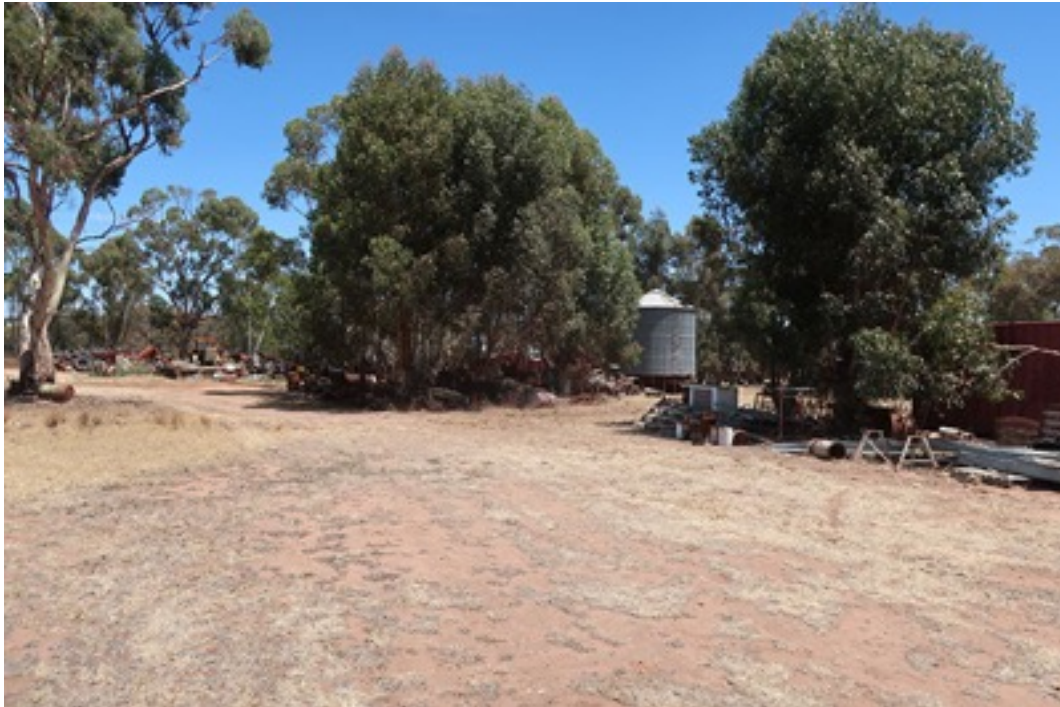
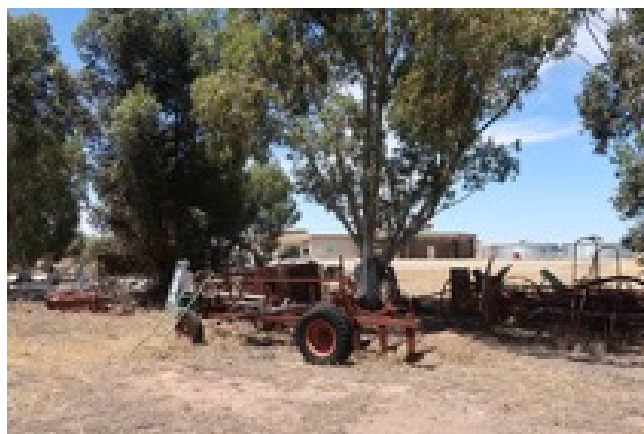
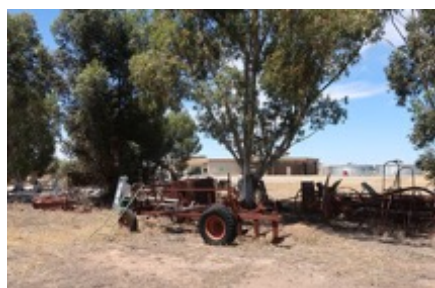
Grounds

Area 13**Grounds: . The Tractors & Machinery (Various - Gaskets, Brake pads, Insulating Materials) has Asbestos Containing Material (ACM) present.****RISK ASSESSMENT**

Type of Asbestos or Hazardous Material	No sample taken - Visual ID	Condition	POOR	Likelihood of Damage	M (Medium) - likely
		Activity	Moderate		
		Sealed	No	Friability	Exposed Fibres
		Labelled	No	Exposure Risk	High - Short term exposure risk
		Quantity

Unbonded surface

Priority	HIGH	Label Required	Yes	Re- Audit Date	16 Feb 2022
Action	Remove during normal maintenance or refurbishment				
Recommendation	Unbonded surface - The area requires immediate remedial repairs. It is recommended the asbestos material be replaced (preferred) or the material be sealed with an approved membrane. Reuse/installation of asbestos products is illegal				
Legislative Requirements Victorian Regulation 2007	Reuse/installation of asbestos products is illegal URGENT - ACM visible in area. Asbestos removal consultant are urgently required. Immediately cease any access to the area and affix warning signs to all entry points. Re-inspect every 12 months or earlier if disturbed or removed in accordance with the Victorian OH&S Regulation 2017. All remedial/removal repairs require a Clearance Inspection & Certificate to be recorded by an approved and competent assessor.

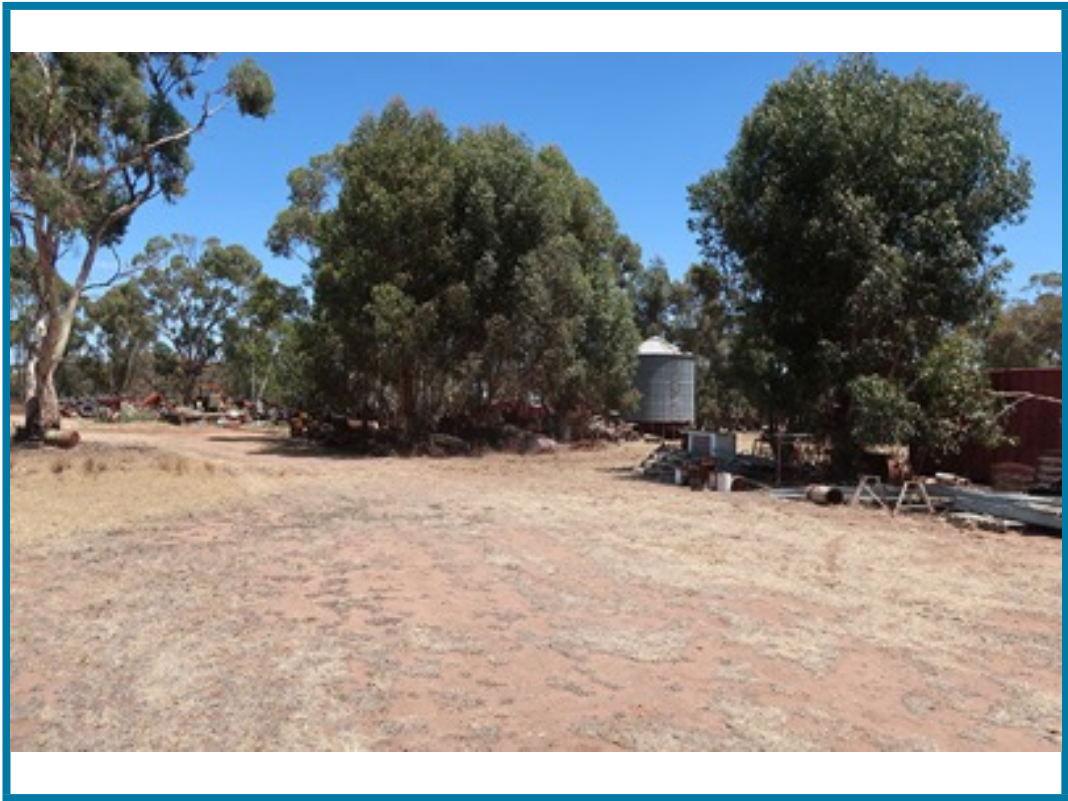
Location	Area	Component Materials	ACM Identified	Type Asbestos Assessment	Condition	Priority	Signage Required
Grounds - .	Tractors & Machinery	Various - Gaskets, Brake pads, Insulating Materials	Yes	No sample taken - Visual ID			
					POOR	HIGH	Yes
					Refer to the Abestos Register for more information.

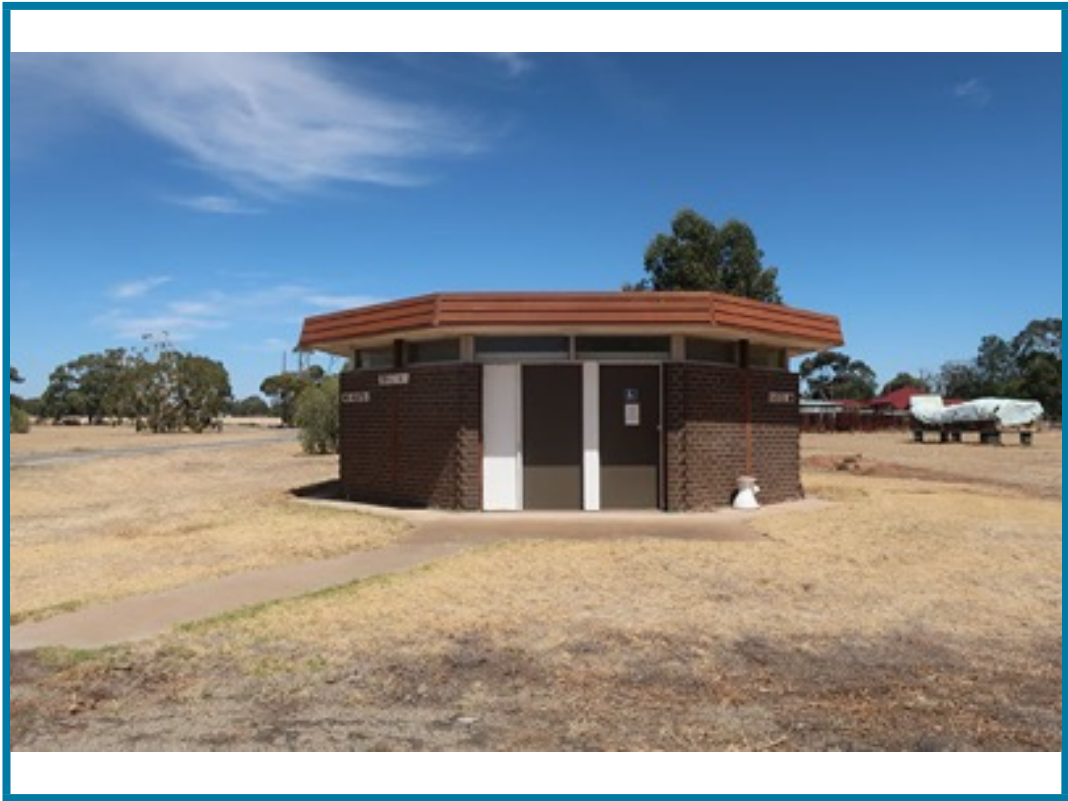
Location	Area	Component Materials	ACM Identified	Type Asbestos Assessment	Condition	Priority	Signage Required
Toilets - entire perimeter of building.	Soffit	F C Sheeting	Yes	No sample taken - Visual ID			
					GOOD	MEDIUM	Yes
	 	 	 	Refer to the Abestos Register for more information.			
Toilets - front of building.	Infill panel next to door	F C Sheeting	Yes	No sample taken - Visual ID			
					GOOD	MEDIUM	Yes
	 	 	 	Refer to the Abestos Register for more information.			
Toilets - Disabled bathroom 1.	Ceiling	F C Sheeting	Yes	No sample taken - Visual ID			
					GOOD	MEDIUM	Yes
	 	 	 	Refer to the Abestos Register for more information.			
Toilets - Storage 2.	Ceiling	F C Sheeting	Yes	No sample taken - Visual ID			
					GOOD	MEDIUM	Yes
	 	 	 	Refer to the Abestos Register for more information.			
Toilets - Storage 2.	Electrical board	Backing Board (Zelemite)	Yes	Chrysotile			
				Sample taken 62133-001			
					GOOD	MEDIUM	Yes
