# Asbestos Report

YARRIAMBIACK SHIRE COUNCIL

PROPERTY ADDRESS:  
LB51 RESIDENCE  
51 GARDINER STREET  
WARRACKNABEAL VIC 3393

INSPECTION DATE: 16 FEBRUARY 2021  
REFERENCE NUMBER: 62136

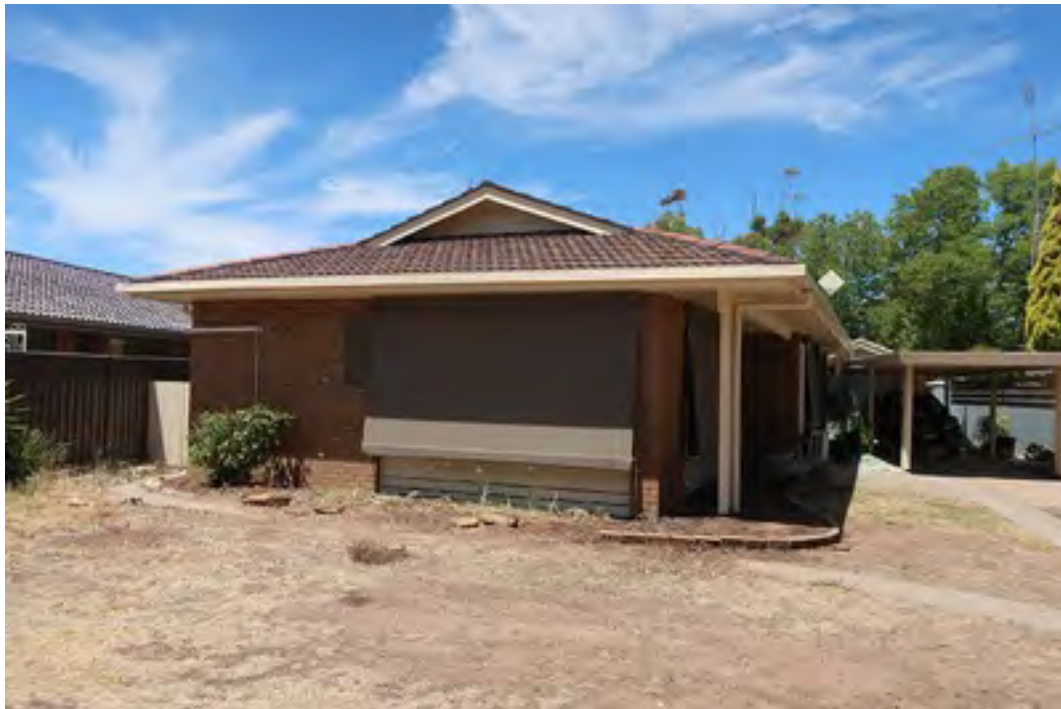
ASBESTOS REGISTER: LB51 Residence , 51 Gardiner Street, Warracknabeal VIC 3393

**Area 3*****Dwelling LB51 Residence: entire perimeter of building. The Soffit (F C Sheeting) has Asbestos Containing Material (ACM) present.*****RISK ASSESSMENT**

<b>Type of Asbestos or Hazardous Material</b>	Chrysotile	<b>Condition</b>	GOOD	<b>Likelihood of Damage</b>	L (Low) – possible
	Sample taken 62136-001	<b>Activity</b>	Moderate		
		<b>Sealed</b>	Yes	<b>Friability</b>	Bonded (non-friable)
		<b>Labelled</b>	Y	<b>Exposure Risk</b>	Low - Negligible or low risk
		<b>Quantity</b>

<b>Priority</b>	MEDIUM	<b>Label Required</b>	Yes	<b>Re- Audit Date</b>	16 Feb 2022
<b>Action</b>	No remedial action required, unless disturbed				
<b>Recommendation</b>	Maintain paint or sealant to ACM surfaces. Particular attention should be given to side edges, ensure paint/sealant covers ALL exposed ACM surfaces.				
<b>Legislative Requirements Victorian Regulation 2007</b>	Warning labels should be affixed. Avoid mechanical damage and abrasion. Remove if refurbishment, structural alteration or demolition is to be carried out in this area. Re-inspect every 12 months or earlier if disturbed or removed in accordance with the Victorian OH&S Regulation 2017. <b>All remedial/removal repairs require a Clearance Inspection &amp; Certificate to be recorded by an approved and competent assessor.</b>

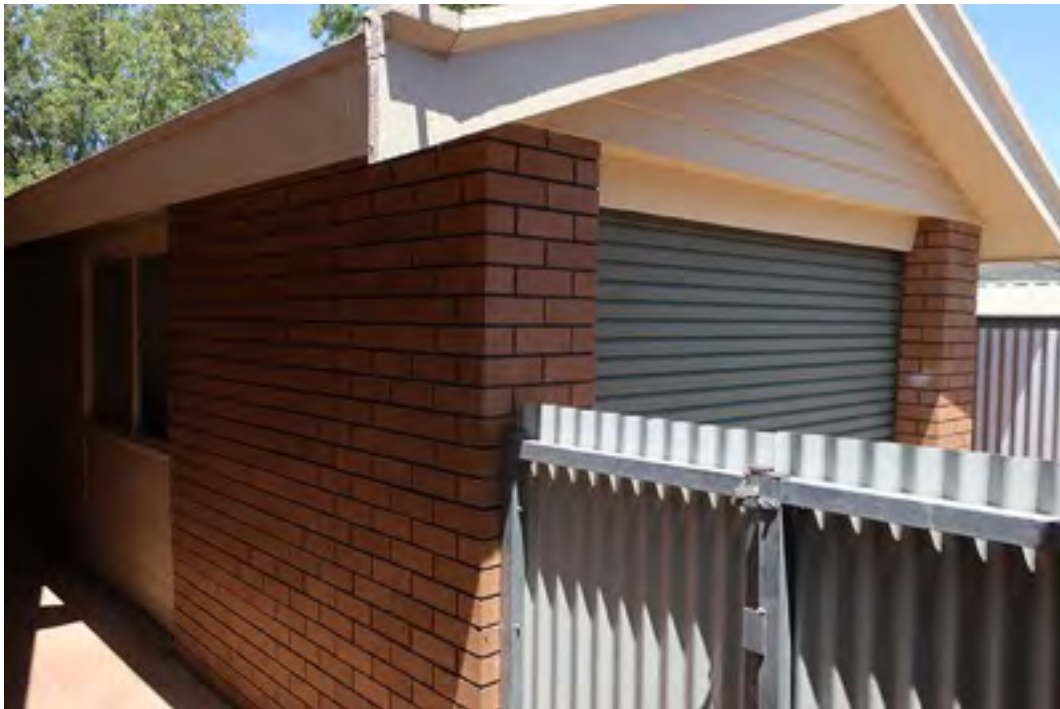
ASBESTOS REGISTER: LB51 Residence , 51 Gardiner Street, Warracknabeal VIC 3393

**Area 5****Garage: entire perimeter of building. The Soffit (F C Sheeting) has Asbestos Containing Material (ACM) present.****RISK ASSESSMENT**

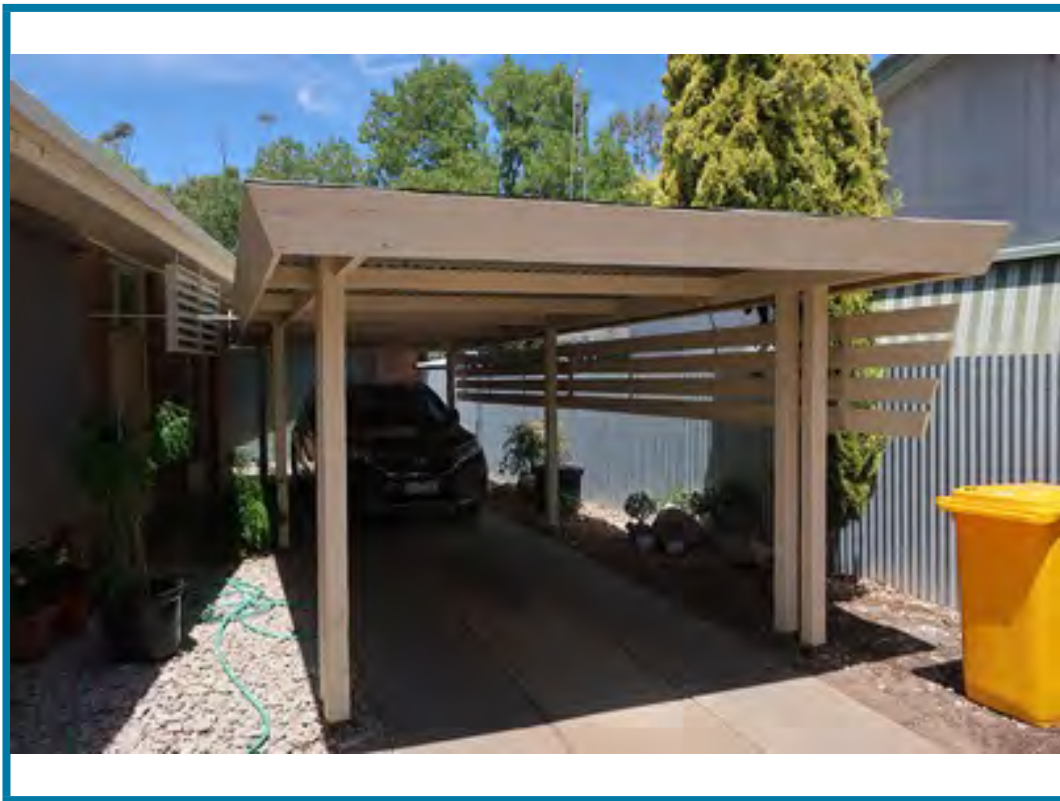
**ASBESTOS SURVEY: Lb51 Residence , 51 Gardiner Street, Warracknabeal Vic 3393**

<b>Location</b>	<b>Area</b>	<b>Component Materials</b>	<b>ACM Identified</b>	<b>Type Asbestos Assessment</b>	<b>ConditionPriority</b>	<b>Signage Required</b>
Carport - Carpot.		No Asbestos Materials	No	No sample taken - Visual ID

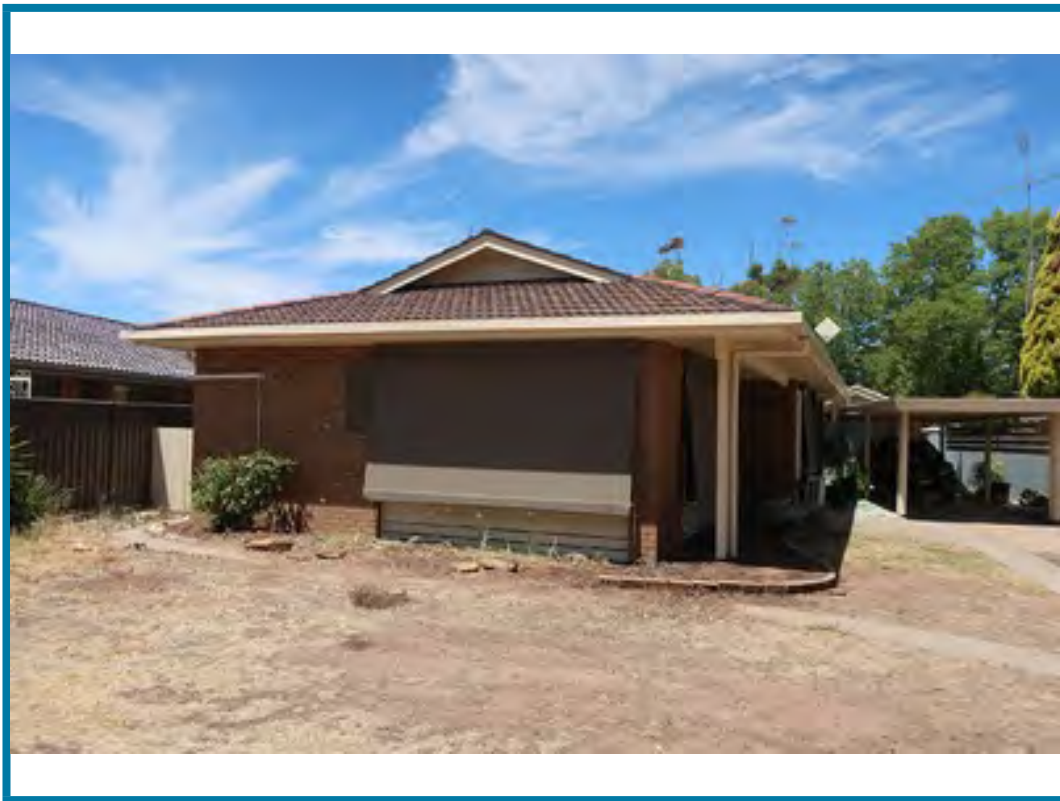
**ASBESTOS SURVEY: Lb51 Residence , 51 Gardiner Street, Warracknabeal Vic 3393**

Location	Area	Component Materials	ACM Identified	Type Asbestos Assessment	Condition	Priority	Signage Required
Dwelling LB51 Residence - entire perimeter of building.	Soffit	F C Sheeting	Yes	Chrysotile	Sample taken 62136-001	GOOD MEDIUM	Yes

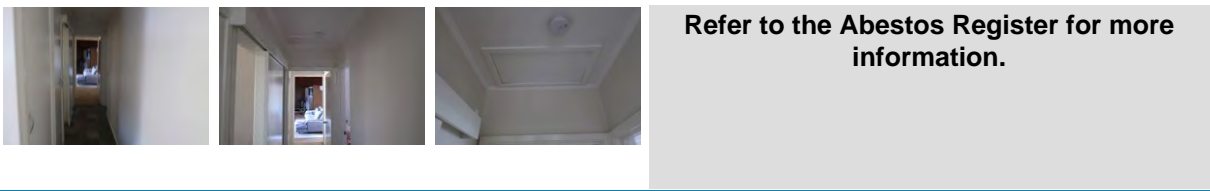
Dwelling LB51 Residence - Hallway 5.	Access panel	F C Sheet	Yes	Chrysotile			
					Same as Sample - 62136-001		
						GOOD IMMEDIATE	Yes

Replace access panel - remove and clean edges under asbestos controls

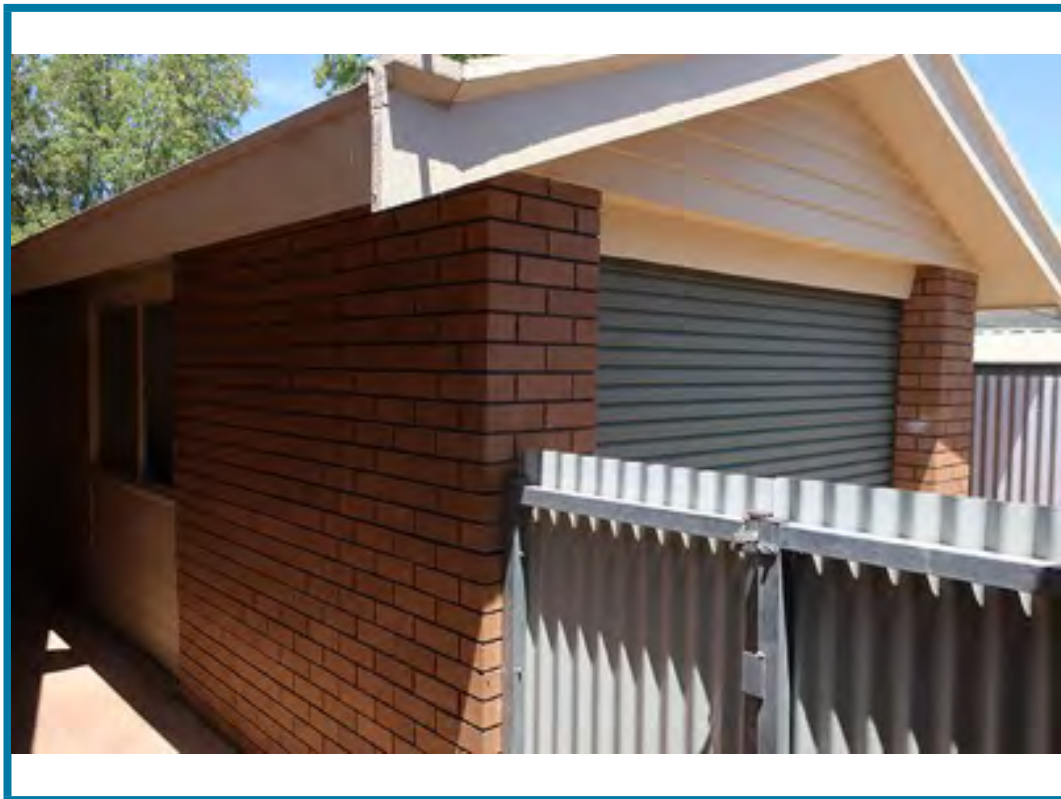
**ASBESTOS SURVEY:** Lb51 Residence , 51 Gardiner Street, Warracknabeal Vic 3393

Location	Area	Component Materials	ACM Identified	Type Asbestos Assessment	Condition	Priority	Signage Required
Garage - entire perimeter of building.	Soffit	F C Sheeting	Yes	Chrysotile	Same as Sample - 62136-001	GOOD MEDIUM	Yes
				  <p><b>Refer to the Abestos Register for more information.</b></p>			
Garage - Garage 1.	Ceiling panels	F C Sheeting	Yes	Chrysotile	Same as Sample - 62136-001	GOOD MEDIUM	Yes
				  <p><b>Refer to the Abestos Register for more information.</b></p>			
Garage - Storage 2.	Ceiling	F C Sheeting	Yes	Chrysotile	Same as Sample - 62136-001	GOOD MEDIUM	Yes
				  <p><b>Refer to the Abestos Register for more information.</b></p>
