Asbestos Report

YARRIAMBIACK SHIRE COUNCIL

**PROPERTY ADDRESS:
LR15D SENIOR CITIZENS
26 JAMOUNEAU STREET
WARRACKNABEAL VIC 3393**

**INSPECTION DATE: 16 FEBRUARY 2021
REFERENCE NUMBER: 62138**

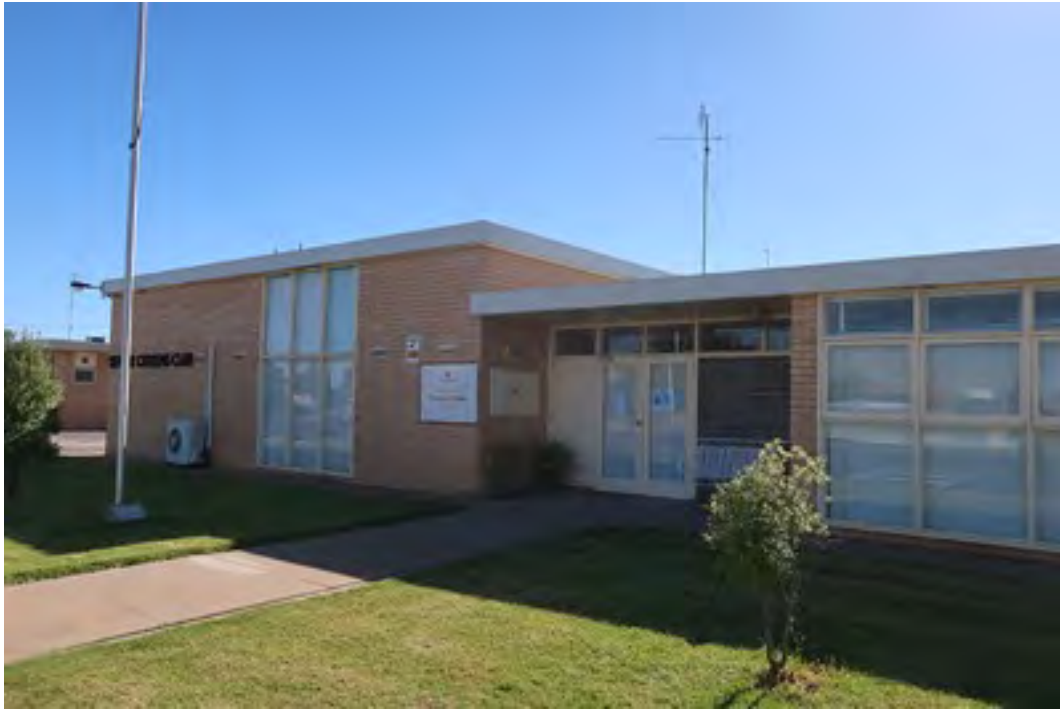
Area 2

2	LR15D Senior Citizens: front of building. The Awning - ceiling/ soffit (F C Sheeting) has Asbestos Containing Material (ACM) present.
6	LR15D Senior Citizens: right side of building. The Awning - ceiling/ soffit (F C Sheeting) has Asbestos Containing Material (ACM) present.
5	LR15D Senior Citizens: rear of building. The Awning - ceiling/ soffit (F C Sheeting) has Asbestos Containing Material (ACM) present.
3	LR15D Senior Citizens: Kitchen 4. The Wall (Vinyl Tiles) has Asbestos Containing Material (ACM) present.
1	LR15D Senior Citizens: Female bathroom 6. The Walls (Vinyl Tiles) has Asbestos Containing Material (ACM) present.
4	LR15D Senior Citizens: Male bathroom 7. The Walls (Vinyl Tiles) has Asbestos Containing Material (ACM) present.
