Asbestos Report

YARRIAMBIACK SHIRE COUNCIL

PROPERTY ADDRESS:
LB101 SHIRE DEPOT
1 PYERS STREET
WARRACKNABEAL VIC 3393

INSPECTION DATE: 16 FEBRUARY 2021
REFERENCE NUMBER: 62139

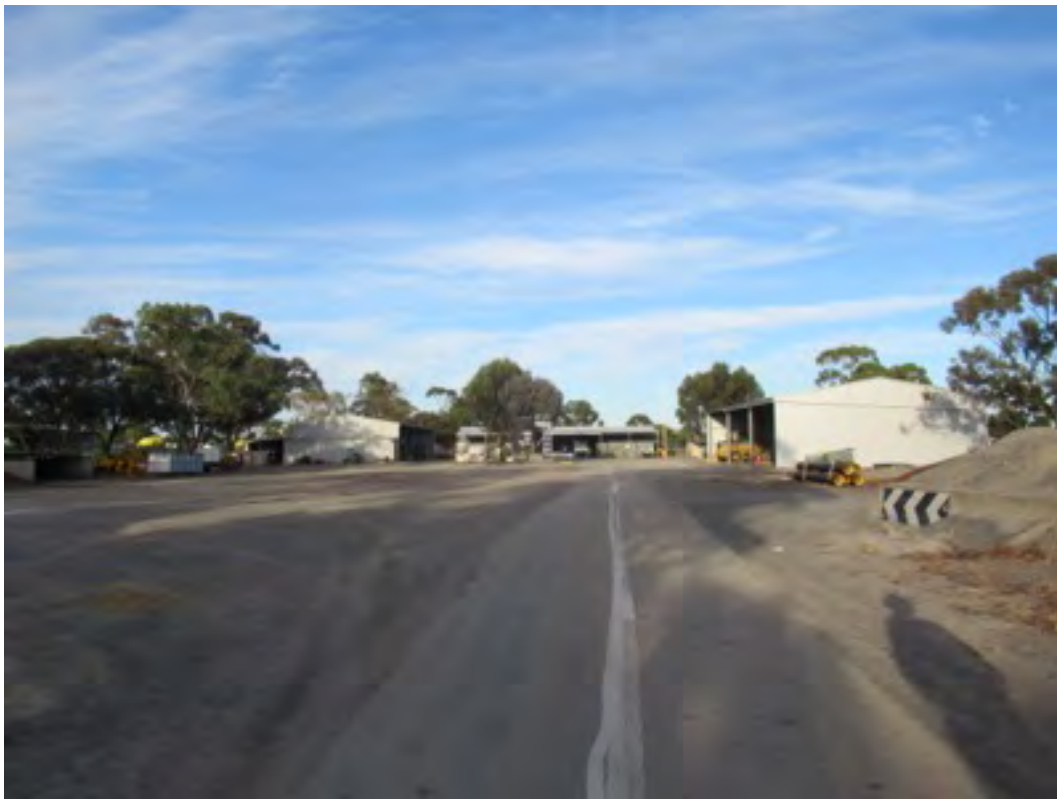
Area 1

Type of Asbestos or Hazardous Material	No sample taken - Visual ID	Condition	AVERAGE	Likelihood of Damage	High
		Activity	Moderate		
		Sealed	No	Friability	Exposed Fibres
		Labelled	No	Exposure Risk	Medium - Moderate risk
		Quantity
