Asbestos Report

YARRIAMBIACK SHIRE COUNCIL

PROPERTY ADDRESS:
LB22 PRIMARY SCHOOL
2808 WARRACKNABEAL-WILKUR ROAD
WILKUR SOUTH VIC 3393

INSPECTION DATE: 11 FEBRUARY 2021
REFERENCE NUMBER: 62147

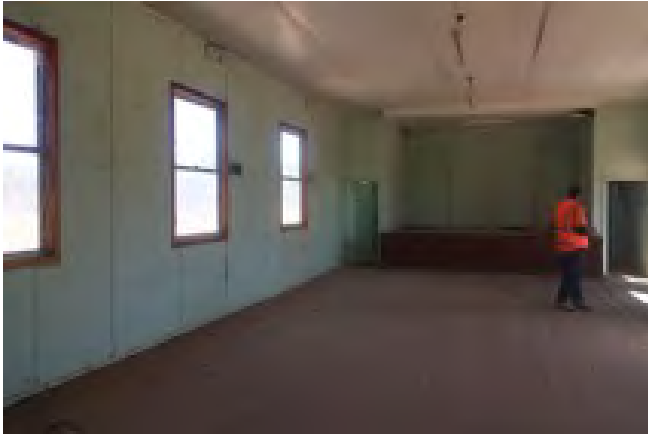
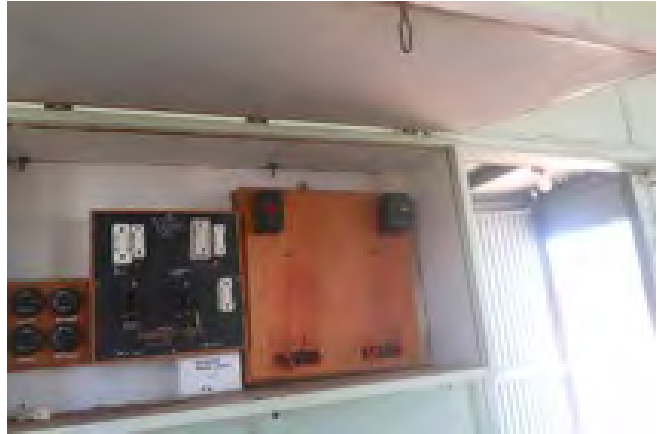
Hall 2. The Electrical Cabinet - lining (Millboard) has Asbestos Containing Material (ACM) present.

RISK ASSESSMENT					
Type of Asbestos or Hazardous Material	No sample taken - Visual ID	Condition	AVERAGE	Likelihood of Damage	L (Low) – possible
		Activity	Moderate		
		Sealed	No	Friability	Friable
		Labelled	Y	Exposure Risk	Medium - Moderate risk
		Quantity

RISK CONTROL					
Priority	HIGH	Label Required	Yes	Re- Audit Date	11 Feb 2022
Action	Remedial repairs required - seal raw material / edges				
Recommendation	Raw material sheeting - The area requires immediate remedial repairs. It is recommended the asbestos material be sealed with an approved membrane.				
Legislative Requirements Victorian Regulation 2007	Damaged ACM visible in area. Requires IMMEDIATE ATTENTION. WARNING labels should be affixed. Avoid mechanical damage and abrasion. Remove if refurbishment, structural alteration or demolition is to be carried out in this area. Re-inspect every 12 months or earlier if disturbed or removed in accordance with the Victorian OH&S Regulation 2017. All remedial/removal repairs require a Clearance Inspection & Certificate to be recorded by an approved and competent assessor.

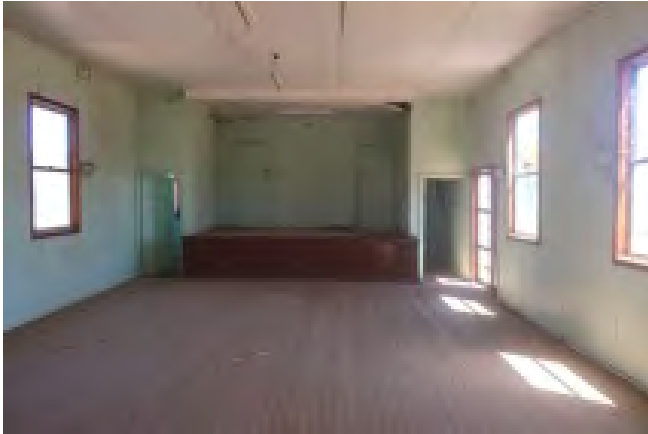
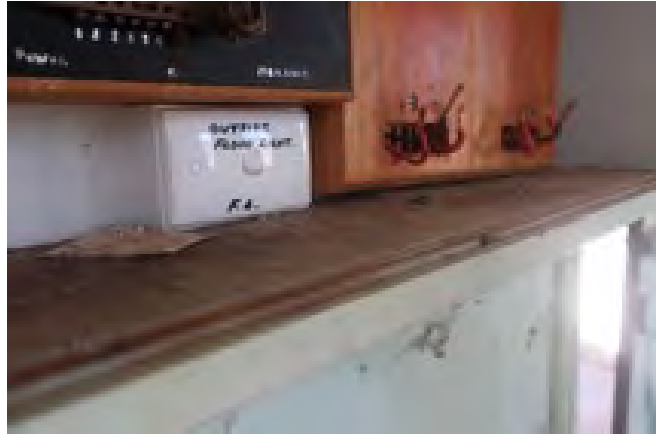
Hall 2. The Electrical Cabinet (Debris) has Asbestos Containing Material (ACM) present.

RISK ASSESSMENT					
Type of Asbestos or Hazardous Material	No sample taken - Visual ID	Condition	POOR	Likelihood of Damage	H (High) - almost certain
		Activity	Low	Friability	Exposed Fibres
		Sealed	No	Exposure Risk	High - Short term exposure risk
		Labelled	Y	Quantity

RISK CONTROL					
Priority	IMMEDIATE	Label Required	Yes	Re- Audit Date	11 Feb 2022
Action	Restrict access and target for imminent removal				
Recommendation	Debris on Surface - The Debris requires immediate cleanup and disposal with specialised equipment and with licensed removalist to safely remove the asbestos debris.				
Legislative Requirements Victorian Regulation 2007	ACM debris visible. Recommend cleanup by licensed Asbestos Removalist. Warning labels should be affixed. Avoid mechanical damage and abrasion. Remove if refurbishment, structural alteration or demolition is to be carried out in this area. Re-inspect every 12 months or earlier if disturbed or removed in accordance with the Victorian OH&S Regulation 2017. All remedial/removal repairs require a Clearance Inspection & Certificate to be recorded by an approved and competent assessor.

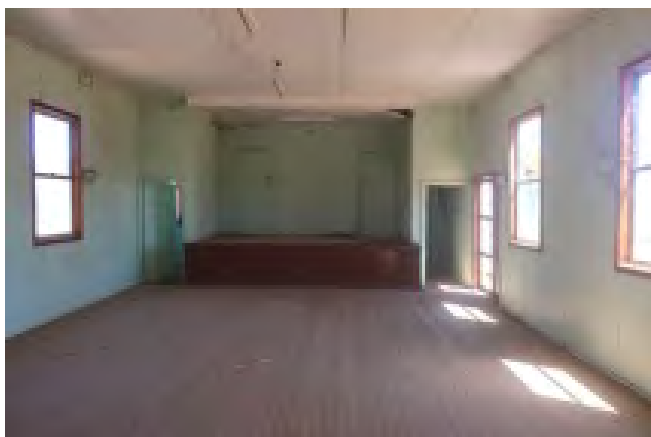
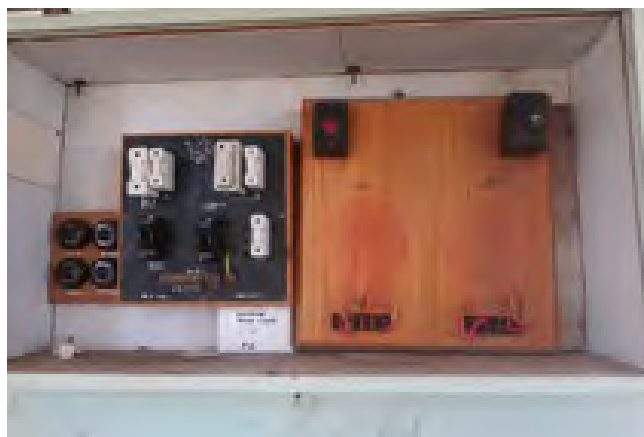
Hall 2. The A: Electrical board; B: Ceramic Fuses (A: Zelemite; B: Cloth Inserts) has Asbestos Containing Material (ACM) present.

RISK ASSESSMENT						
Type of Asbestos or Hazardous Material	No sample taken - Visual ID	Condition	AVERAGE	Likelihood of Damage	L (Low) – possible	
		Activity	Moderate			
		Sealed	Yes	Friability		Exposed Fibres
		Labelled	Y	Exposure Risk		Medium - Moderate risk
		Quantity

Priority	HIGH	Label Required	Yes	Re- Audit Date	11 Feb 2022
Action	Remedial repairs required - seal raw material / edges				
Recommendation	Penetration Holes - The exposed edges require approved sealant. It is further recommended the gaps be filled with sealant. Do not remove the fuses without asbestos controls - test for cloth inserts				
Legislative Requirements Victorian Regulation 2007	Damaged ACM visible in area. Requires IMMEDIATE ATTENTION. WARNING labels should be affixed. Avoid mechanical damage and abrasion. Remove if refurbishment, structural alteration or demolition is to be carried out in this area. Re-inspect every 12 months or earlier if disturbed or removed in accordance with the Victorian OH&S Regulation 2017. All remedial/removal repairs require a Clearance Inspection & Certificate to be recorded by an approved and competent assessor.

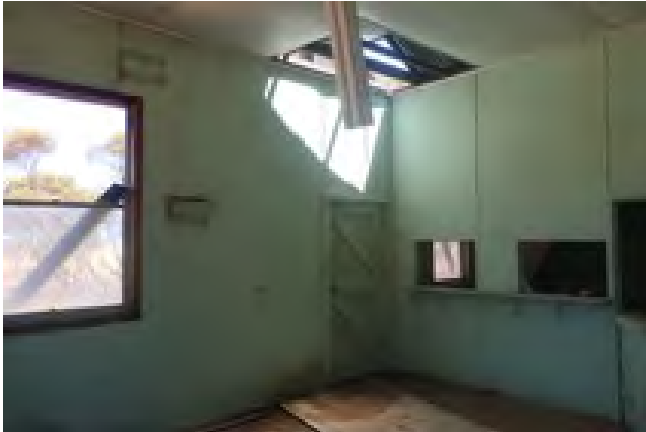
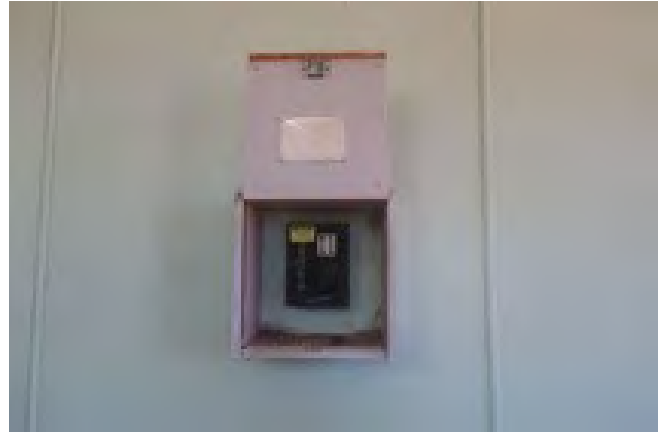
Area 6**Rear room 3. The Electrical Cabinet - lining (F C Sheeting) has Asbestos Containing Material (ACM) present.****RISK ASSESSMENT**

Type of Asbestos or Hazardous Material	No sample taken - Visual ID	Condition	AVERAGE	Likelihood of Damage	L (Low) – possible
		Activity	Moderate		
		Sealed	No	Friability	Bonded (non-friable)
		Labelled	Y	Exposure Risk	Medium - Moderate risk
		Quantity

Priority	HIGH	Label Required	Yes	Re- Audit Date	11 Feb 2022
Action	Remedial repairs required - seal raw material / edges				
Recommendation	Raw material sheeting - The area requires immediate remedial repairs. It is recommended the asbestos material be sealed with an approved membrane.				
Legislative Requirements Victorian Regulation 2007	<p>Damaged ACM visible in area. Requires IMMEDIATE ATTENTION. WARNING labels should be affixed. Avoid mechanical damage and abrasion. Remove if refurbishment, structural alteration or demolition is to be carried out in this area. Re-inspect every 12 months or earlier if disturbed or removed in accordance with the Victorian OH&S Regulation 2017.</p> <p>All remedial/removal repairs require a Clearance Inspection & Certificate to be recorded by an approved and competent assessor.</p>

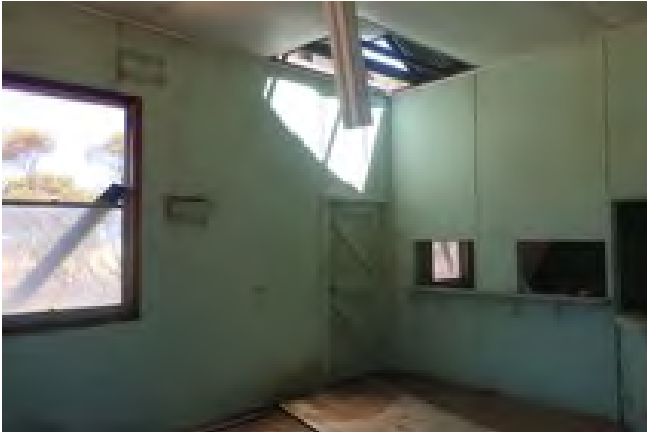
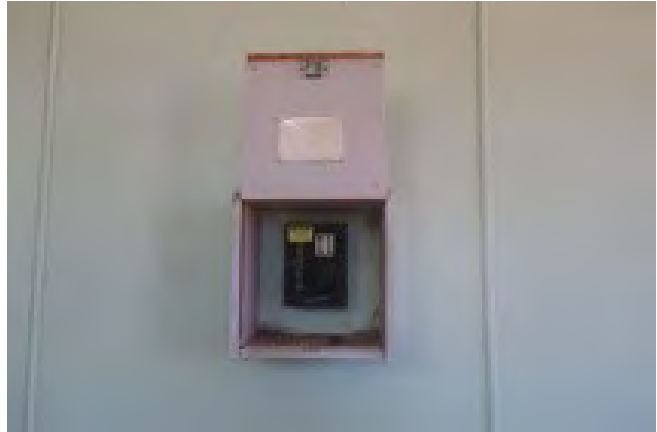
Rear room 3. The Electrical board (Backing Board (Zelemite)) has Asbestos Containing Material (ACM) present.

RISK ASSESSMENT					
Type of Asbestos or Hazardous Material	No sample taken - Visual ID	Condition	GOOD	Likelihood of Damage	L (Low) – possible
		Activity	Moderate		
		Sealed	Yes	Friability	Bonded (non-friable)
		Labelled	Y	Exposure Risk	Low - Negligible or low risk
		Quantity

RISK CONTROL					
Priority	MEDIUM	Label Required	Yes	Re- Audit Date	11 Feb 2022
Action	No remedial action required, unless disturbed				
Recommendation	Maintain paint or sealant to ACM surfaces. Particular attention should be given to side edges, ensure paint/sealant covers ALL exposed ACM surfaces.				
Legislative Requirements Victorian Regulation 2007	Warning labels should be affixed. Avoid mechanical damage and abrasion. Remove if refurbishment, structural alteration or demolition is to be carried out in this area. Re-inspect every 12 months or earlier if disturbed or removed in accordance with the Victorian OH&S Regulation 2017. All remedial/removal repairs require a Clearance Inspection & Certificate to be recorded by an approved and competent assessor.

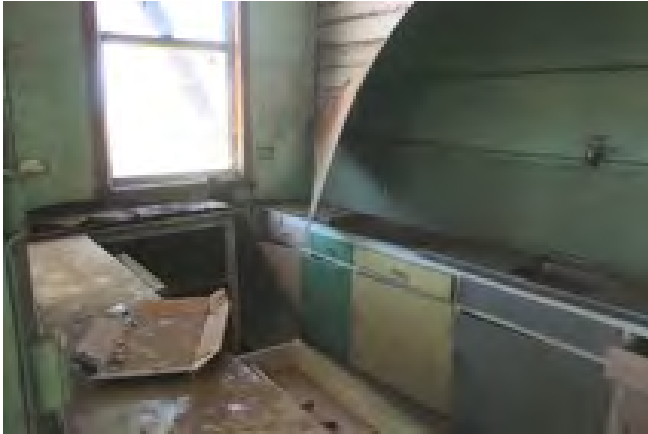
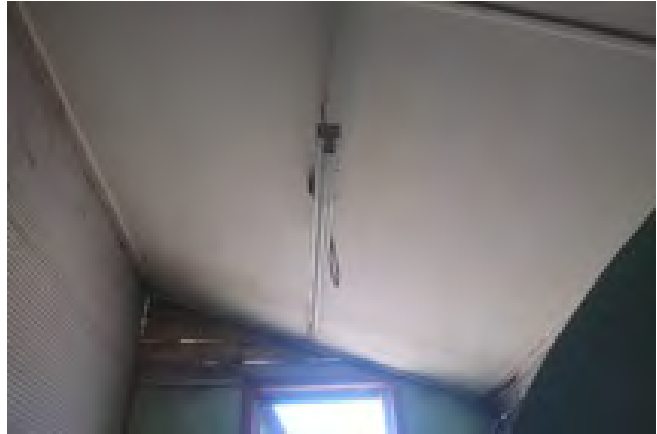
Kitchen. The Ceiling (F C Sheeting) has Asbestos Containing Material (ACM) present.

RISK ASSESSMENT					
Type of Asbestos or Hazardous Material	No sample taken - Visual ID	Condition	GOOD	Likelihood of Damage	L (Low) – possible
		Activity	Moderate		
		Sealed	Yes	Friability	Bonded (non-friable)
		Labelled	Y	Exposure Risk	Low - Negligible or low risk
		Quantity

Priority	MEDIUM	Label Required	Yes	Re- Audit Date	11 Feb 2022
Action	No remedial action required, unless disturbed				
Recommendation	Maintain paint or sealant to ACM surfaces. Particular attention should be given to side edges, ensure paint/sealant covers ALL exposed ACM surfaces.				
Legislative Requirements Victorian Regulation 2007	Warning labels should be affixed. Avoid mechanical damage and abrasion. Remove if refurbishment, structural alteration or demolition is to be carried out in this area. Re-inspect every 12 months or earlier if disturbed or removed in accordance with the Victorian OH&S Regulation 2017. All remedial/removal repairs require a Clearance Inspection & Certificate to be recorded by an approved and competent assessor.

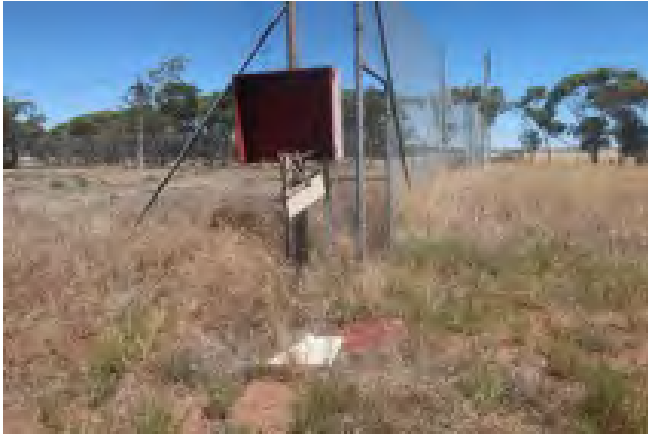
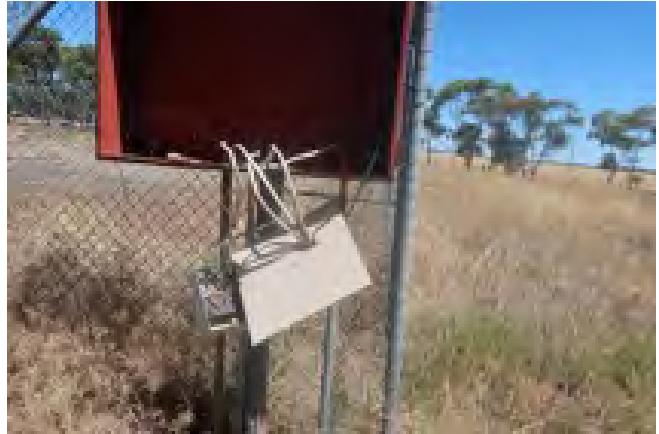
Tennis Court: External. The Electrical board (Backing Board (Zelemite)) has Asbestos Containing Material (ACM) present.

RISK ASSESSMENT					
Type of Asbestos or Hazardous Material	No sample taken - Visual ID	Condition	POOR	Likelihood of Damage	L (Low) – possible
		Activity	Moderate		
		Sealed	Yes	Friability	Exposed Fibres
		Labelled	Y	Exposure Risk	Medium - Moderate risk
		Quantity

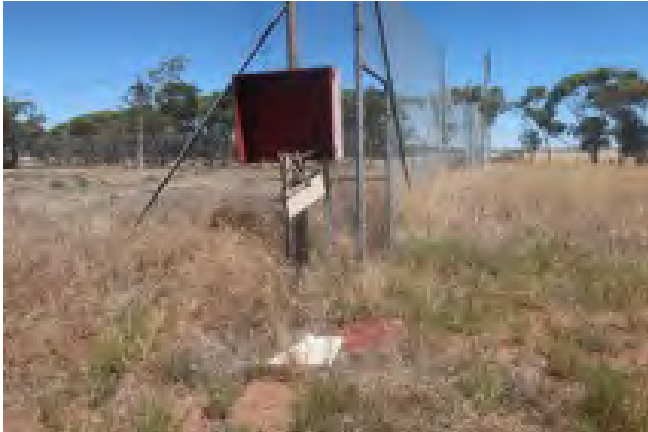
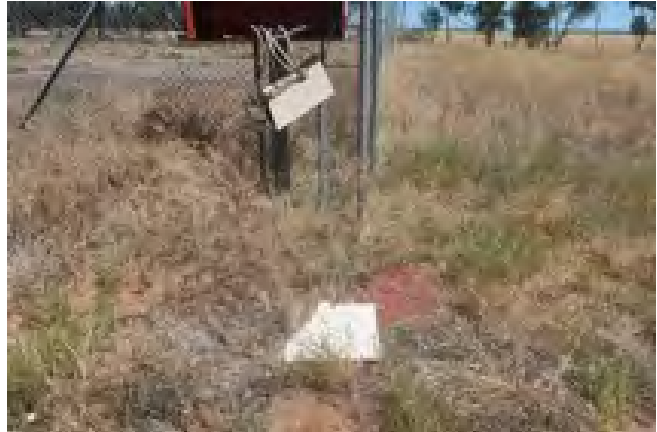
Tennis Court: External. The Debris - Broken (Debris) has Asbestos Containing Material (ACM) present.

RISK ASSESSMENT					
Type of Asbestos or Hazardous Material	No sample taken - Visual ID	Condition	POOR	Likelihood of Damage	H (High) - almost certain
		Activity	Moderate		
		Sealed	No	Friability	Exposed Fibres
		Labelled	No	Exposure Risk	High - Short term exposure risk
		Quantity
