Asbestos Report

YARRIAMBIACK SHIRE COUNCIL

PROPERTY ADDRESS:
LB88 BOWLING CLUB
18-20 GLOUCESTER AVENUE
WOOMELANG VIC 3485

INSPECTION DATE: 11 FEBRUARY 2021
REFERENCE NUMBER: 62148

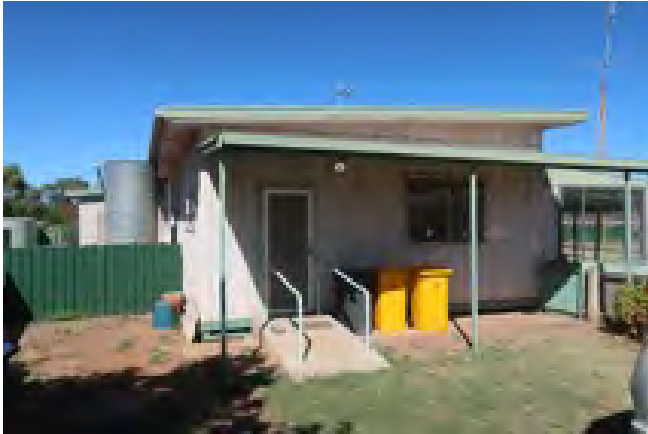
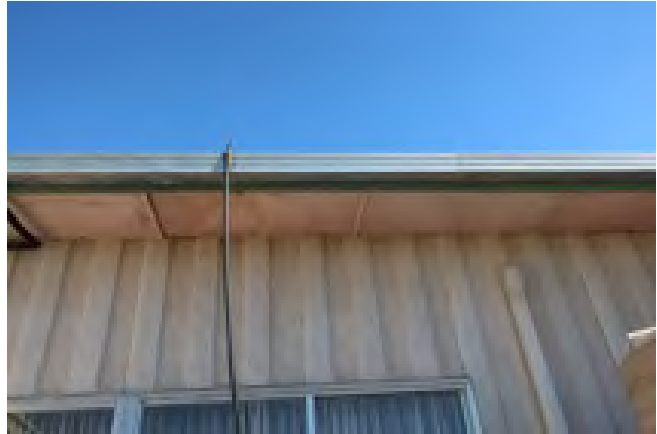
Area 5

Type of Asbestos or Hazardous Material	No sample taken - Visual ID	Condition	AVERAGE	Likelihood of Damage	L (Low) – possible
		Activity	Moderate		
		Sealed	No	Friability	Bonded (non-friable)
		Labelled	Y	Exposure Risk	Medium - Moderate risk
		Quantity

Priority	HIGH	Label Required	Yes	Re- Audit Date	11 Feb 2022
Action	Remedial repairs required - seal raw material / edges				
Recommendation	Raw material sheeting - The area requires immediate remedial repairs. It is recommended the asbestos material be sealed with an approved membrane.				
Legislative Requirements Victorian Regulation 2007	Damaged ACM visible in area. Requires IMMEDIATE ATTENTION. WARNING labels should be affixed. Avoid mechanical damage and abrasion. Remove if refurbishment, structural alteration or demolition is to be carried out in this area. Re-inspect every 12 months or earlier if disturbed or removed in accordance with the Victorian OH&S Regulation 2017. All remedial/removal repairs require a Clearance Inspection & Certificate to be recorded by an approved and competent assessor.

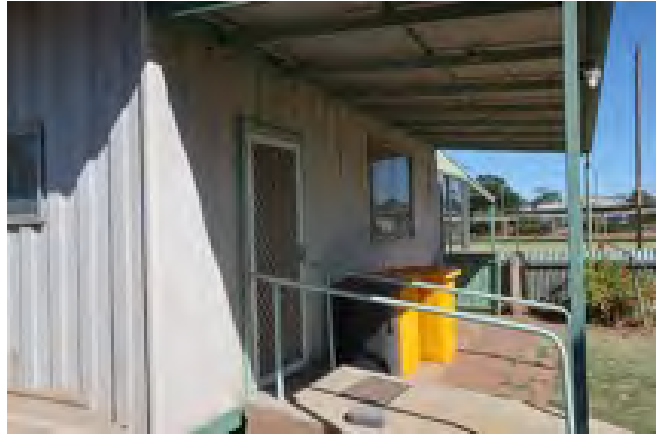
Type of Asbestos or Hazardous Material	No sample taken - Visual ID	Condition	AVERAGE	Likelihood of Damage	L (Low) – possible
		Activity	Moderate		
		Sealed	No	Friability	Bonded (non-friable)
		Labelled	Y	Exposure Risk	Medium - Moderate risk
		Quantity

Priority	HIGH	Label Required	Yes	Re- Audit Date	11 Feb 2022
Action	Remedial repairs required - seal raw material / edges				
Recommendation	Raw material sheeting - The area requires immediate remedial repairs. It is recommended the asbestos material be sealed with an approved membrane. Asbestos materials have been reused in the recent building extensions				
Legislative Requirements Victorian Regulation 2007	Damaged ACM visible in area. Requires IMMEDIATE ATTENTION. WARNING labels should be affixed. Avoid mechanical damage and abrasion. Remove if refurbishment, structural alteration or demolition is to be carried out in this area. Re-inspect every 12 months or earlier if disturbed or removed in accordance with the Victorian OH&S Regulation 2017. All remedial/removal repairs require a Clearance Inspection & Certificate to be recorded by an approved and competent assessor.

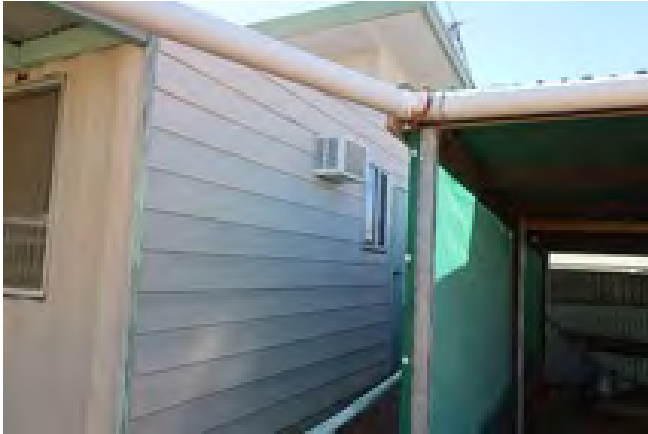
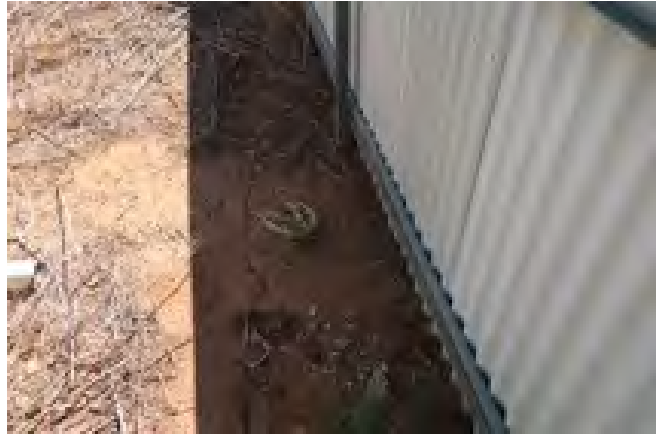
- 2 **LB88 Bowling Club: rear of building. The Debris - Broken (Debris) has Asbestos Containing Material (ACM) present.**

LB88 Bowling Club: rear of building. The Debris - Broken (Debris) has Asbestos Containing Material (ACM) present.

RISK ASSESSMENT					
Type of Asbestos or Hazardous Material	No sample taken - Visual ID	Condition	POOR	Likelihood of Damage	H (High) - almost certain
		Activity	Moderate		
		Sealed	No	Friability	Exposed Fibres
		Labelled	No	Exposure Risk	High - Short term exposure risk
		Quantity

RISK CONTROL					
Priority	IMMEDIATE	Label Required	Yes	Re- Audit Date	11 Feb 2022
Action	Restrict access and target for imminent removal				
Recommendation	Debris on Surface - The Debris requires immediate cleanup and disposal with specialised equipment and with licensed removalist to safely remove the asbestos debris.				
Legislative Requirements Victorian Regulation 2007	ACM debris visible. Recommend cleanup by licensed Asbestos Removalist. Warning labels should be affixed. Avoid mechanical damage and abrasion. Remove if refurbishment, structural alteration or demolition is to be carried out in this area. Re-inspect every 12 months or earlier if disturbed or removed in accordance with the Victorian OH&S Regulation 2017. All remedial/removal repairs require a Clearance Inspection & Certificate to be recorded by an approved and competent assessor.

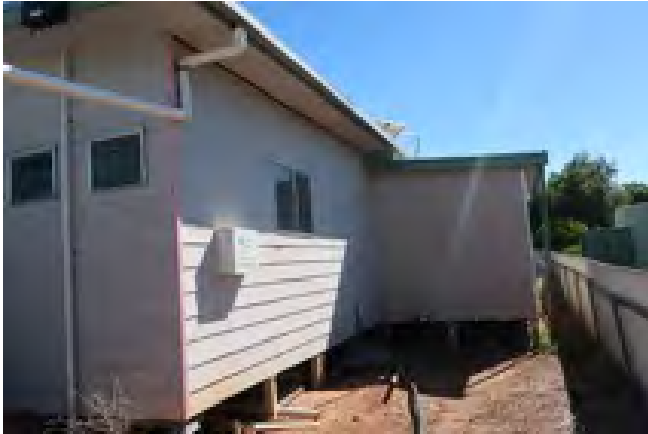
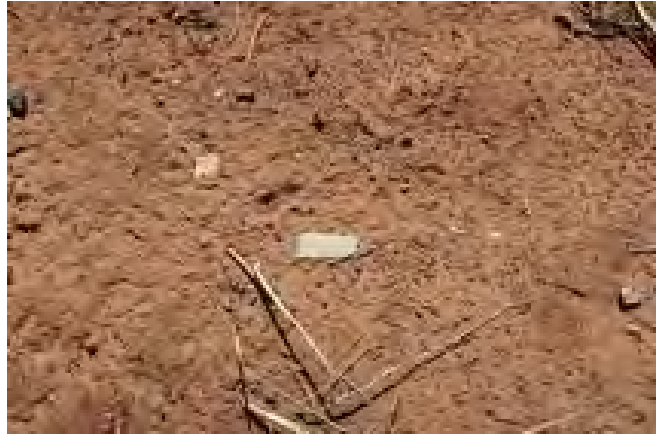
- 1 **LB88 Bowling Club: left side of building. The Debris - Broken (Debris) has Asbestos Containing Material (ACM) present.**

LB88 Bowling Club: left side of building. The Debris - Broken (Debris) has Asbestos Containing Material (ACM) present.

RISK ASSESSMENT					
Type of Asbestos or Hazardous Material	No sample taken - Visual ID	Condition	POOR	Likelihood of Damage	H (High) - almost certain
		Activity	Moderate		
		Sealed	No	Friability	Exposed Fibres
		Labelled	No	Exposure Risk	High - Short term exposure risk
		Quantity

RISK CONTROL					
Priority	IMMEDIATE	Label Required	Yes	Re- Audit Date	11 Feb 2022
Action	Restrict access and target for imminent removal				
Recommendation	Debris on Surface - The Debris requires immediate cleanup and disposal with specialised equipment and with licensed removalist to safely remove the asbestos debris.				
Legislative Requirements Victorian Regulation 2007	ACM debris visible. Recommend cleanup by licensed Asbestos Removalist. Warning labels should be affixed. Avoid mechanical damage and abrasion. Remove if refurbishment, structural alteration or demolition is to be carried out in this area. Re-inspect every 12 months or earlier if disturbed or removed in accordance with the Victorian OH&S Regulation 2017. All remedial/removal repairs require a Clearance Inspection & Certificate to be recorded by an approved and competent assessor.

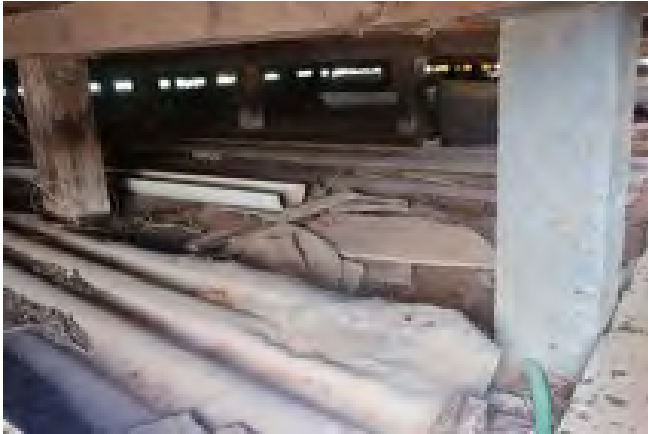
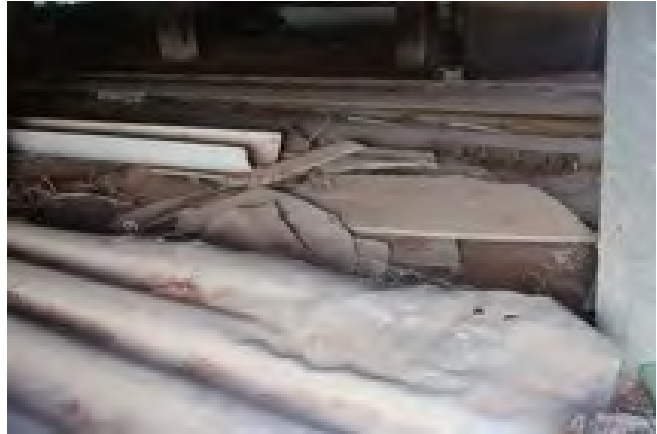
3 LB88 Bowling Club: Subfloor. The Debris - Broken (Debris) has Asbestos Containing Material (ACM) present.

LB88 Bowling Club: Subfloor. The Debris - Broken (Debris) has Asbestos Containing Material (ACM) present.

RISK ASSESSMENT					
Type of Asbestos or Hazardous Material	Chrysotile	Condition	POOR	Likelihood of Damage	H (High) - almost certain
	Amosite	Activity	Moderate		
	Sample taken 62148-003	Sealed	No	Friability	Exposed Fibres
		Labelled	No	Exposure Risk	High - Short term exposure risk
		Quantity

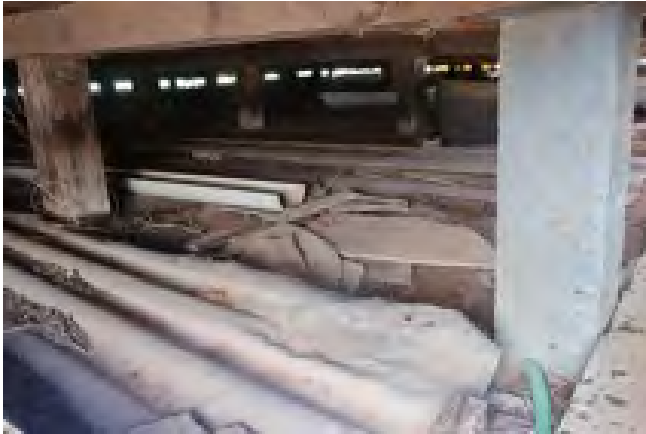
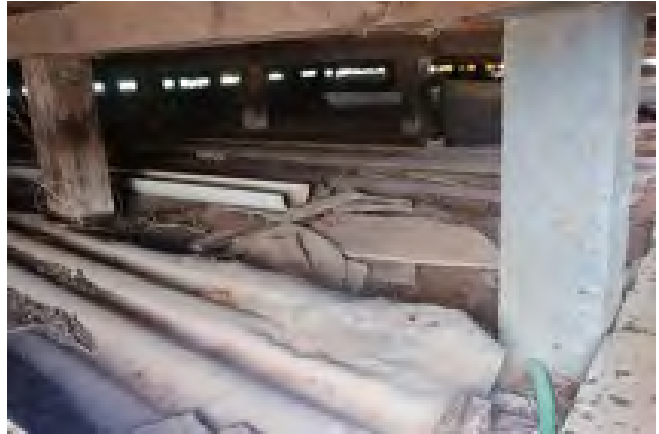
LB88 Bowling Club: Subfloor. The Stored Material (Debris) has Asbestos Containing Material (ACM) present.

RISK ASSESSMENT					
Type of Asbestos or Hazardous Material	No sample taken - Visual ID	Condition	POOR	Likelihood of Damage	L (Low) – possible
		Activity	Moderate		
		Sealed	No	Friability	Exposed Fibres
		Labelled	Y	Exposure Risk	Medium - Moderate risk
		Quantity

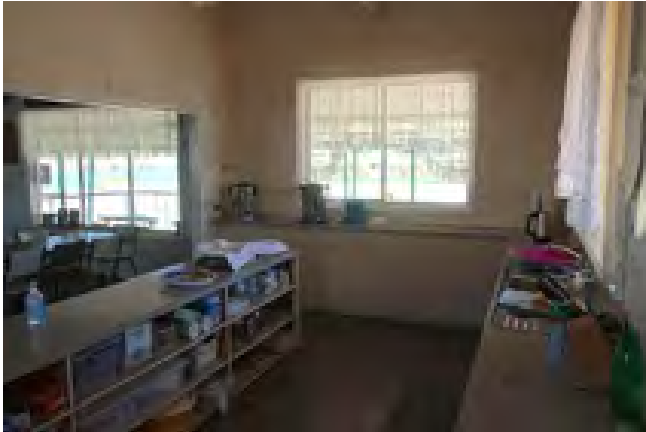
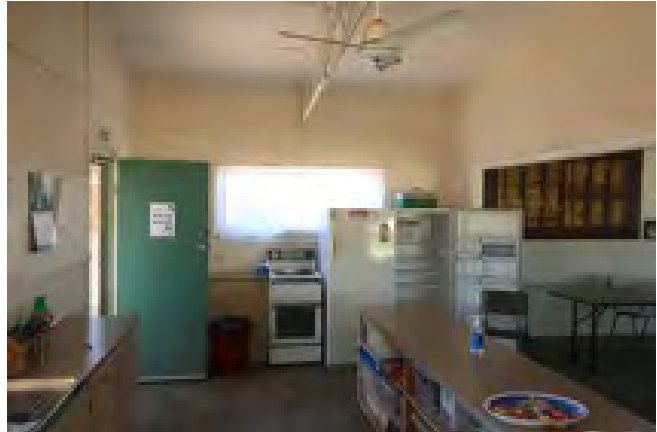
LB88 Bowling Club: Kitchen 1. The Walls and Ceiling (F C Sheeting) has Asbestos Containing Material (ACM) present.

RISK ASSESSMENT					
Type of Asbestos or Hazardous Material	No sample taken - Visual ID	Condition	GOOD	Likelihood of Damage	L (Low) – possible
		Activity	Moderate		
		Sealed	Yes	Friability	Bonded (non-friable)
		Labelled	Y	Exposure Risk	Low - Negligible or low risk
		Quantity

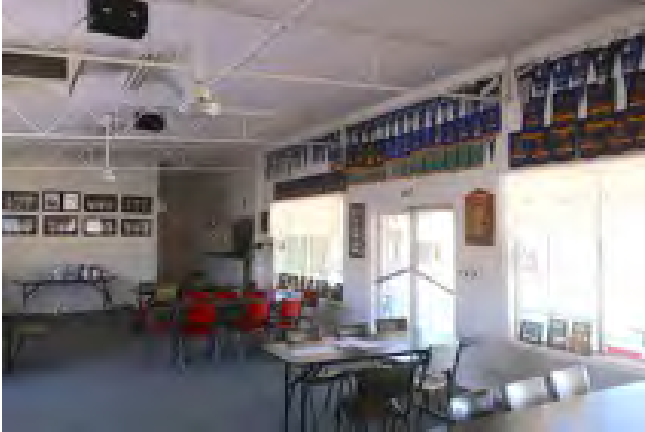
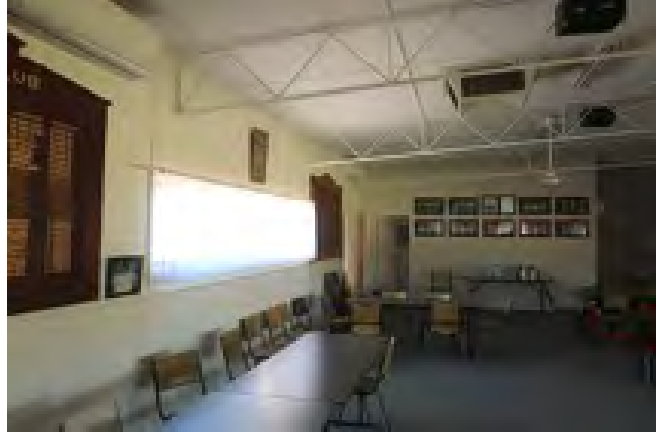
Area 9**LB88 Bowling Club: Clubroom 2. The Walls and Ceiling (F C Sheeting) has Asbestos Containing Material (ACM) present.****RISK ASSESSMENT**

Type of Asbestos or Hazardous Material	No sample taken - Visual ID	Condition	GOOD	Likelihood of Damage	L (Low) – possible
		Activity	Moderate		
		Sealed	Yes	Friability	Bonded (non-friable)
		Labelled	Y	Exposure Risk	Low - Negligible or low risk
		Quantity

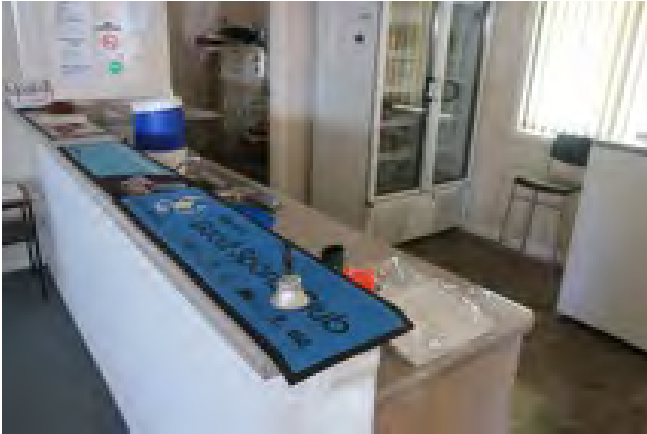
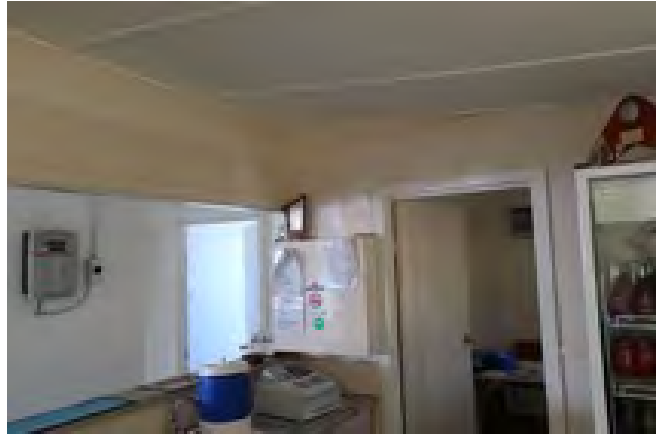
LB88 Bowling Club: Bar 7. The Walls and Ceiling (F C Sheeting) has Asbestos Containing Material (ACM) present.

RISK ASSESSMENT					
Type of Asbestos or Hazardous Material	No sample taken - Visual ID	Condition	GOOD	Likelihood of Damage	L (Low) – possible
		Activity	Moderate		
		Sealed	Yes	Friability	Bonded (non-friable)
		Labelled	Y	Exposure Risk	Low - Negligible or low risk
		Quantity

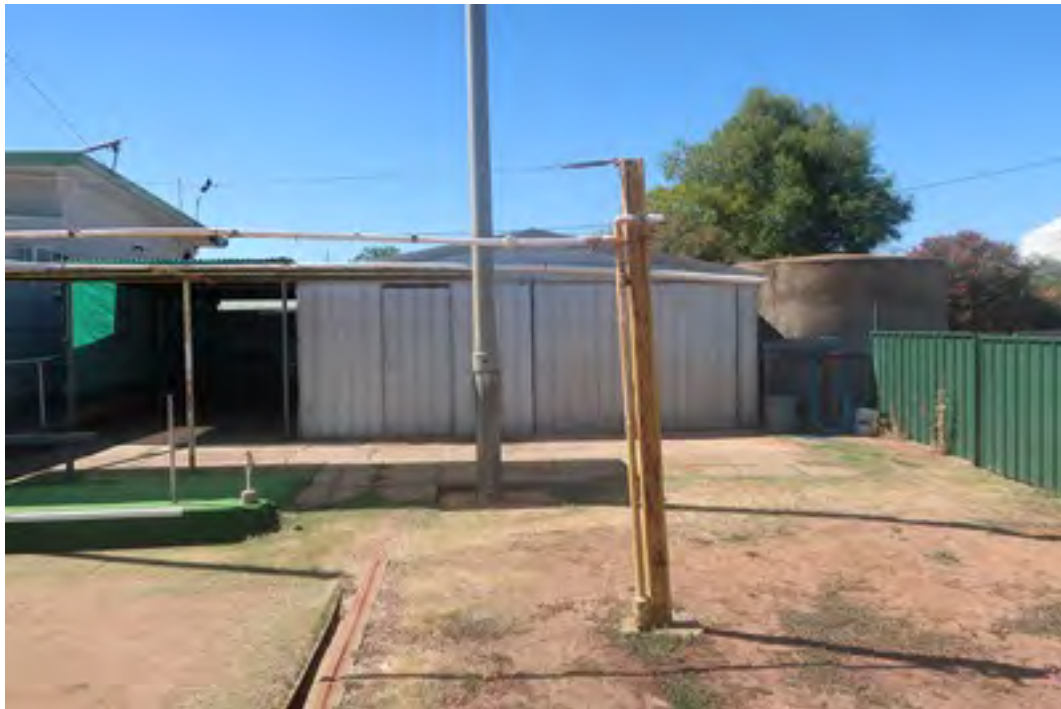
Area 7

7	Shed: . Until the area is inspected, it should be managed as if it Asbestos Containing Material (ACM) is present.	Orange
---	---	--------

Type of Asbestos or Hazardous Material	No sample taken - No Access	Condition		Likelihood of Damage	
		Activity			
		Sealed		Friability	
		Labelled	No	Exposure Risk	
		Quantity
