Asbestos Report

YARRIAMBIACK SHIRE COUNCIL

PROPERTY ADDRESS:
LB27 ELDERLY CITIZEN CLUBROOMS (OLD
BANK)
59 BROOK STREET
WOOMELANG VIC 3485

INSPECTION DATE: 11 FEBRUARY 2021
REFERENCE NUMBER: 62150

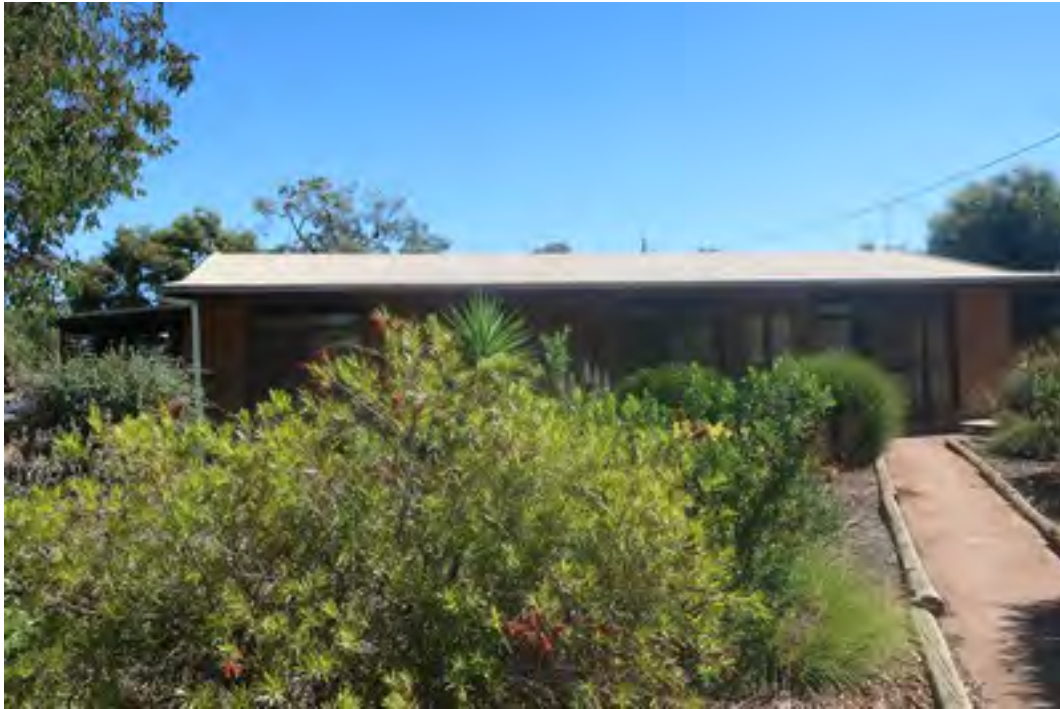
Area 3

LB27 Elderly Citizen Clubrooms (Old Bank): rear of building. The Debris - Broken (Debris) has Asbestos Containing Material (ACM) present.
