**Global
Asbestos
Audits**

Asbestos Report

PROPERTY ADDRESS:
LB65 TIP WOOMELANG
121 CHURCH STREET
WOOMELANG VIC 3485

INSPECTION DATE: 11 FEBRUARY 2021
REFERENCE NUMBER: 62151

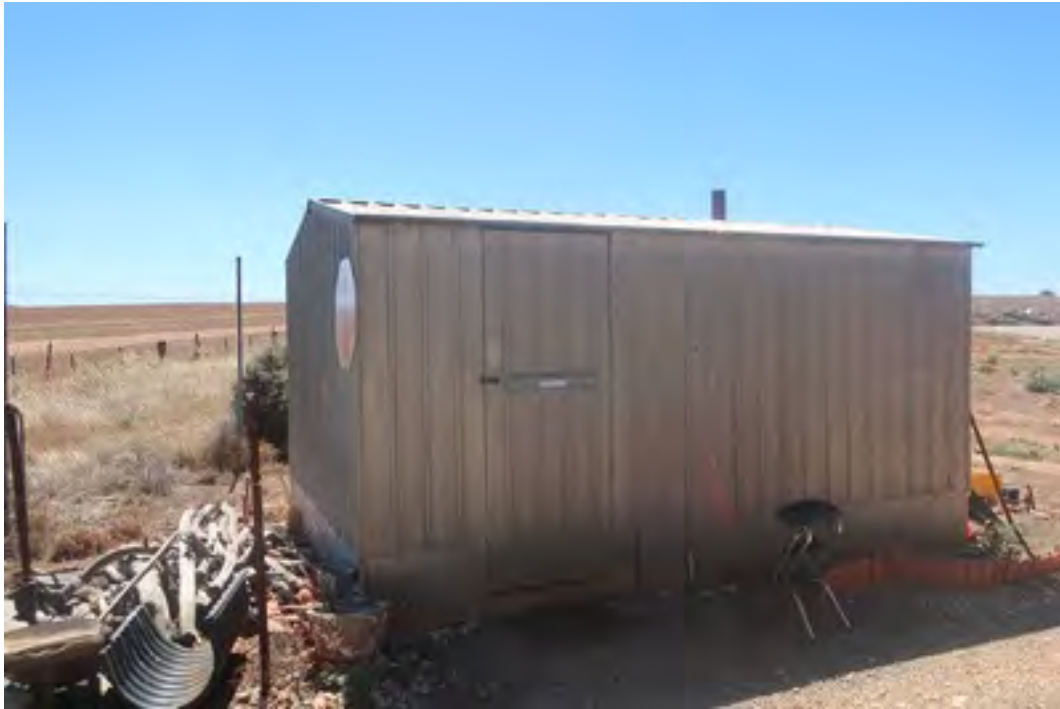
Area 2

2 Shed LB65 Tip: right & rear of building. The Debris - Broken (Debris) has Asbestos Containing Material (ACM) present.

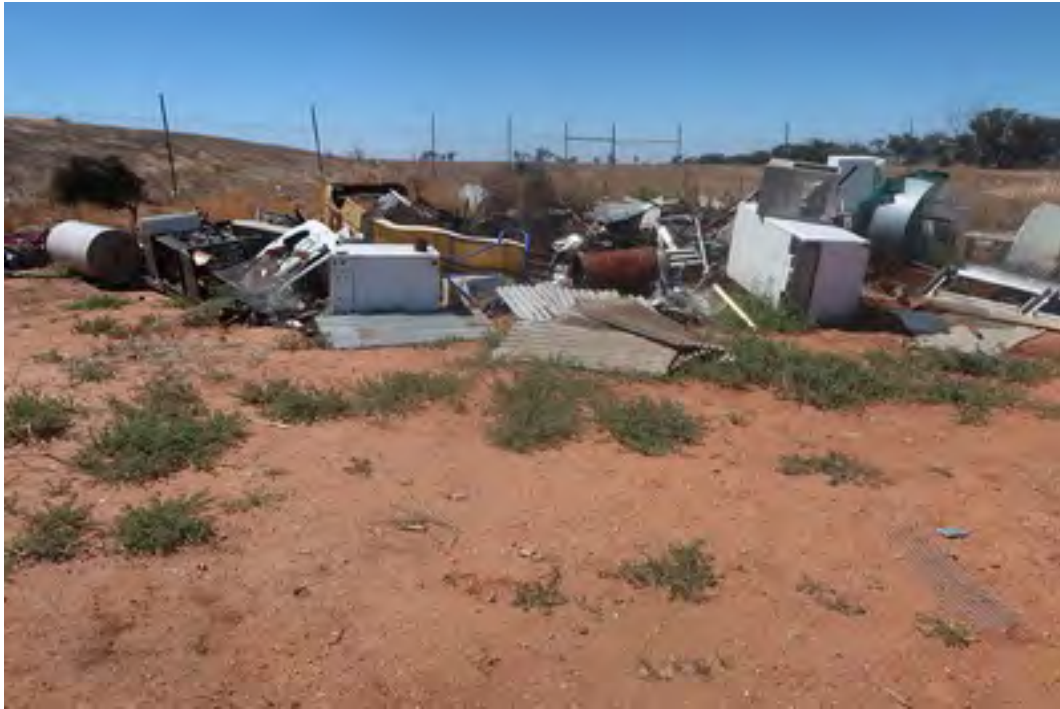
Area 1

- 1 Grounds: Tip. The Debris - Broken (Debris) has Asbestos Containing Material (ACM) present.**

Grounds: Tip. The Debris - Broken (Debris) has Asbestos Containing Material (ACM) present.

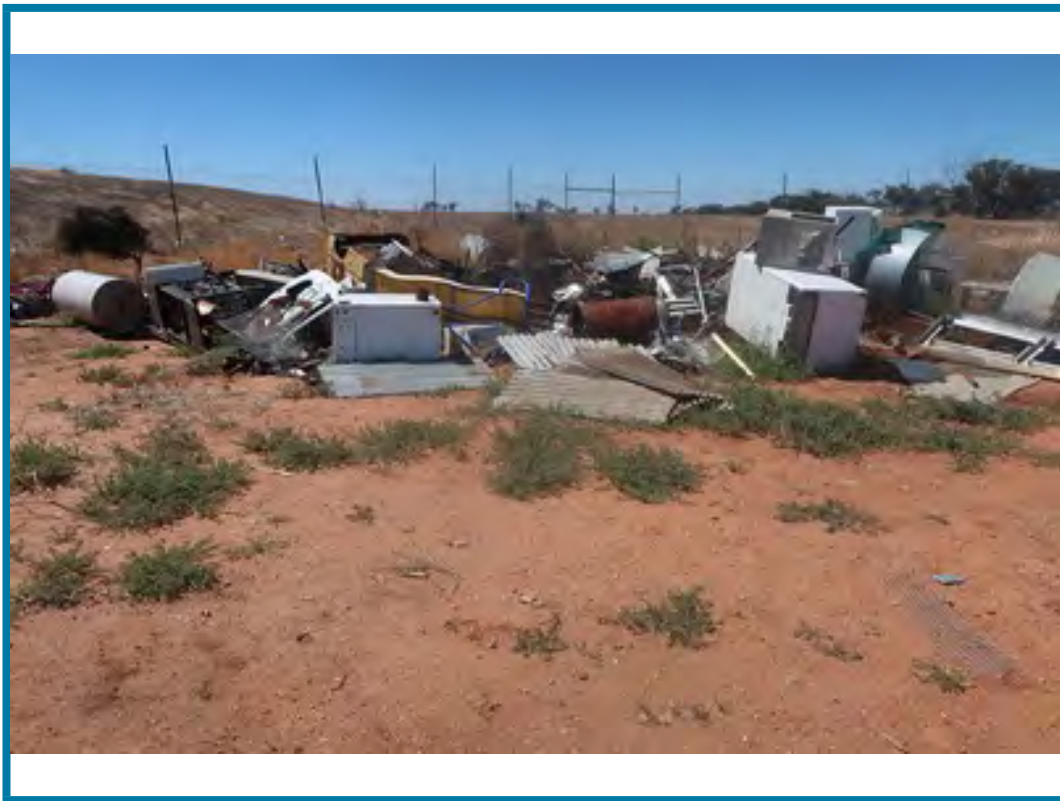
Location	Area	Component Materials	ACM Identified	Type Asbestos Assessment	Condition Priority	Signage Required
Grounds - Tip.	Debris - Broken	Debris	Yes	No sample taken - Visual ID

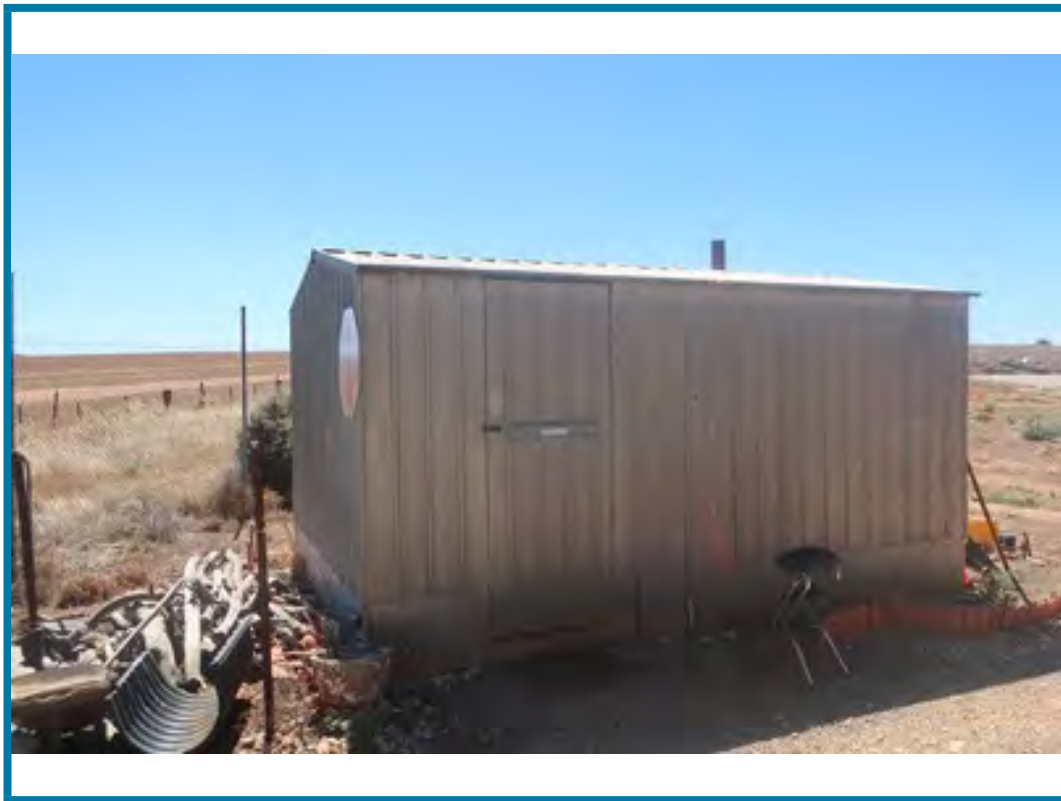
Location	Area	Component Materials	ACM Identified	Type Asbestos Assessment	ConditionPriority	Signage Required
Shed LB65 Tip - entire perimeter of building.		No Asbestos Materials	No	No sample taken - Visual ID
