Asbestos Report

YARRIAMBIACK SHIRE COUNCIL

PROPERTY ADDRESS:
LB100 WOOMELANG UNITS
24 GLOUCESTER AVENUE
WOOMELANG VIC 3485

INSPECTION DATE: 11 FEBRUARY 2021
REFERENCE NUMBER: 62153

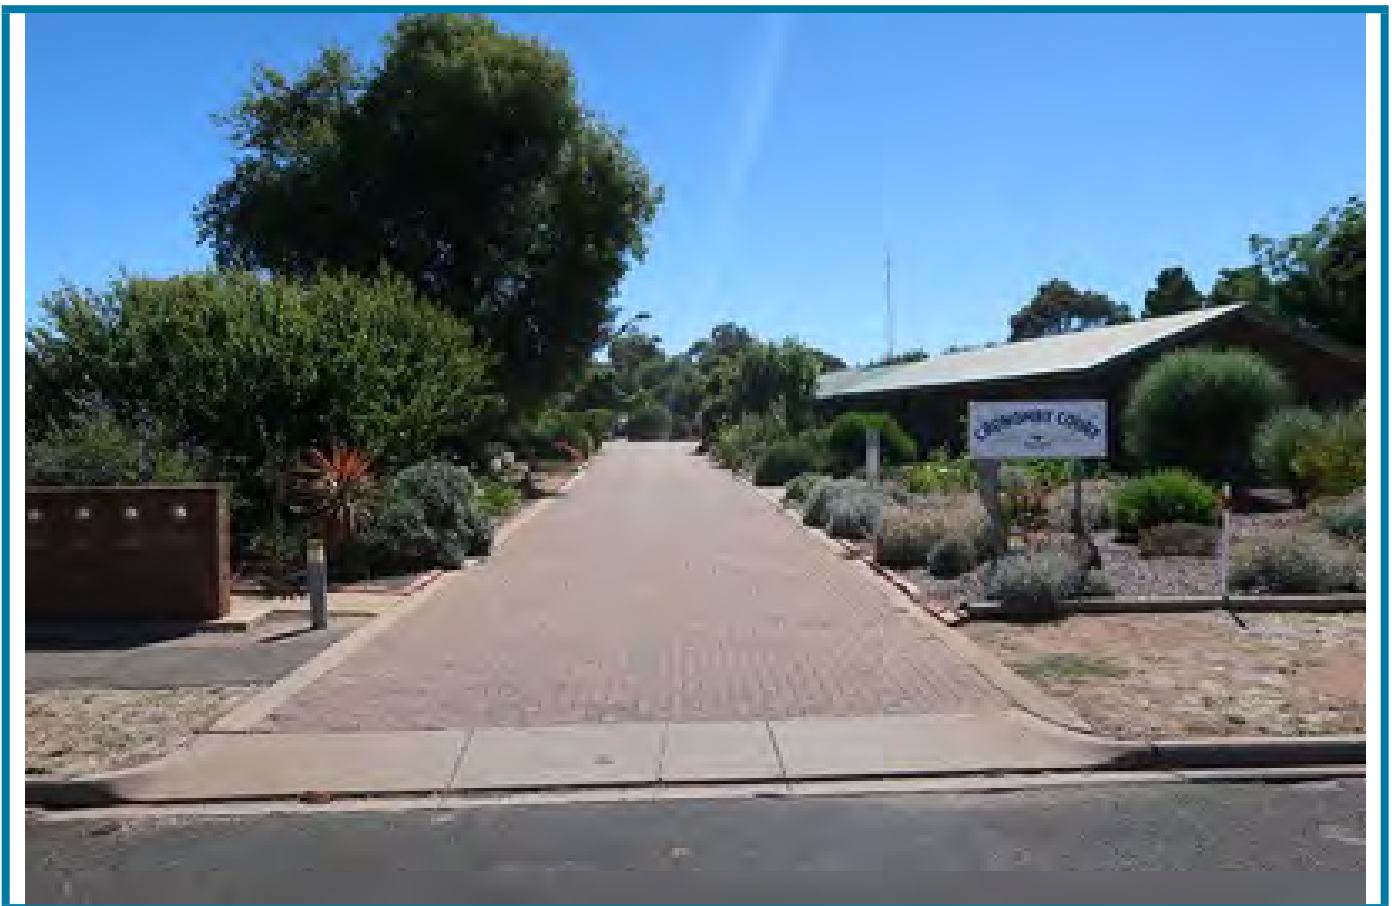
Location	Area	Component Materials	ACM Identified	Type Asbestos Assessment	Condition Priority	Signage Required
Unit 1 - entire perimeter of building.	Soffit	F C Sheeting	No	No Asbestos Detected		
						Same as Sample - 62153-001
