Asbestos Report

YARRIAMBIACK SHIRE COUNCIL

PROPERTY ADDRESS:
LR30 TIP
599 RAINBOW YAAPEET ROAD
YAAPEET VIC 3424

INSPECTION DATE: 11 FEBRUARY 2021
REFERENCE NUMBER: 62154

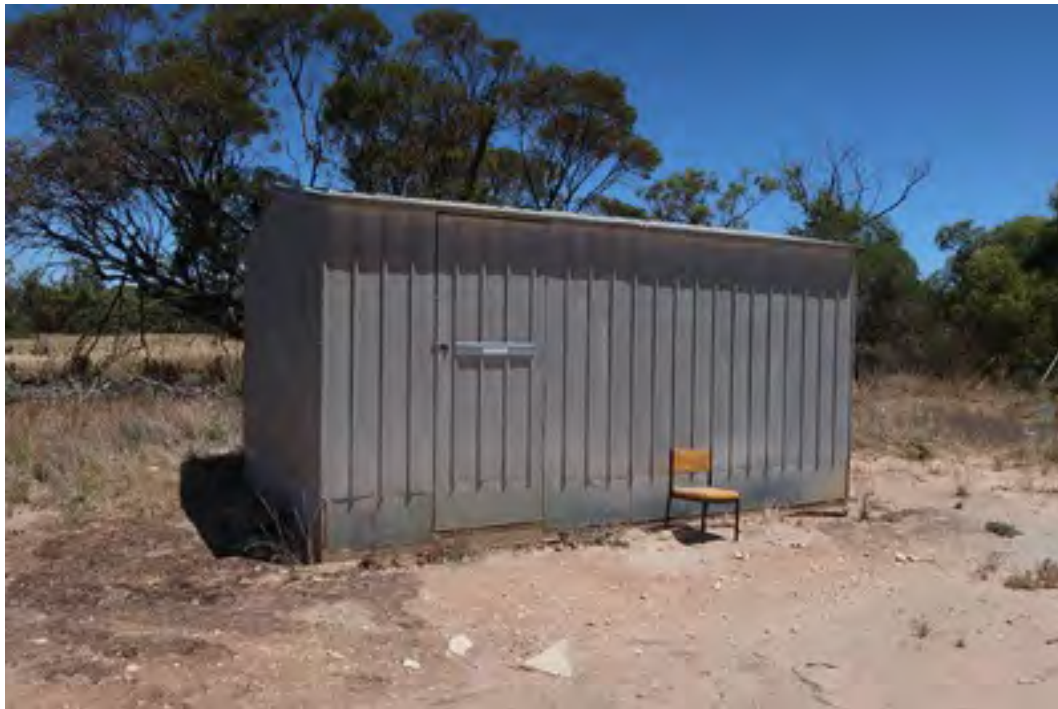
Area 5

5 Shed LR30 Tip: left side of building. The Debris - Broken (Debris) has Asbestos Containing Material (ACM) present.

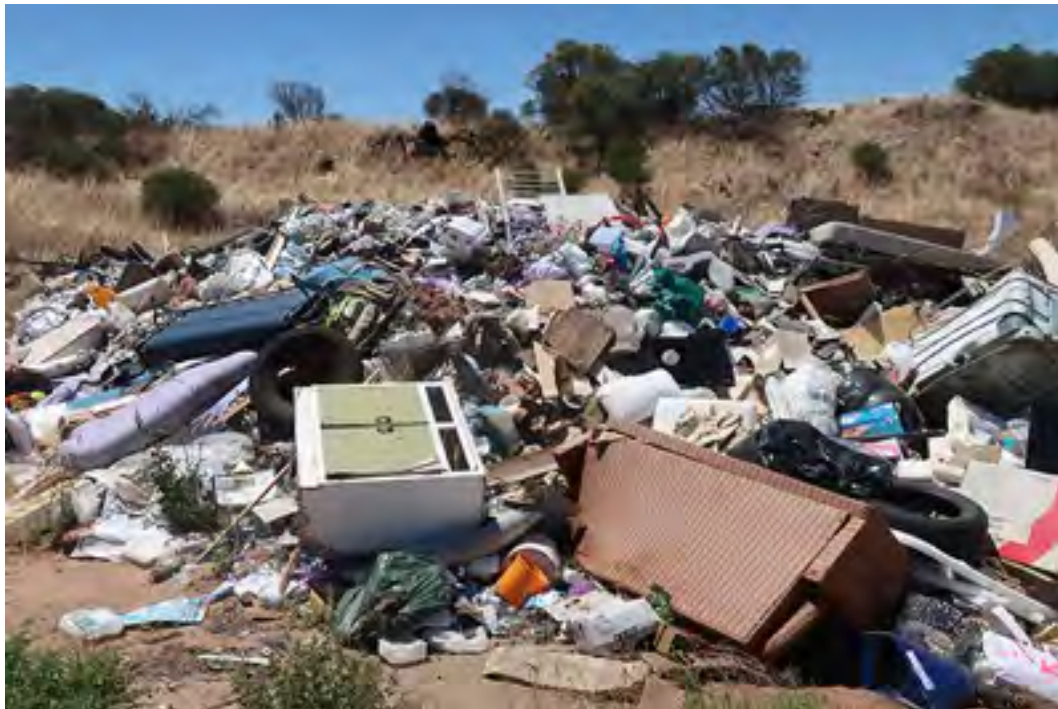
Area 4

4 Grounds: Tip. The Debris - Broken (Debris) has Asbestos Containing Material (ACM) present.
