# Asbestos Report

YARRIAMBIACK SHIRE COUNCIL

PROPERTY ADDRESS:  
OLD POWERHOUSE (DEPOT)  
51 Lascelles Street  
HOPETOUN VIC 3396

Inspection Date: 22 January 2021  
Reference Number: 62061

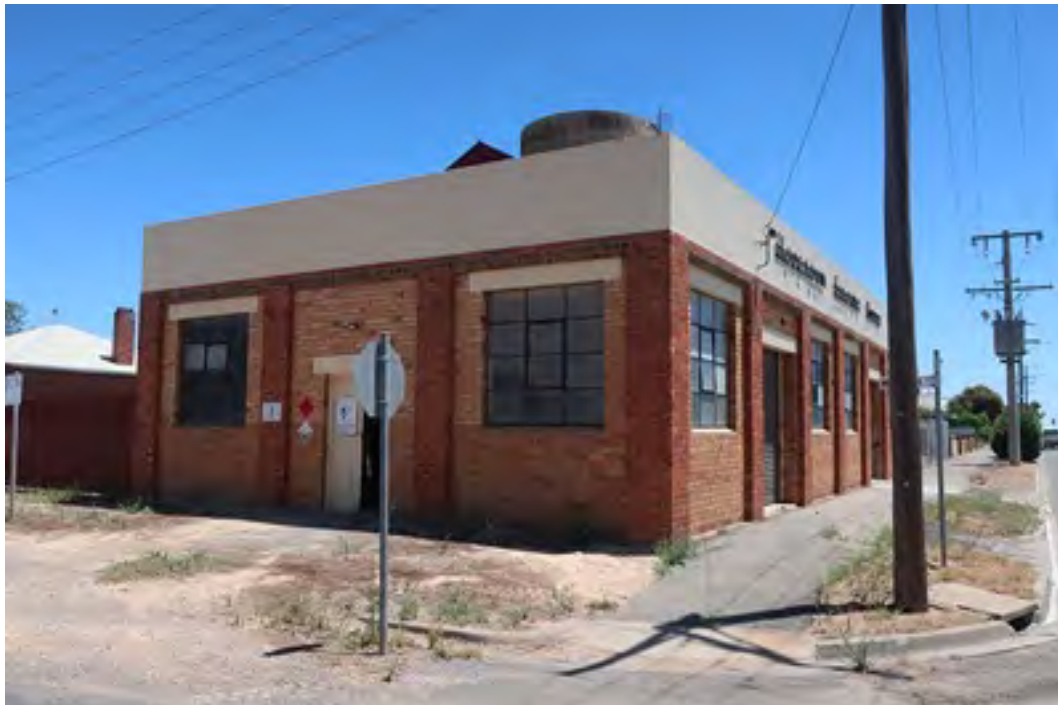
**Area 3**

**Old Powerhouse (Depot): left side of building left side of building - Footpath. The Debris - Broken (Debri) has Asbestos Containing Material (ACM) present.**
