**Global
Asbestos
Audits**

Asbestos Report

YARRIAMBIACK SHIRE COUNCIL

PROPERTY ADDRESS:
LB77 MEMORIAL HALL
13 AUSTIN STREET
HOPETOUN VIC 3396

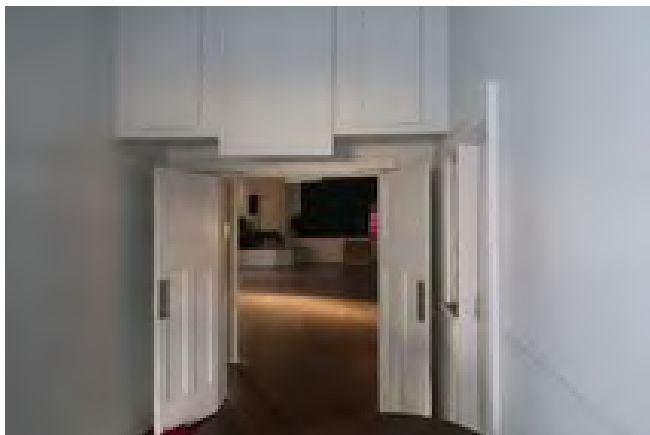
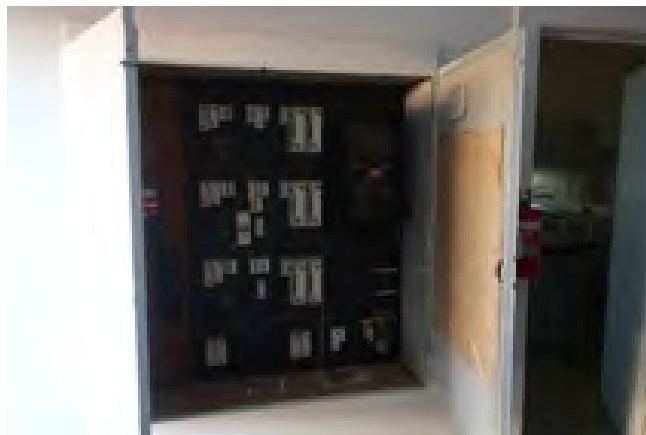
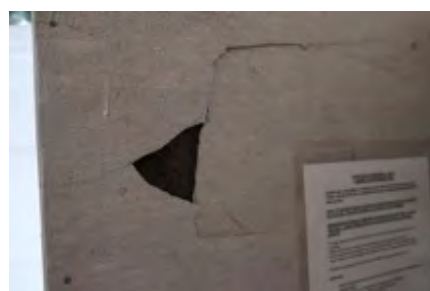
Area 4**LB77 Memorial Hall: Ground Floor Entrance 1. The Electrical cabinet - lining (F C Sheeting) has Asbestos Containing Material (ACM) present.****RISK ASSESSMENT**

Type of Asbestos or Hazardous Material	No sample taken - Visual ID	Condition	AVERAGE	Likelihood of Damage	L (Low) – possible
		Activity	Moderate		
		Sealed	Yes	Friability	Exposed Fibres
		Labelled	Y	Exposure Risk	High - Short term exposure risk
		Quantity

Holes (impact)

Priority	HIGH	Label Required	Yes	Re- Audit Date	27 Jan 2022
Action	Remedial repairs required - seal exposed edges or replace or laminate over damaged material				
Recommendation	Holes (impact) - The damaged area requires immediate remedial repairs. It is recommended the asbestos sheeting be replaced (preferred) or edges sealed with approved sealant and then the area be concealed by laminating (sheeting).				
Legislative Requirements Victorian Regulation 2007	Damaged ACM visible in area. Requires IMMEDIATE ATTENTION. WARNING labels should be affixed. Avoid mechanical damage and abrasion. Remove if refurbishment, structural alteration or demolition is to be carried out in this area. Re-inspect every 12 months or earlier if disturbed or removed in accordance with the Victorian OH&S Regulation 2017. All remedial/removal repairs require a Clearance Inspection & Certificate to be recorded by an approved and competent assessor.

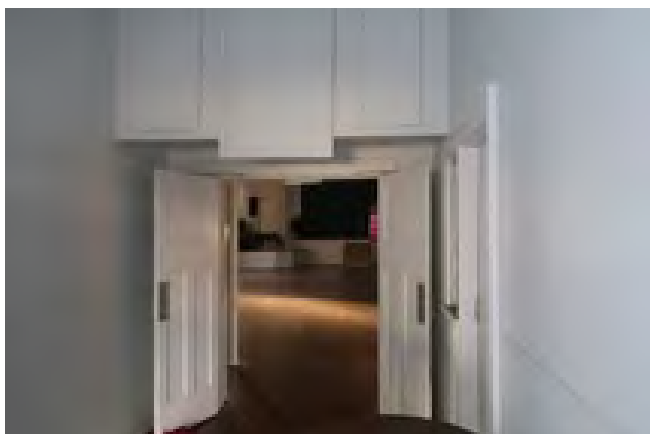
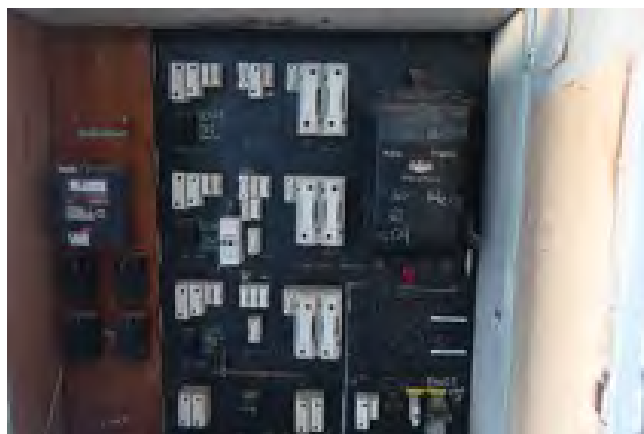
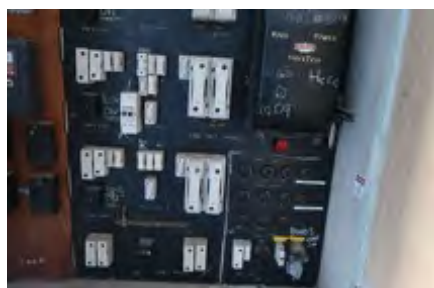
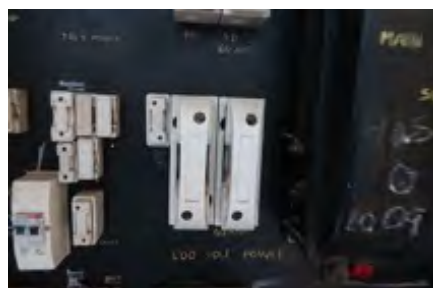
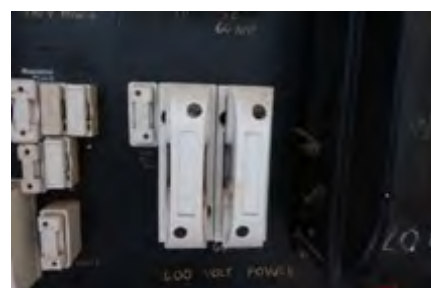
Area 10**LB77 Memorial Hall: Ground Floor Entrance 1. The A: Electrical board; B: Ceramic Fuses (A: Zelemite; B: Cloth Inserts) has Asbestos Containing Material (ACM) present.****RISK ASSESSMENT**

Type of Asbestos or Hazardous Material	No sample taken - Visual ID	Condition	GOOD	Likelihood of Damage	L (Low) – possible
		Activity	Moderate		
		Sealed	Yes	Friability	Bonded (non-friable)
		Labelled	Y	Exposure Risk	Low - Negligible or low risk
		Quantity

Priority	MEDIUM	Label Required	Yes	Re- Audit Date	27 Jan 2022
Action	No remedial action required, unless disturbed				
Recommendation	Maintain paint or sealant to ACM surfaces. Particular attention should be given to side edges, ensure paint/sealant covers ALL exposed ACM surfaces. Do not remove the fuses without asbestos controls - test for cloth inserts				
Legislative Requirements Victorian Regulation 2007	Warning labels should be affixed. Avoid mechanical damage and abrasion. Remove if refurbishment, structural alteration or demolition is to be carried out in this area. Re-inspect every 12 months or earlier if disturbed or removed in accordance with the Victorian OH&S Regulation 2017. All remedial/removal repairs require a Clearance Inspection & Certificate to be recorded by an approved and competent assessor.

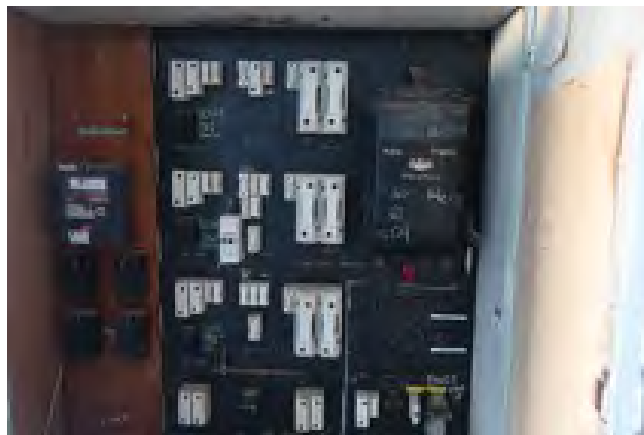
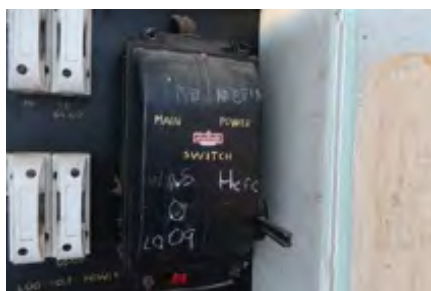
Type of Asbestos or Hazardous Material	No sample taken - Visual ID	Condition	GOOD	Likelihood of Damage	L (Low) – possible
		Activity	Moderate		
		Sealed	Yes	Friability	Bonded (non-friable)
		Labelled	Y	Exposure Risk	Low - Negligible or low risk
		Quantity

Priority	MEDIUM	Label Required	Yes	Re- Audit Date	27 Jan 2022
Action	No remedial action required, unless disturbed				
Recommendation	Maintain paint or sealant to ACM surfaces. Particular attention should be given to side edges, ensure paint/sealant covers ALL exposed ACM surfaces.				
Legislative Requirements Victorian Regulation 2007	Warning labels should be affixed. Avoid mechanical damage and abrasion. Remove if refurbishment, structural alteration or demolition is to be carried out in this area. Re-inspect every 12 months or earlier if disturbed or removed in accordance with the Victorian OH&S Regulation 2017. All remedial/removal repairs require a Clearance Inspection & Certificate to be recorded by an approved and competent assessor.

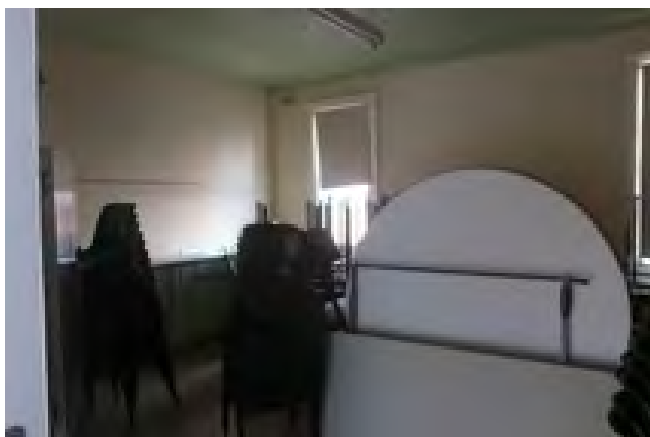
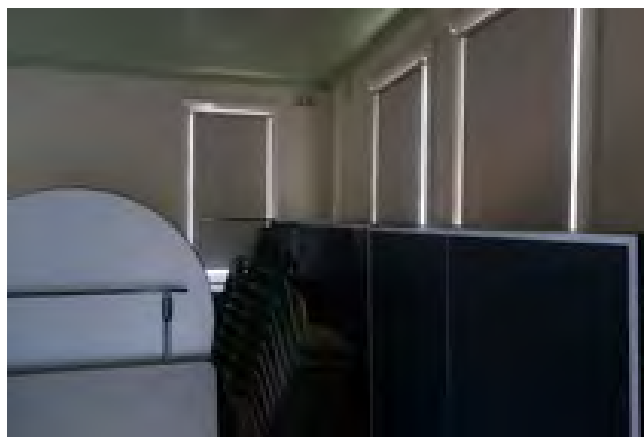
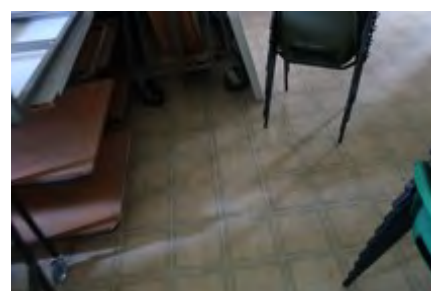
Area 17**LB77 Memorial Hall: Ground Floor Storage 2. The Floor (Linoleum) has Asbestos Containing Material (ACM) present.****RISK ASSESSMENT**

Type of Asbestos or Hazardous Material	No sample taken - Visual ID	Condition	GOOD	Likelihood of Damage	L (Low) – possible
		Activity	Moderate		
		Sealed	Yes	Friability	Bonded (non-friable)
		Labelled	Y	Exposure Risk	Low - Negligible or low risk
		Quantity

Maintain paint or sealant

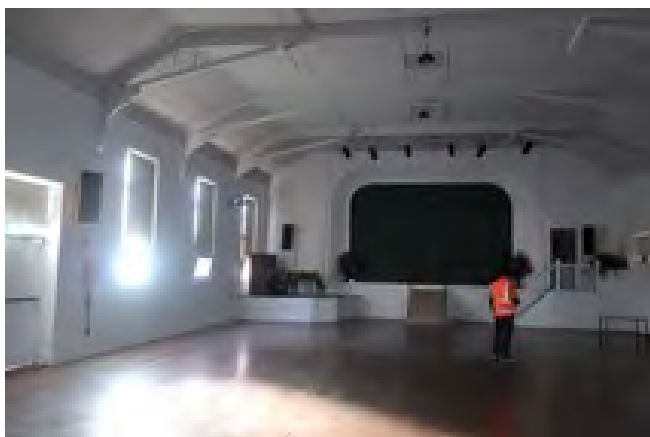
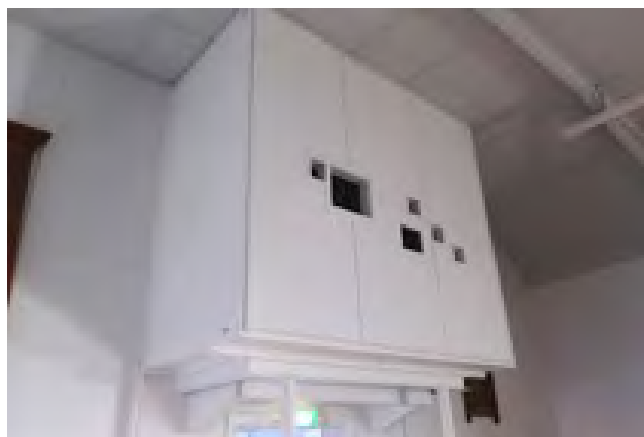
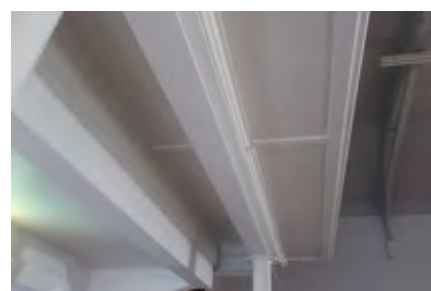
Area 13**LB77 Memorial Hall: Ground Floor Hall 5. The Projector box - ceiling (F C Sheeting) has Asbestos Containing Material (ACM) present.****RISK ASSESSMENT**

Type of Asbestos or Hazardous Material	No sample taken - Visual ID	Condition	GOOD	Likelihood of Damage	L (Low) – possible
		Activity	Moderate		
		Sealed	Yes	Friability	Bonded (non-friable)
		Labelled	Y	Exposure Risk	Low - Negligible or low risk
		Quantity

Priority	MEDIUM	Label Required	Yes	Re- Audit Date	27 Jan 2022
Action	No remedial action required, unless disturbed				
Recommendation	Maintain paint or sealant to ACM surfaces. Particular attention should be given to side edges, ensure paint/sealant covers ALL exposed ACM surfaces.				
Legislative Requirements Victorian Regulation 2007	Warning labels should be affixed. Avoid mechanical damage and abrasion. Remove if refurbishment, structural alteration or demolition is to be carried out in this area. Re-inspect every 12 months or earlier if disturbed or removed in accordance with the Victorian OH&S Regulation 2017. All remedial/removal repairs require a Clearance Inspection & Certificate to be recorded by an approved and competent assessor.

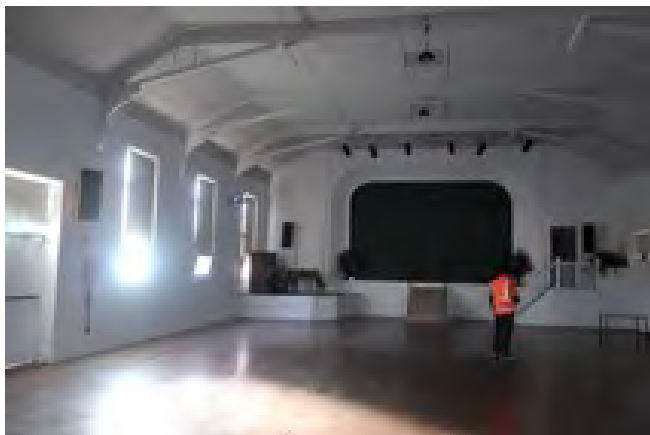
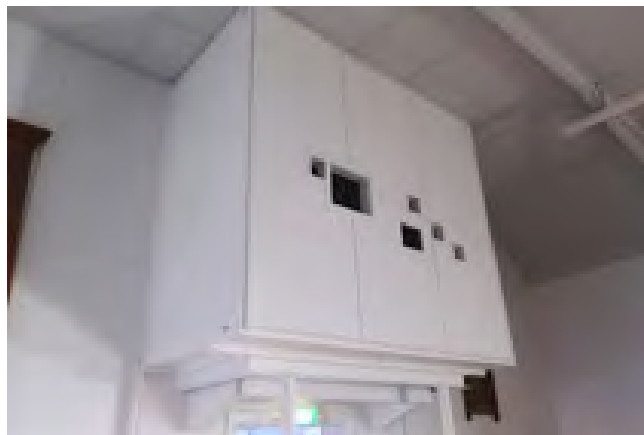
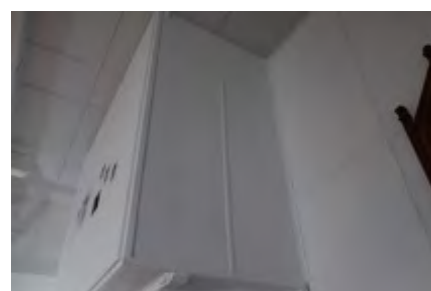
Area 14**LB77 Memorial Hall: Ground Floor Hall 5. The Projector box - side walls (F C Sheet) has Asbestos Containing Material (ACM) present.****RISK ASSESSMENT**

Type of Asbestos or Hazardous Material	Chrysotile	Condition	GOOD	Likelihood of Damage	L (Low) – possible
	Sample taken 62071-006	Activity	Moderate		
		Sealed	Yes	Friability	Bonded (non-friable)
		Labelled	Y	Exposure Risk	Low - Negligible or low risk
		Quantity

Maintain paint or sealant

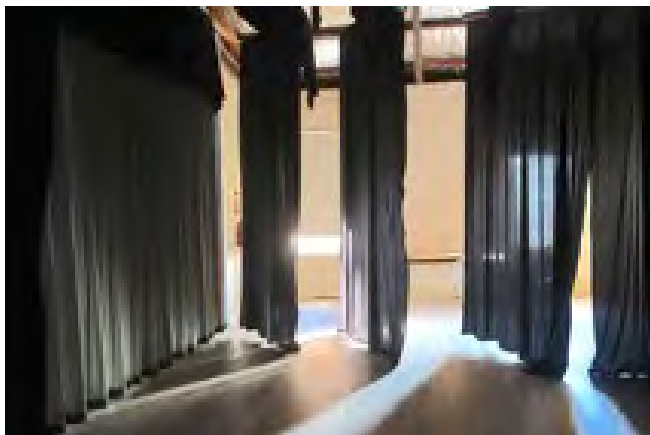
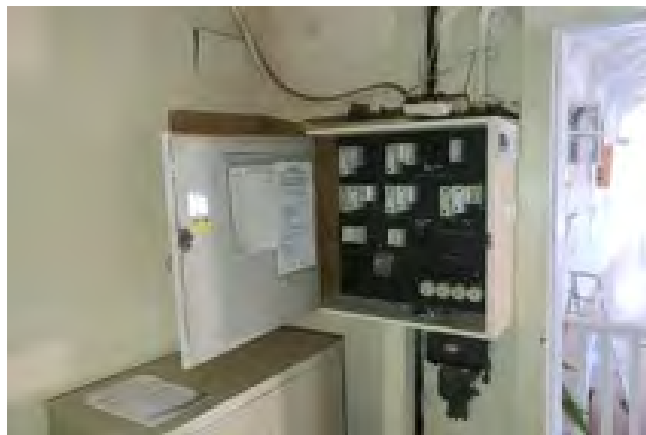
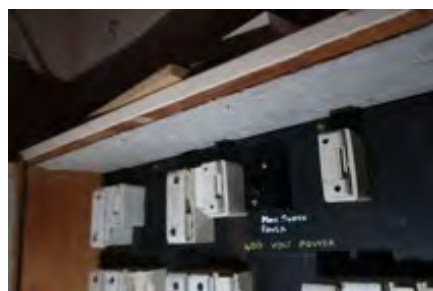
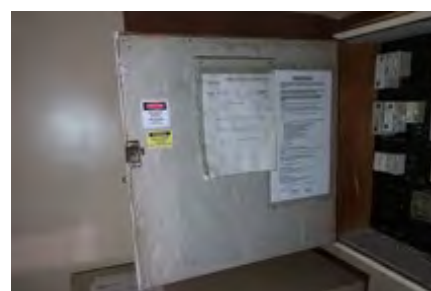
Area 5**LB77 Memorial Hall: Ground Floor Stage 6. The Electrical Cabinet - lining (F C Sheeting) has Asbestos Containing Material (ACM) present.****RISK ASSESSMENT**

Type of Asbestos or Hazardous Material	No sample taken - Visual ID	Condition	AVERAGE	Likelihood of Damage	L (Low) – possible
		Activity	Moderate		
		Sealed	No	Friability	Bonded (non-friable)
		Labelled	Y	Exposure Risk	Medium - Moderate risk
		Quantity

Raw Material

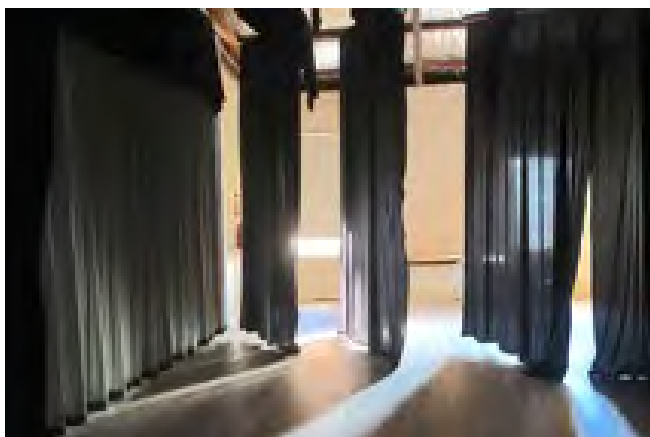
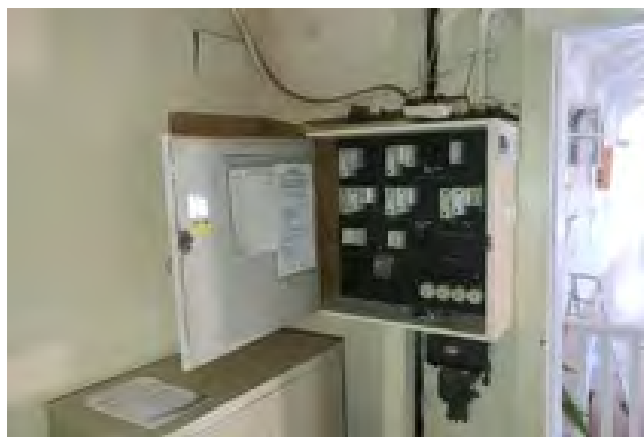
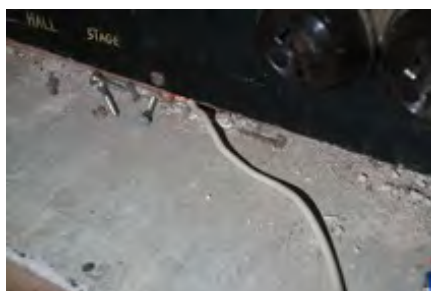
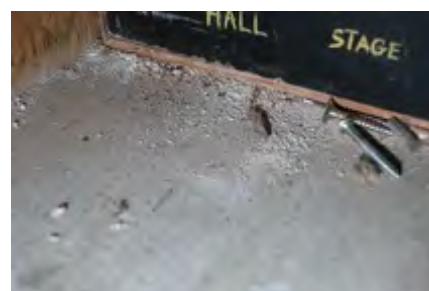
Area 1**LB77 Memorial Hall: Ground Floor Stage 6. The Electrical Cabinet (Debris) has Asbestos Containing Material (ACM) present.****RISK ASSESSMENT**

Type of Asbestos or Hazardous Material	Chrysotile Amosite Sample taken 62071-002	Condition	POOR	Likelihood of Damage	H (High) - almost certain
		Activity	Low		
		Sealed	No	Friability	Exposed Fibres
		Labelled	Y	Exposure Risk	High - Short term exposure risk
		Quantity

Debris on Ground

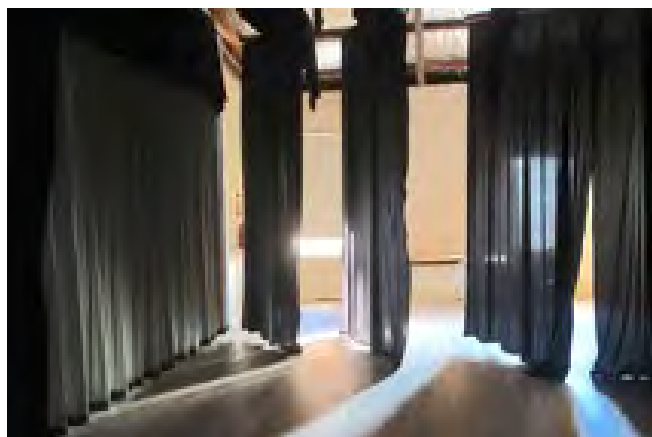
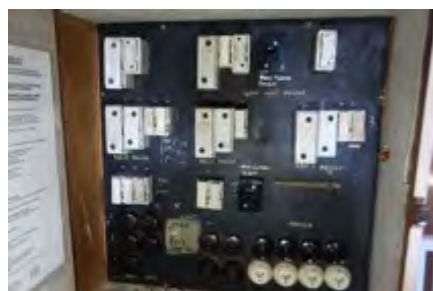
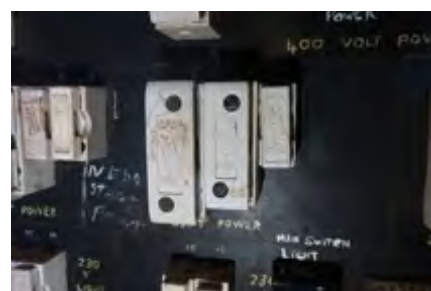
Area 15**LB77 Memorial Hall: Ground Floor Stage 6. The A: Electrical board; B: Ceramic Fuses (A: Zelemite; B: Cloth Inserts) has Asbestos Containing Material (ACM) present.****RISK ASSESSMENT**

Type of Asbestos or Hazardous Material	Chrysotile	Condition	GOOD	Likelihood of Damage	L (Low) – possible
	Sample taken 62071-003 (Zelemite)	Activity	Moderate		
		Sealed	Yes	Friability	Bonded (non-friable)
		Labelled	Y	Exposure Risk	Low - Negligible or low risk
		Quantity

Maintain paint or sealant

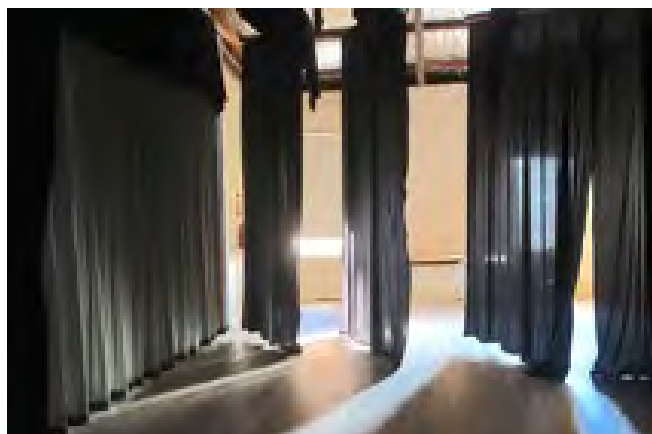
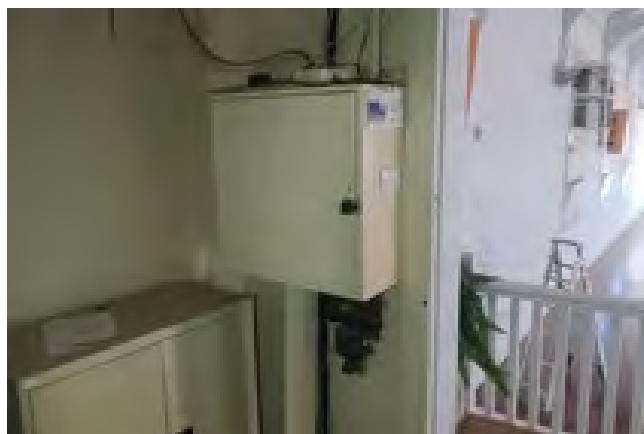
Area 16**LB77 Memorial Hall: Ground Floor Stage 6. The Electrical Switch & Electrical Cable (Fire Retardant) has Asbestos Containing Material (ACM) present.****RISK ASSESSMENT**

Type of Asbestos or Hazardous Material	No sample taken - Visual ID	Condition	GOOD	Likelihood of Damage	VL (Very Low)- unlikely or rare
		Activity	Low		
		Sealed	Yes	Friability	Bonded (non-friable)
		Labelled	Y	Exposure Risk	Low - Negligible or low risk
		Quantity

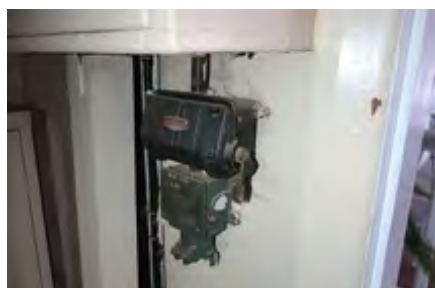
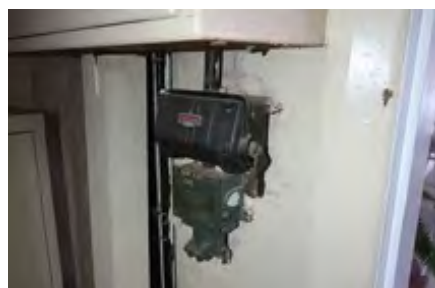
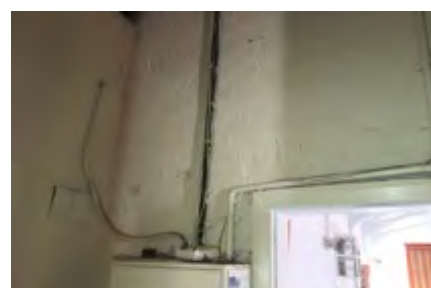
Maintain paint or sealant

Priority	MEDIUM	Label Required	Yes	Re- Audit Date	27 Jan 2022
Action	No remedial action required, unless disturbed				
Recommendation	Maintain paint or sealant to ACM surfaces. Particular attention should be given to side edges, ensure paint/sealant covers ALL exposed ACM surfaces.				
Legislative Requirements Victorian Regulation 2007	Warning labels should be affixed. Avoid mechanical damage and abrasion. Remove if refurbishment, structural alteration or demolition is to be carried out in this area. Re-inspect every 12 months or earlier if disturbed or removed in accordance with the Victorian OH&S Regulation 2017. All remedial/removal repairs require a Clearance Inspection & Certificate to be recorded by an approved and competent assessor.

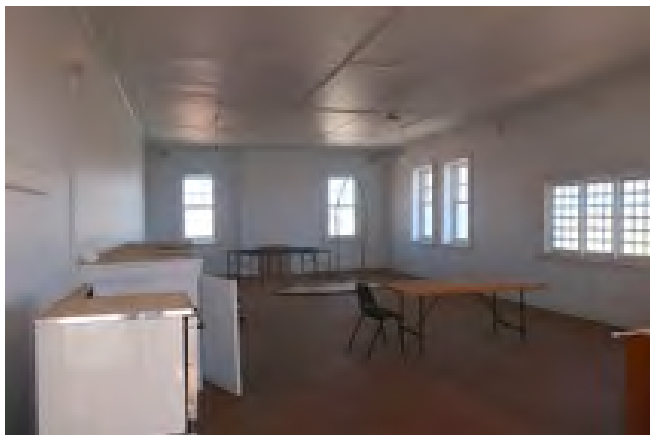
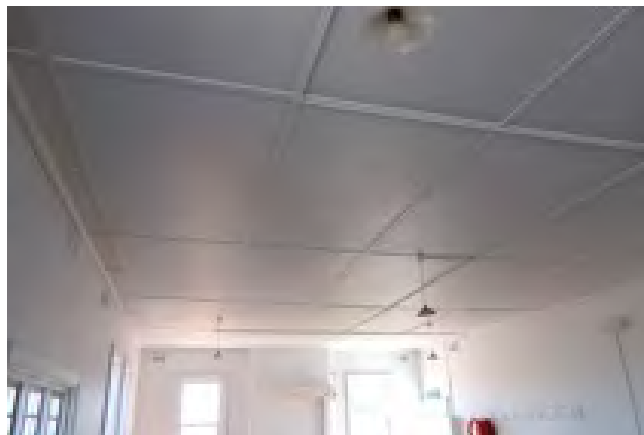
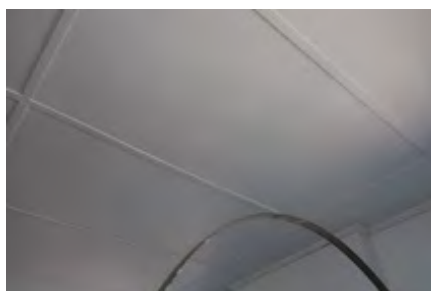
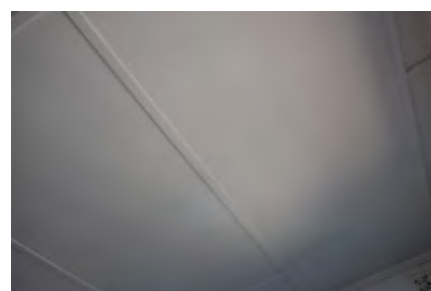
Area 18**LB77 Memorial Hall: Level 1 Open room 10. The Ceiling (F C Sheeting) has Asbestos Containing Material (ACM) present.****RISK ASSESSMENT**

Type of Asbestos or Hazardous Material	No sample taken - Visual ID	Condition	GOOD	Likelihood of Damage	L (Low) – possible
		Activity	Moderate		
		Sealed	Yes	Friability	Bonded (non-friable)
		Labelled	Y	Exposure Risk	Low - Negligible or low risk
		Quantity

Maintain paint or sealant

Priority	MEDIUM	Label Required	Yes	Re- Audit Date	27 Jan 2022
Action	No remedial action required, unless disturbed				
Recommendation	Maintain paint or sealant to ACM surfaces. Particular attention should be given to side edges, ensure paint/sealant covers ALL exposed ACM surfaces.				
Legislative Requirements Victorian Regulation 2007	Warning labels should be affixed. Avoid mechanical damage and abrasion. Remove if refurbishment, structural alteration or demolition is to be carried out in this area. Re-inspect every 12 months or earlier if disturbed or removed in accordance with the Victorian OH&S Regulation 2017. All remedial/removal repairs require a Clearance Inspection & Certificate to be recorded by an approved and competent assessor.

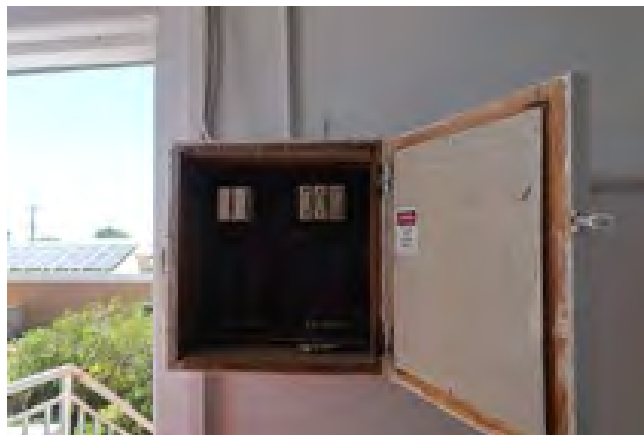
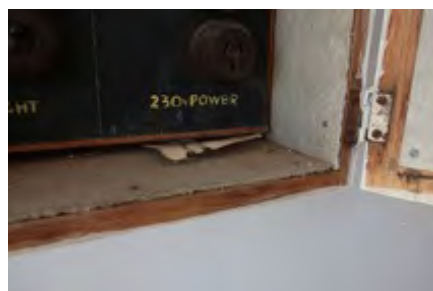
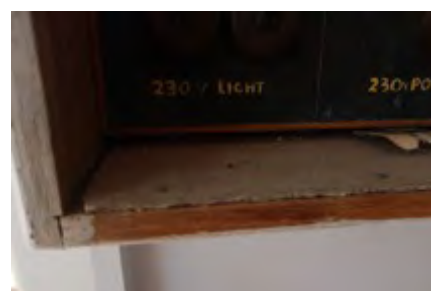
Type of Asbestos or Hazardous Material	No sample taken - Visual ID	Condition	AVERAGE	Likelihood of Damage	L (Low) – possible
		Activity	Moderate		
		Sealed	No	Friability	Bonded (non-friable)
		Labelled	Y	Exposure Risk	Medium - Moderate risk
		Quantity

Raw Material

Priority	HIGH	Label Required	Yes	Re- Audit Date	27 Jan 2022
Action	Remedial repairs required - seal raw material / edges				
Recommendation	Raw material sheeting - The area requires immediate remedial repairs. It is recommended the asbestos material be sealed with an approved membrane.				
Legislative Requirements Victorian Regulation 2007	<p>Damaged ACM visible in area. Requires IMMEDIATE ATTENTION. WARNING labels should be affixed. Avoid mechanical damage and abrasion. Remove if refurbishment, structural alteration or demolition is to be carried out in this area. Re-inspect every 12 months or earlier if disturbed or removed in accordance with the Victorian OH&S Regulation 2017.</p> <p>All remedial/removal repairs require a Clearance Inspection & Certificate to be recorded by an approved and competent assessor.</p>

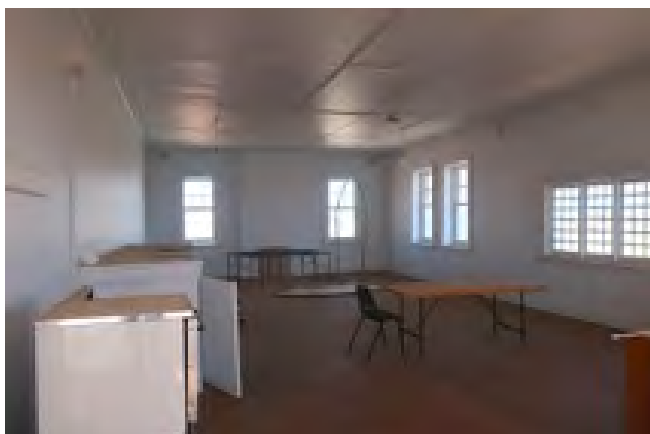
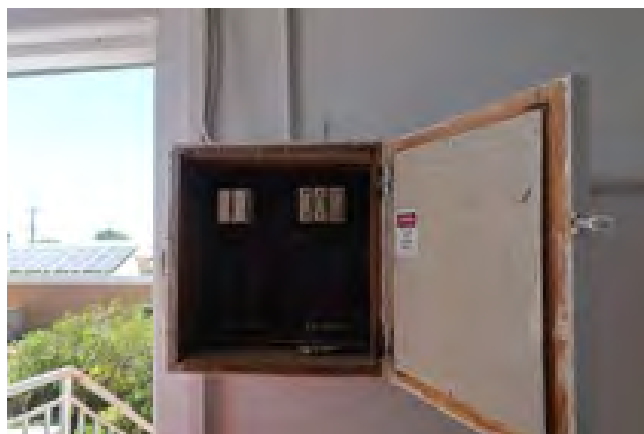
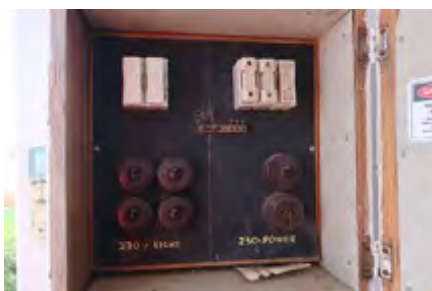
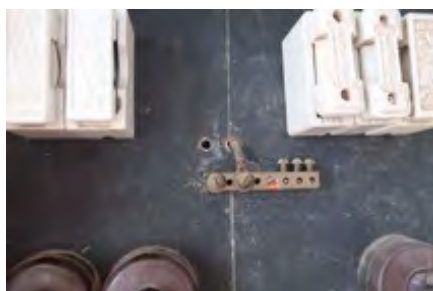
Area 6**LB77 Memorial Hall: Level 1 Open room 10. The A: Electrical board; B: Ceramic Fuses (A: Zelemite; B: Cloth Inserts) has Asbestos Containing Material (ACM) present.****RISK ASSESSMENT**

Type of Asbestos or Hazardous Material	No sample taken - Visual ID	Condition	AVERAGE	Likelihood of Damage	L (Low) – possible
		Activity	Moderate		
		Sealed	Yes	Friability	Exposed Fibres
		Labelled	Y	Exposure Risk	Medium - Moderate risk
		Quantity

Penetration Holes

Priority	HIGH	Label Required	Yes	Re- Audit Date	27 Jan 2022
Action	Remedial repairs required - seal raw material / edges				
Recommendation	Penetration Holes - The exposed edges require approved sealant. It is further recommended the gaps be filled with sealant. Do not remove the fuses without asbestos controls - test for cloth inserts				
Legislative Requirements Victorian Regulation 2007	Damaged ACM visible in area. Requires IMMEDIATE ATTENTION. WARNING labels should be affixed. Avoid mechanical damage and abrasion. Remove if refurbishment, structural alteration or demolition is to be carried out in this area. Re-inspect every 12 months or earlier if disturbed or removed in accordance with the Victorian OH&S Regulation 2017. All remedial/removal repairs require a Clearance Inspection & Certificate to be recorded by an approved and competent assessor.

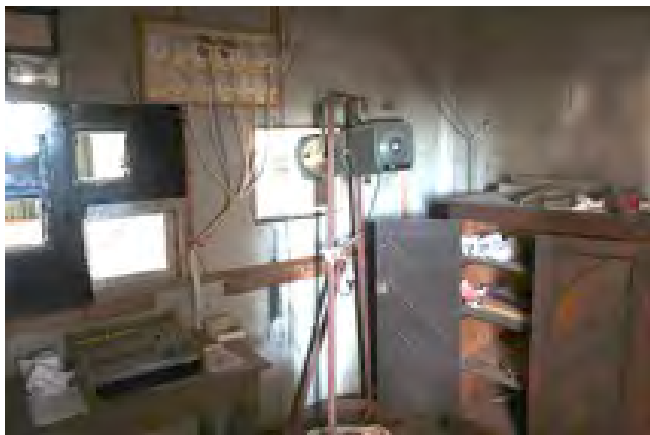
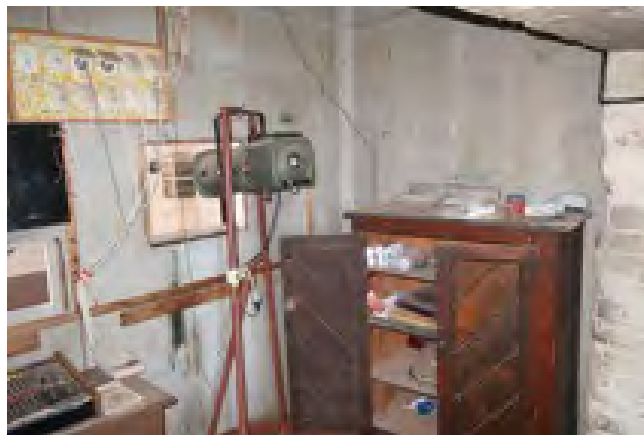
Area 3**LB77 Memorial Hall: Level 1 Projector room 11. The Walls and Ceiling (F C Sheeting) has Asbestos Containing Material (ACM) present.****RISK ASSESSMENT**

Type of Asbestos or Hazardous Material	No sample taken - Visual ID	Condition	POOR	Likelihood of Damage	L (Low) – possible
		Activity	Moderate		
		Sealed	Yes	Friability	Exposed Fibres
		Labelled	Y	Exposure Risk	High - Short term exposure risk
		Quantity

Priority	IMMEDIATE	Label Required	Yes	Re- Audit Date	27 Jan 2022
Action	Remedial repairs required - seal exposed edges or replace or laminate over damaged material				
Recommendation	Damaged material - The damaged area requires immediate remedial repairs. It is recommended the asbestos sheeting be replaced.				
Legislative Requirements Victorian Regulation 2007	ACM debris visible. Recommend cleanup by licensed Asbestos Removalist. Warning labels should be affixed. Avoid mechanical damage and abrasion. Remove if refurbishment, structural alteration or demolition is to be carried out in this area. Re-inspect every 12 months or earlier if disturbed or removed in accordance with the Victorian OH&S Regulation 2017. All remedial/removal repairs require a Clearance Inspection & Certificate to be recorded by an approved and competent assessor.

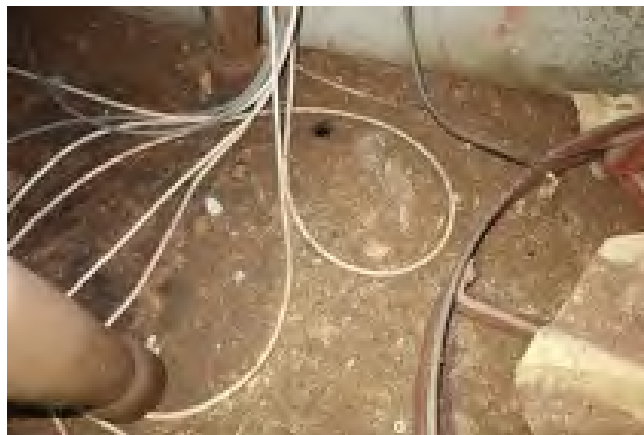
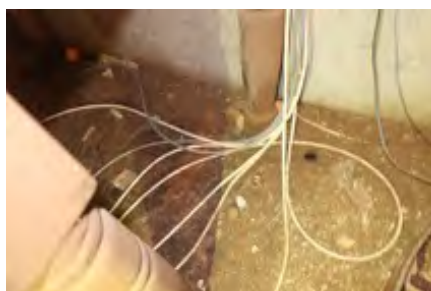
Area 2**LB77 Memorial Hall: Level 1 Projector room 11. The Debris - Broken (Debris) has Asbestos Containing Material (ACM) present.****RISK ASSESSMENT**

Type of Asbestos or Hazardous Material	No sample taken - Visual ID	Condition	POOR	Likelihood of Damage	H (High) - almost certain
		Activity	Moderate		
		Sealed	No	Friability	Exposed Fibres
		Labelled	No	Exposure Risk	High - Short term exposure risk
		Quantity

Debris on Surface

Priority	IMMEDIATE	Label Required	Yes	Re- Audit Date	27 Jan 2022
Action	Restrict access and target for imminent removal				
Recommendation	Air Monitoring required before occupation. Debris on Surface - The Debris requires immediate cleanup and disposal with specialised equipment and with licensed removalist to safely remove the asbestos debris.				
Legislative Requirements Victorian Regulation 2007	ACM debris visible. Recommend cleanup by licensed Asbestos Removalist. Warning labels should be affixed. Avoid mechanical damage and abrasion. Remove if refurbishment, structural alteration or demolition is to be carried out in this area. Re-inspect every 12 months or earlier if disturbed or removed in accordance with the Victorian OH&S Regulation 2017. All remedial/removal repairs require a Clearance Inspection & Certificate to be recorded by an approved and competent assessor.

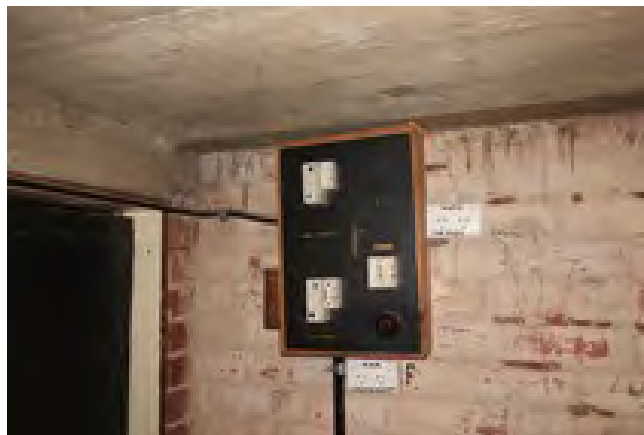
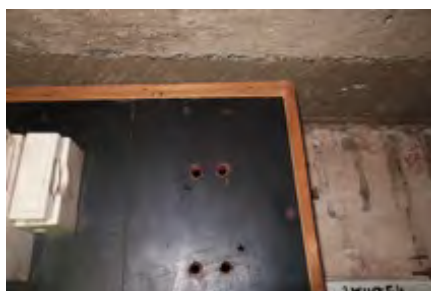
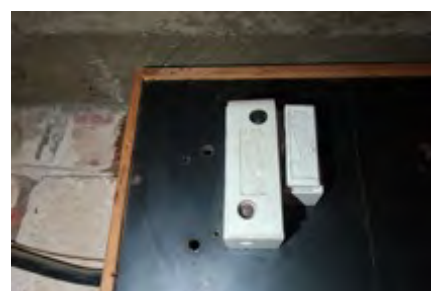
Type of Asbestos or Hazardous Material	No sample taken - Visual ID	Condition	AVERAGE	Likelihood of Damage	L (Low) – possible
		Activity	Moderate		
		Sealed	Yes	Friability	Exposed Fibres
		Labelled	Y	Exposure Risk	Medium - Moderate risk
		Quantity

Penetration Holes

Priority	HIGH	Label Required	Yes	Re- Audit Date	27 Jan 2022
Action	Remedial repairs required - seal raw material / edges				
Recommendation	Penetration Holes - The exposed edges require approved sealant. It is further recommended the gaps be filled with sealant. Do not remove the fuses without asbestos controls - test for cloth inserts				
Legislative Requirements Victorian Regulation 2007	Damaged ACM visible in area. Requires IMMEDIATE ATTENTION. WARNING labels should be affixed. Avoid mechanical damage and abrasion. Remove if refurbishment, structural alteration or demolition is to be carried out in this area. Re-inspect every 12 months or earlier if disturbed or removed in accordance with the Victorian OH&S Regulation 2017. All remedial/removal repairs require a Clearance Inspection & Certificate to be recorded by an approved and competent assessor.

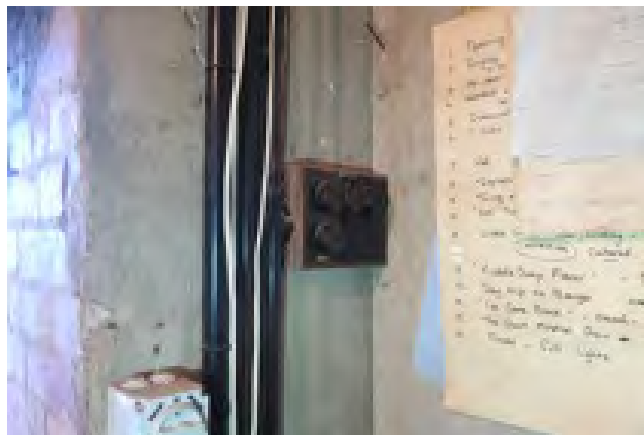
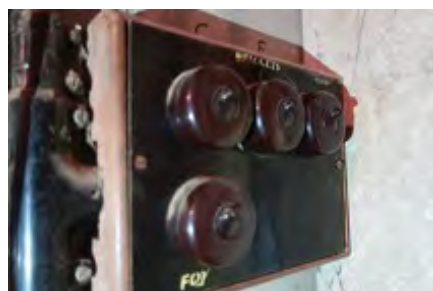
Type of Asbestos or Hazardous Material	No sample taken - Visual ID	Condition	GOOD	Likelihood of Damage	L (Low) – possible
		Activity	Moderate		
		Sealed	Yes	Friability	Bonded (non-friable)
		Labelled	Y	Exposure Risk	Low - Negligible or low risk
		Quantity

Maintain paint or sealant

Priority	MEDIUM	Label Required	Yes	Re- Audit Date	27 Jan 2022
Action	No remedial action required, unless disturbed				
Recommendation	Maintain paint or sealant to ACM surfaces. Particular attention should be given to side edges, ensure paint/sealant covers ALL exposed ACM surfaces.				
Legislative Requirements Victorian Regulation 2007	Warning labels should be affixed. Avoid mechanical damage and abrasion. Remove if refurbishment, structural alteration or demolition is to be carried out in this area. Re-inspect every 12 months or earlier if disturbed or removed in accordance with the Victorian OH&S Regulation 2017. All remedial/removal repairs require a Clearance Inspection & Certificate to be recorded by an approved and competent assessor.

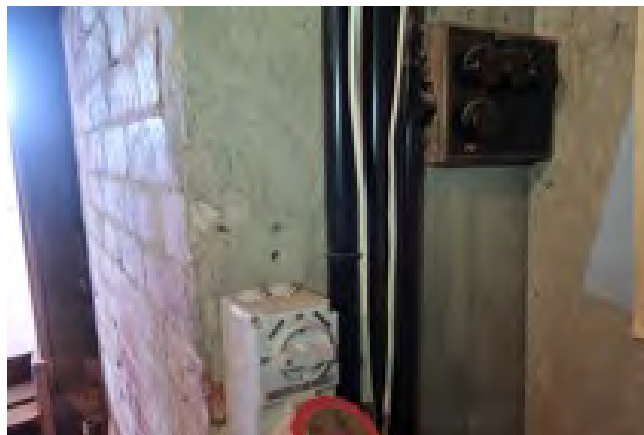
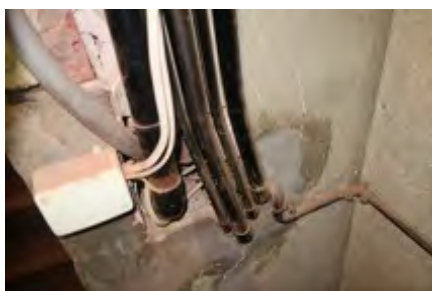
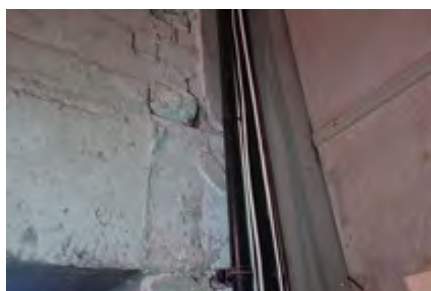
Type of Asbestos or Hazardous Material	No sample taken - Visual ID	Condition	GOOD	Likelihood of Damage	VL (Very Low)- unlikely or rare
		Activity	Low		
		Sealed	Yes	Friability	Bonded (non-friable)
		Labelled	Y	Exposure Risk	Low - Negligible or low risk
		Quantity

Maintain paint or sealant

Priority	MEDIUM	Label Required	Yes	Re- Audit Date	27 Jan 2022
Action	No remedial action required, unless disturbed				
Recommendation	Maintain paint or sealant to ACM surfaces. Particular attention should be given to side edges, ensure paint/sealant covers ALL exposed ACM surfaces.				
Legislative Requirements Victorian Regulation 2007	Warning labels should be affixed. Avoid mechanical damage and abrasion. Remove if refurbishment, structural alteration or demolition is to be carried out in this area. Re-inspect every 12 months or earlier if disturbed or removed in accordance with the Victorian OH&S Regulation 2017. All remedial/removal repairs require a Clearance Inspection & Certificate to be recorded by an approved and competent assessor.
