Asbestos Report

YARRIAMBIACK SHIRE COUNCIL

PROPERTY ADDRESS:
LB119 RECREATION RESERVE
29 STRACHAN STREET
HOPETOUN VIC 3396

INSPECTION DATE: 27 JANUARY 2021
REFERENCE NUMBER: 62073

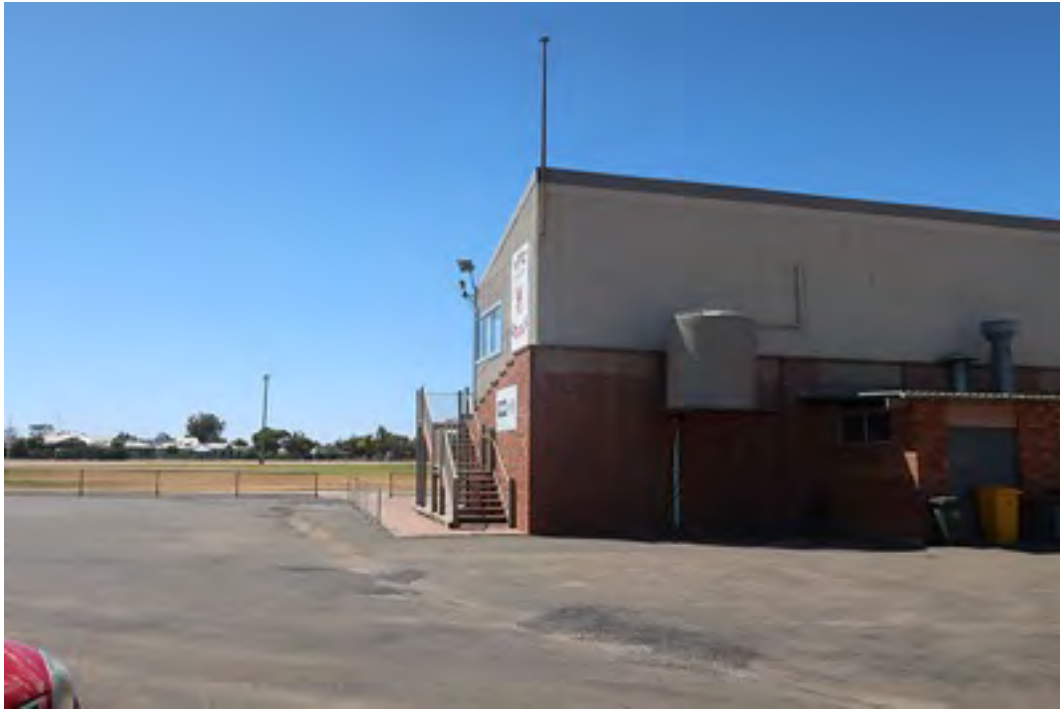
Football Club - Clubrooms

Area 9**Football Club - Clubrooms: front of building. The Ceiling (F C Sheeting) has Asbestos Containing Material (ACM) present.****RISK ASSESSMENT**

Type of Asbestos or Hazardous Material	Chrysotile Same as Sample - 62073 -001	Condition	GOOD	Likelihood of Damage	L (Low) – possible
		Activity	Moderate		
		Sealed	Yes	Friability	Bonded (non-friable)
		Labelled	Y	Exposure Risk	Low - Negligible or low risk
		Quantity

Priority	MEDIUM	Label Required	Yes	Re- Audit Date	27 Jan 2022
Action	No remedial action required, unless disturbed				
Recommendation	Maintain paint or sealant to ACM surfaces. Particular attention should be given to side edges, ensure paint/sealant covers ALL exposed ACM surfaces.				
Legislative Requirements Victorian Regulation 2007	Warning labels should be affixed. Avoid mechanical damage and abrasion. Remove if refurbishment, structural alteration or demolition is to be carried out in this area. Re-inspect every 12 months or earlier if disturbed or removed in accordance with the Victorian OH&S Regulation 2017. All remedial/removal repairs require a Clearance Inspection & Certificate to be recorded by an approved and competent assessor.

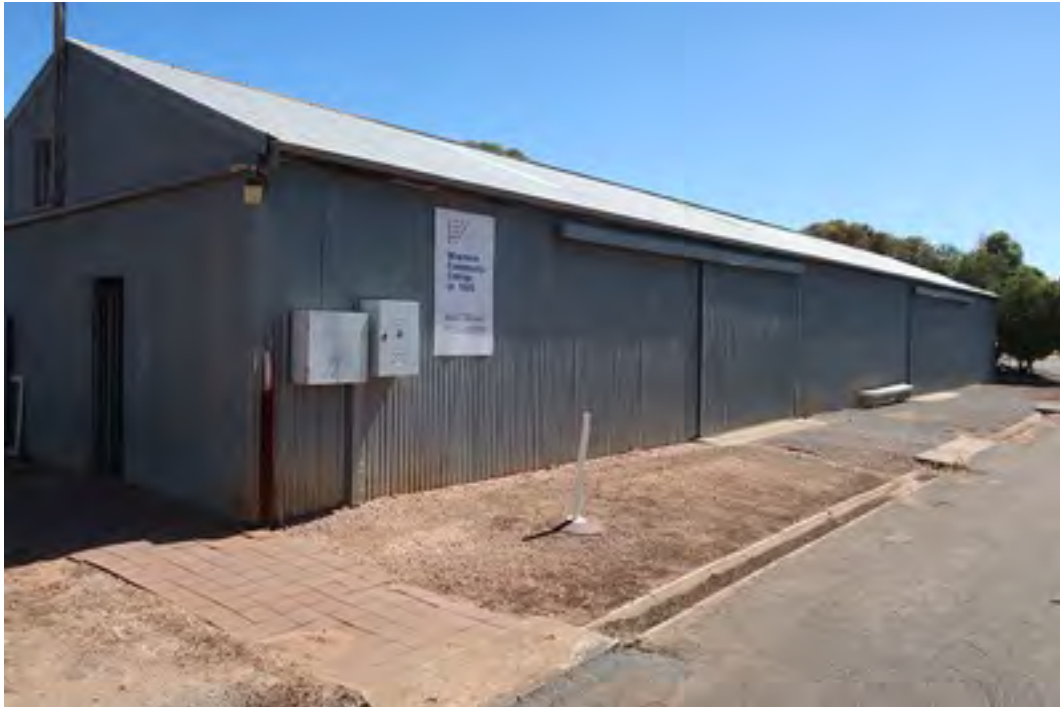
Farmers Shed (Ag Society)

Area 1**Farmers Shed (Ag Society): Shed 1. The A: Electrical board; B: Ceramic Fuses (A: Zelemite; B: Cloth Inserts) has Asbestos Containing Material (ACM) present.****RISK ASSESSMENT**

Type of Asbestos or Hazardous Material	No sample taken - Visual ID	Condition	GOOD	Likelihood of Damage	L (Low) – possible
		Activity	Moderate		
		Sealed	Yes	Friability	Bonded (non-friable)
		Labelled	Y	Exposure Risk	Low - Negligible or low risk
		Quantity

Priority	HIGH	Label Required	Yes	Re- Audit Date	27 Jan 2022
Action	Remedial repairs required - seal raw material / edges				
Recommendation	Penetration holes (purpose) -The exposed edges require approved sealant. It is further recommended the gaps be filled with sealant. Do not remove the fuses without asbestos controls - test for cloth inserts				
Legislative Requirements Victorian Regulation 2007	Damaged ACM visible in area. Requires IMMEDIATE ATTENTION. WARNING labels should be affixed. Avoid mechanical damage and abrasion. Remove if refurbishment, structural alteration or demolition is to be carried out in this area. Re-inspect every 12 months or earlier if disturbed or removed in accordance with the Victorian OH&S Regulation 2017. All remedial/removal repairs require a Clearance Inspection & Certificate to be recorded by an approved and competent assessor.

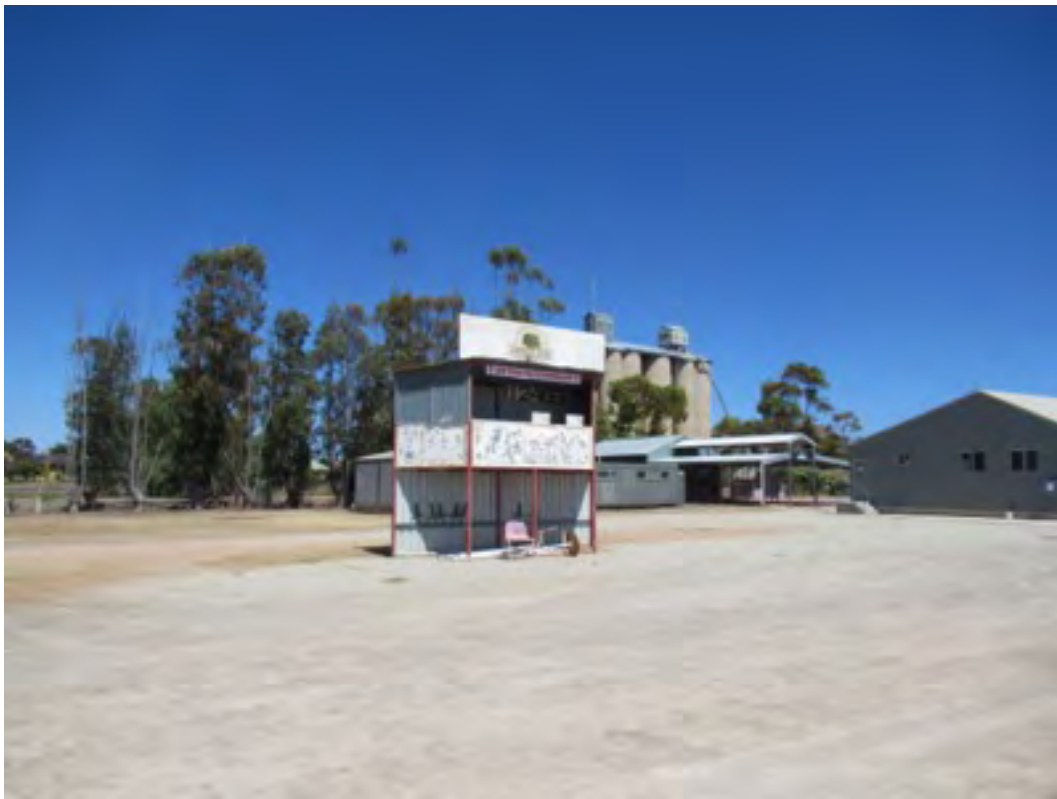
Pergola/ score box

Area 4***Pergola/ score box: . Until the area is inspected, it should be managed as if it Asbestos Containing Material (ACM) is present.*****RISK ASSESSMENT**

Type of Asbestos or Hazardous Material	No sample taken - No Access	Condition		Likelihood of Damage	
		Activity			
		Sealed		Friability	
		Labelled	No	Exposure Risk	
		Quantity

Priority	HIGH	Label Required	Yes	Re- Audit Date	27 Jan 2022
Action					
Recommendation					
Legislative Requirements Victorian Regulation 2007	Unable to Gain Access. Assume asbestos in area and provide monitoring if work undertaken in these areas. If access is made available, contact Global Asbestos Audits for re-inspection

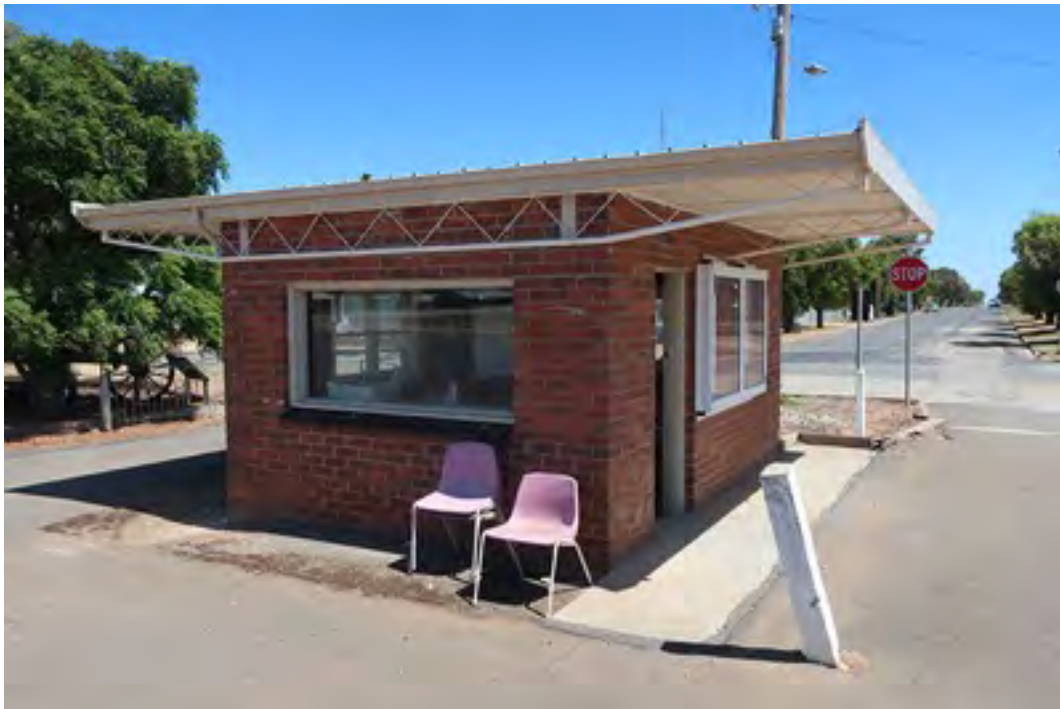
Ticket Office

Area 11***Ticket Office: front & rear of building. The Ceiling/ soffit (F C Sheeting) has Asbestos Containing Material (ACM) present.*****RISK ASSESSMENT**

Type of Asbestos or Hazardous Material	Chrysotile Amosite Sample taken 62073-003	Condition	GOOD	Likelihood of Damage	L (Low) – possible
		Activity	Moderate		
		Sealed	Yes	Friability	Bonded (non-friable)
		Labelled	Y	Exposure Risk	Low - Negligible or low risk
		Quantity

Priority	MEDIUM	Label Required	Yes	Re- Audit Date	27 Jan 2022
Action	No remedial action required, unless disturbed				
Recommendation	Maintain paint or sealant to ACM surfaces. Particular attention should be given to side edges, ensure paint/sealant covers ALL exposed ACM surfaces.				
Legislative Requirements Victorian Regulation 2007	Warning labels should be affixed. Avoid mechanical damage and abrasion. Remove if refurbishment, structural alteration or demolition is to be carried out in this area. Re-inspect every 12 months or earlier if disturbed or removed in accordance with the Victorian OH&S Regulation 2017. All remedial/removal repairs require a Clearance Inspection & Certificate to be recorded by an approved and competent assessor.

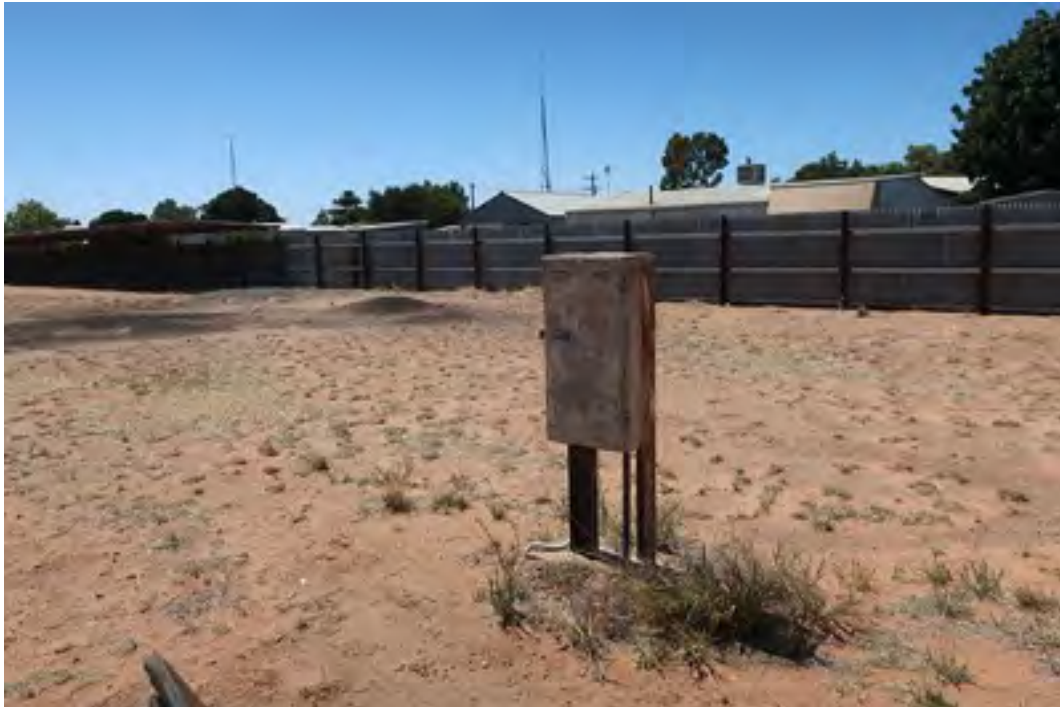
Grounds

Area 3**Grounds: near ticket office. The Electrical board (Backing Board (Zelemite)) has Asbestos Containing Material (ACM) present.****RISK ASSESSMENT**

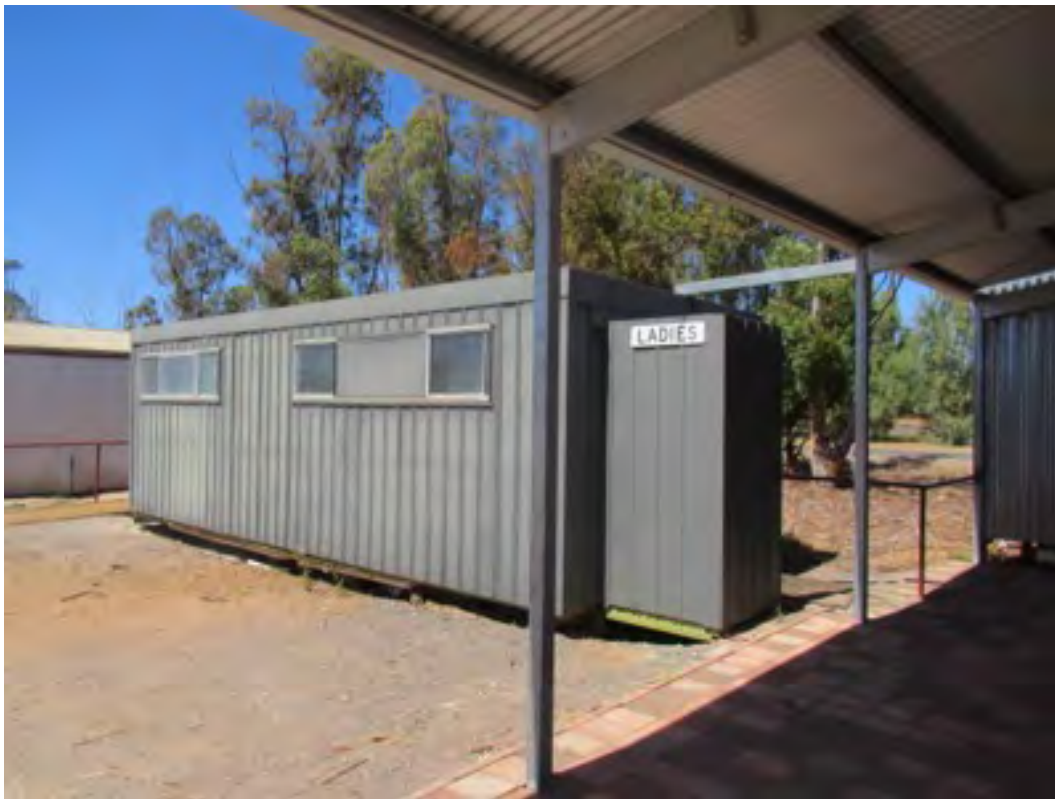
Toilet block

Area 5**Toilet block: Female bathroom 1. The Cubical Walls (F C Sheet) has Asbestos Containing Material (ACM) present.****RISK ASSESSMENT**

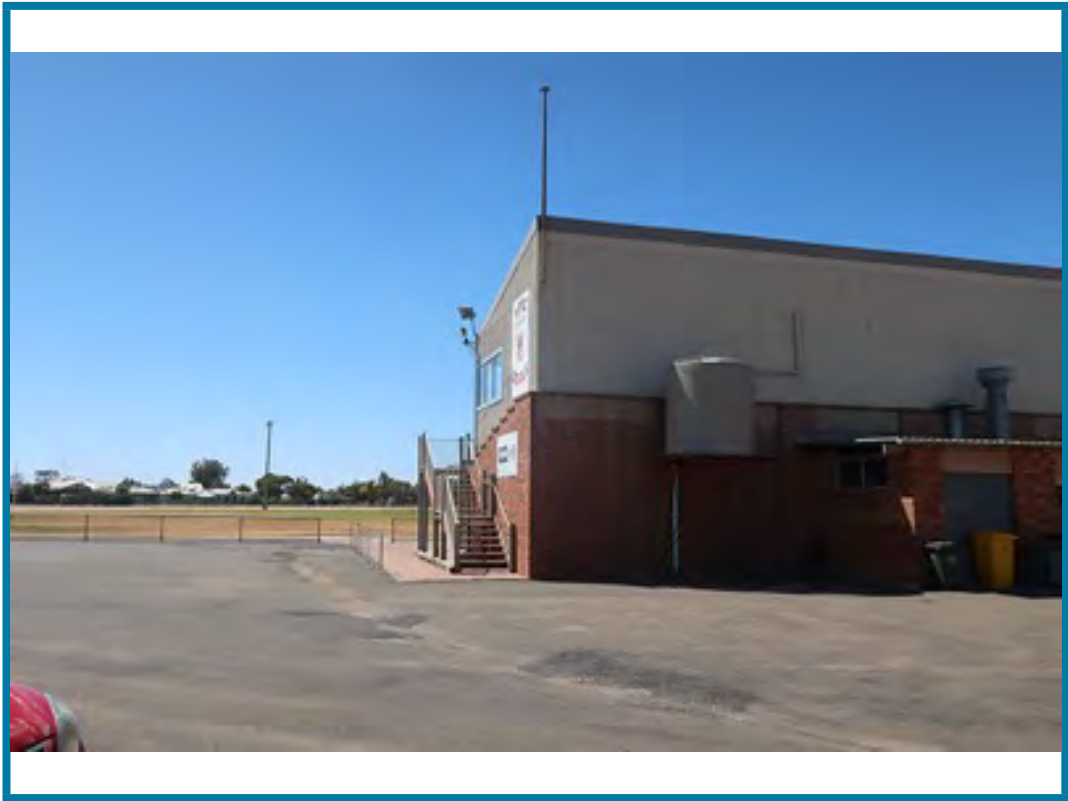
Location	Area	Component Materials	ACM Identified	Type Asbestos Assessment	Condition	Priority	Signage Required
Football Club - Clubrooms - front of building.	Ceiling	F C Sheeting	Yes	Chrysotile	Same as Sample - 62073-001	GOOD MEDIUM	Yes
				Refer to the Abestos Register for more information.			
Football Club - Clubrooms - front of building.	Wall - planking	F C Sheeting	No	No Asbestos Detected	Sample taken 62073-002		
Football Club - Clubrooms - front of building - commentators box.	Soffit	F C Sheeting	Yes	No sample taken - Visual ID	GOOD MEDIUM	Yes	
				Refer to the Abestos Register for more information.			
Football Club - Clubrooms - left side of building.	Electrical board	No Asbestos Materials	No	No sample taken - Visual ID			
Football Club - Clubrooms - rear of building.	Soffit	F C Sheeting	Yes	Chrysotile	Sample taken 62073-001	GOOD MEDIUM	Yes
				Refer to the Abestos Register for more information.

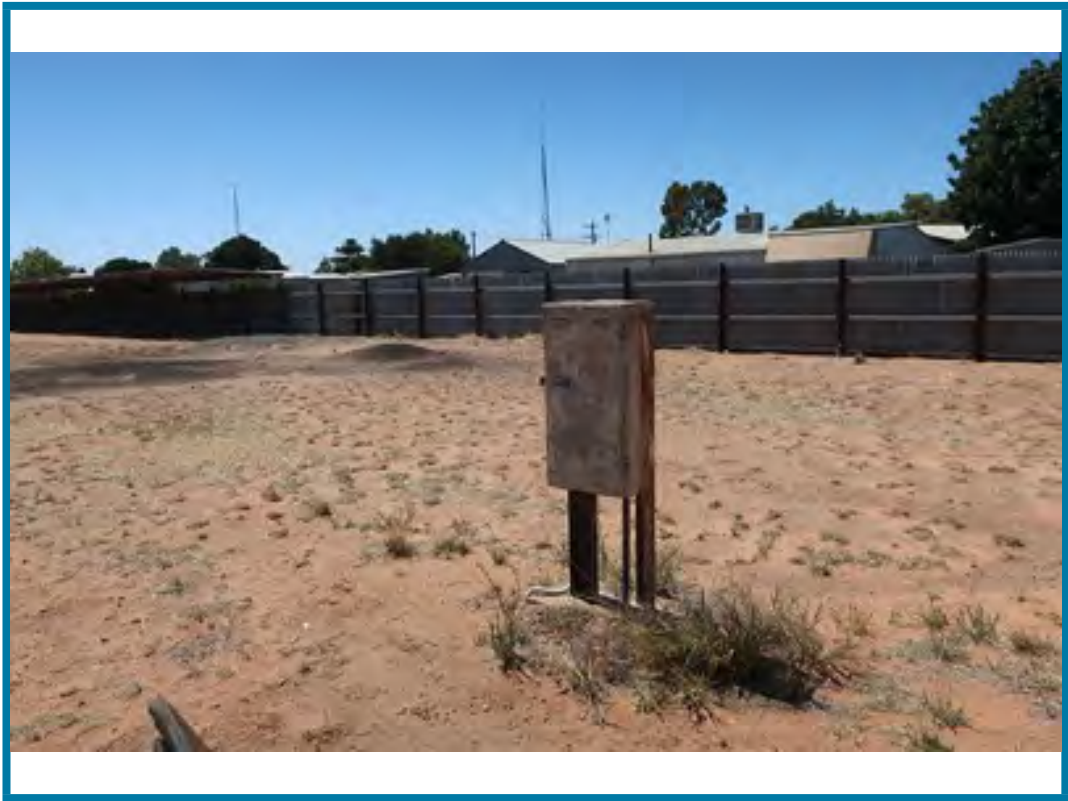
Location	Area	Component Materials	ACM Identified	Type Asbestos Assessment	Condition	Priority	Signage Required
Grounds - Grounds - near ticket office.	Electrical board	Backing Board (Zelemite)	Yes	No sample taken - Visual ID

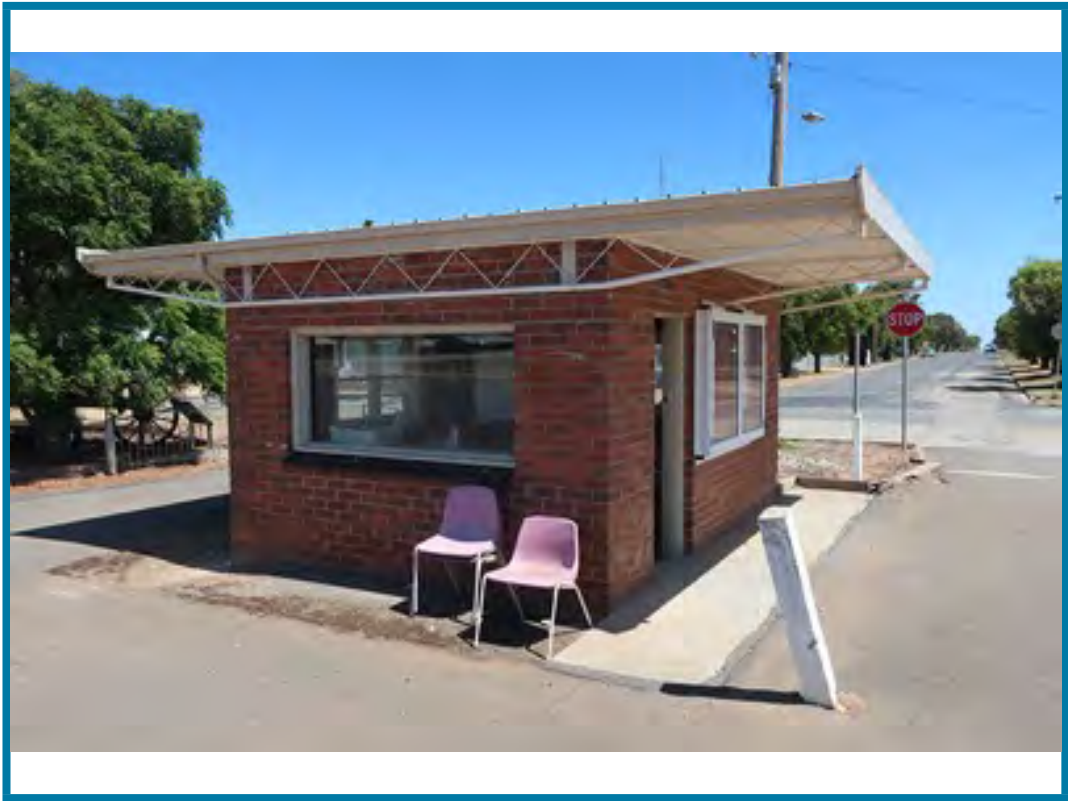
Location	Area	Component Materials	ACM Identified	Type Asbestos Assessment	Condition	Priority	Signage Required
Ticket Office - front & rear of building.	Ceiling/ soffit	F C Sheeting	Yes	Chrysotile Amosite	GOOD	MEDIUM	Yes
