Asbestos Report

YARRIAMBIACK SHIRE COUNCIL

PROPERTY ADDRESS:
LB28 RECREATION RESERVE
GIBSON STREET
RUPANYUP VIC 3388

INSPECTION DATE: 10 FEBRUARY 2021
REFERENCE NUMBER: 62112

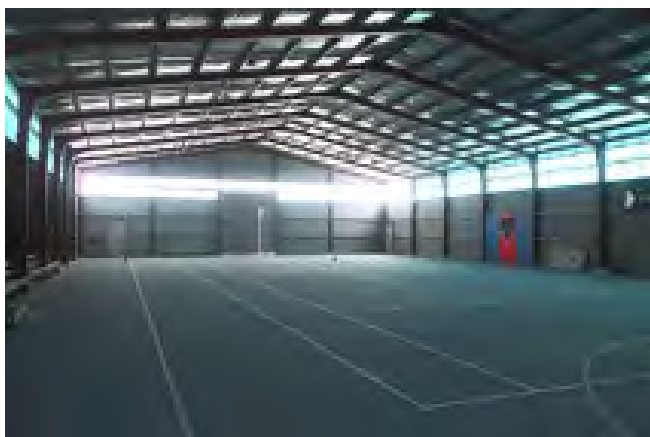
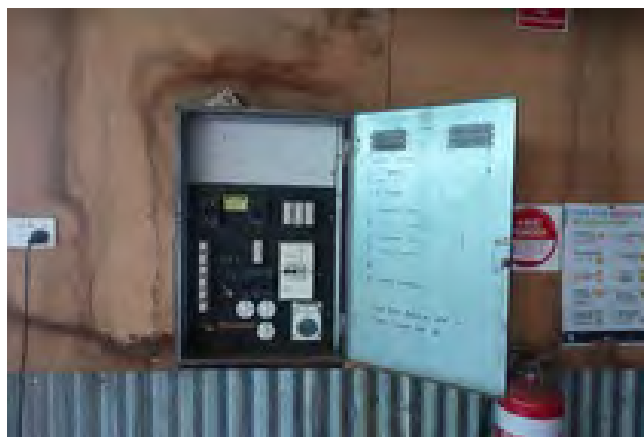
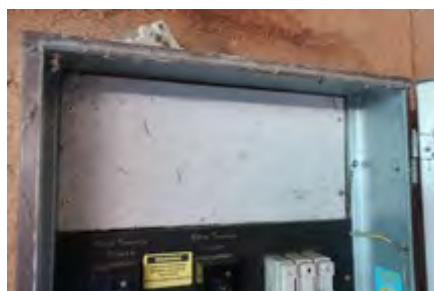
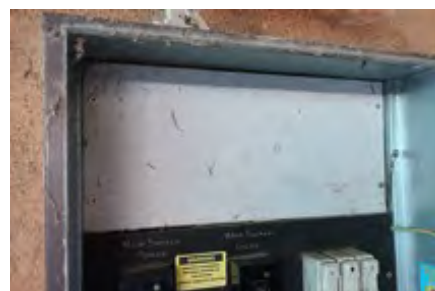
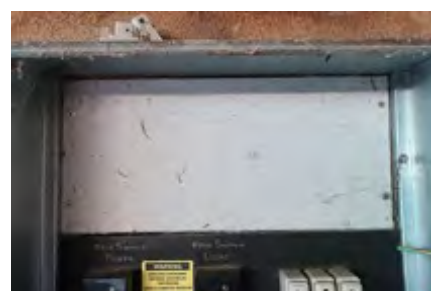
Area 8**Net ball court 1. The Electrical board - backing (F C Sheet) has Asbestos Containing Material (ACM) present.****RISK ASSESSMENT**

Type of Asbestos or Hazardous Material	Chrysotile	Condition	AVERAGE	Likelihood of Damage	L (Low) – possible
	Sample taken 62112-002	Activity	Moderate		
		Sealed	No	Friability	Bonded (non-friable)
		Labelled	Y	Exposure Risk	Medium - Moderate risk
		Quantity

Raw Material

Raw material sheeting - The area requires immediate remedial repairs. It is recommended the asbestos material be sealed with an approved membrane.

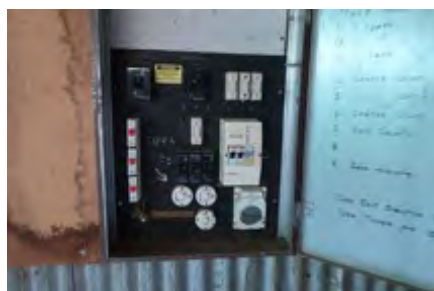
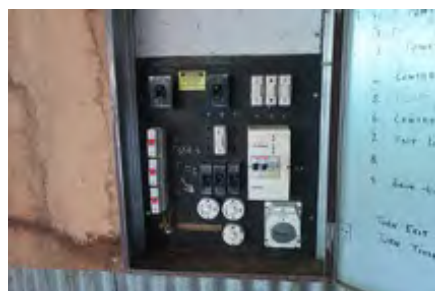
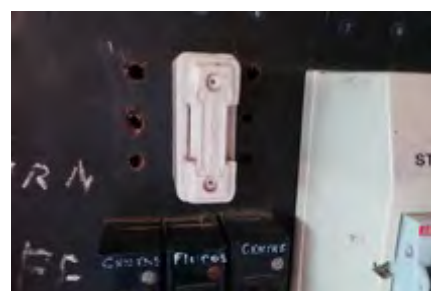
Area 9**Net ball: Front of building. The Electrical Board (Zelemite backing board) has Asbestos Containing Material (ACM) present.****RISK ASSESSMENT**

Penetration Holes

- 9 Net ball: Front of building. The Electrical Board (Zelemite backing board) has Asbestos Containing Material (ACM) present.**
- Penetration Holes - The exposed edges require approved sealant. It is further recommended the gaps be filled with sealant.

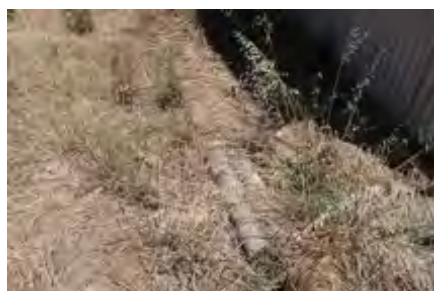
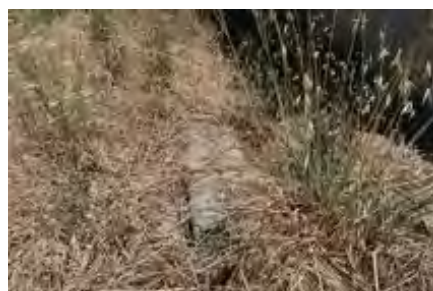
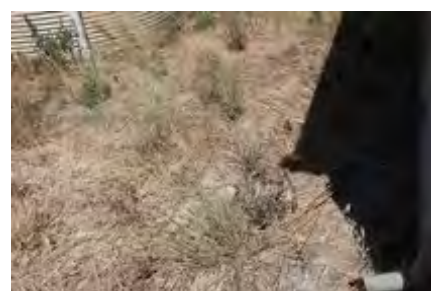
Area 2**Charle Ayrey Pavlion: left side of building. The Pipe(s) (F C Sheeting) has Asbestos Containing Material (ACM) present.****RISK ASSESSMENT**

Debris on Surface

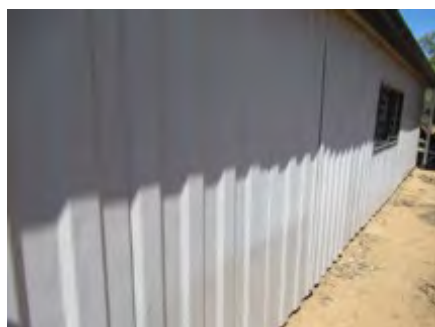
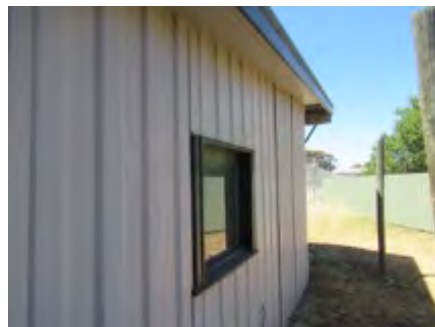
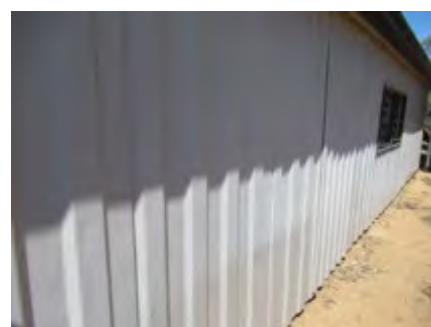
Area 17***Tennis: entire perimeter of building. The Walls (F C Sheeting) has Asbestos Containing Material (ACM) present.*****RISK ASSESSMENT**

Maintain paint or sealant

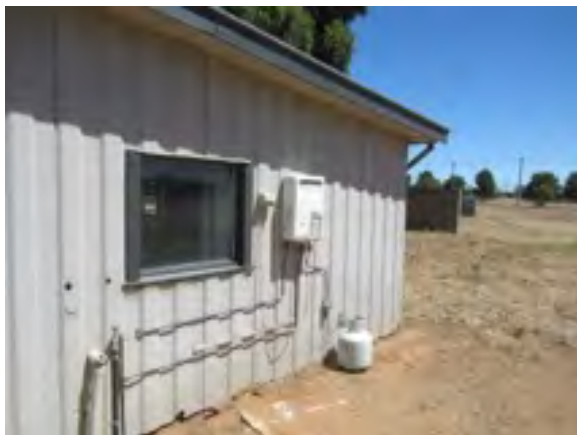
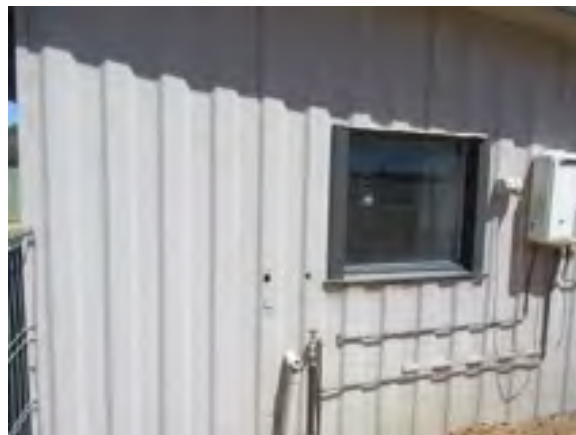
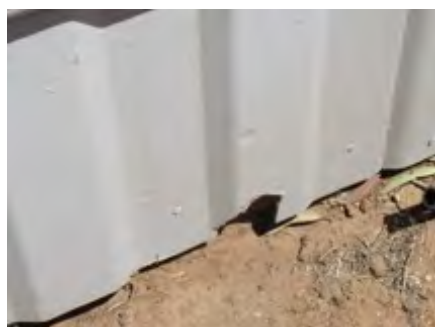
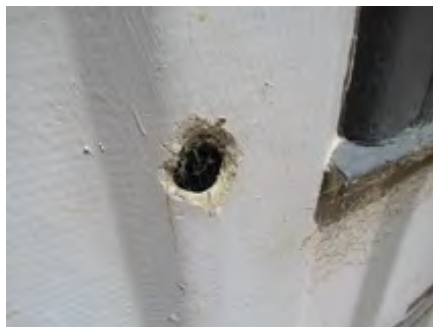
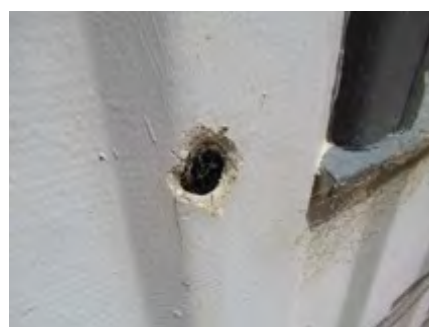
Area 13**Tennis: left side of building. The Wall (F C Sheeting) has Asbestos Containing Material (ACM) present.****RISK ASSESSMENT**

Type of Asbestos or Hazardous Material	No sample taken - Visual ID	Condition	AVERAGE	Likelihood of Damage	L (Low) – possible
		Activity	Moderate		
		Sealed	Yes	Friability	Exposed Fibres
		Labelled	Y	Exposure Risk	Medium - Moderate risk
		Quantity

Penetration Holes

- 13 Tennis: left side of building. The Wall (F C Sheeting) has Asbestos Containing Material (ACM) present.**
- Penetration Holes - The exposed edges require approved sealant. It is further recommended the gaps be filled with sealant.

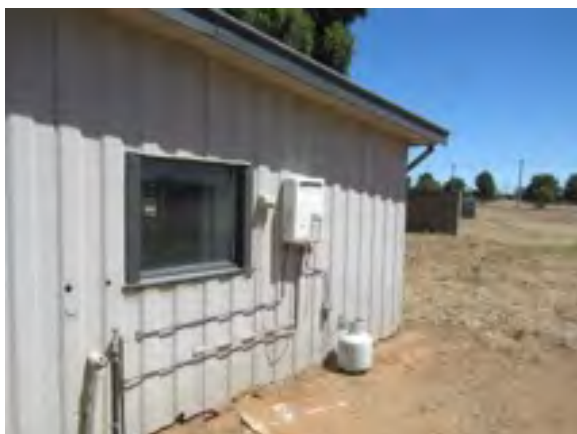
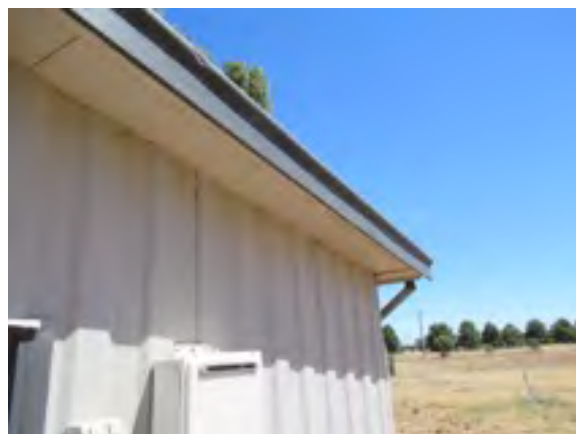
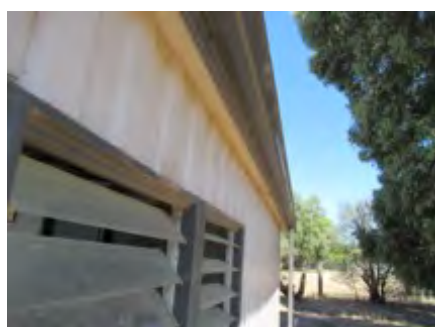
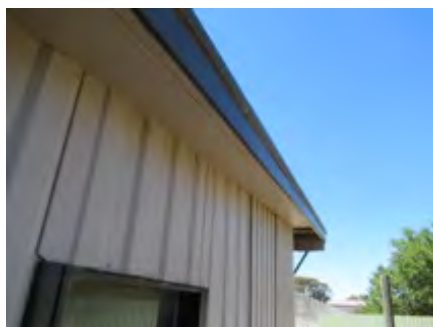
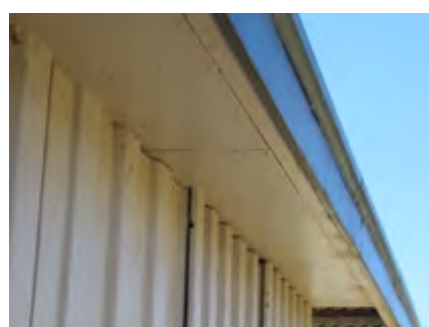
Area 19**Tennis: left, right & rear of building. The Soffit (F C Sheeting) has Asbestos Containing Material (ACM) present.****RISK ASSESSMENT**

Type of Asbestos or Hazardous Material	No sample taken - Visual ID	Condition	GOOD	Likelihood of Damage	L (Low) – possible
		Activity	Moderate		
		Sealed	Yes	Friability	Bonded (non-friable)
		Labelled	Y	Exposure Risk	Low - Negligible or low risk
		Quantity

Maintain paint or sealant

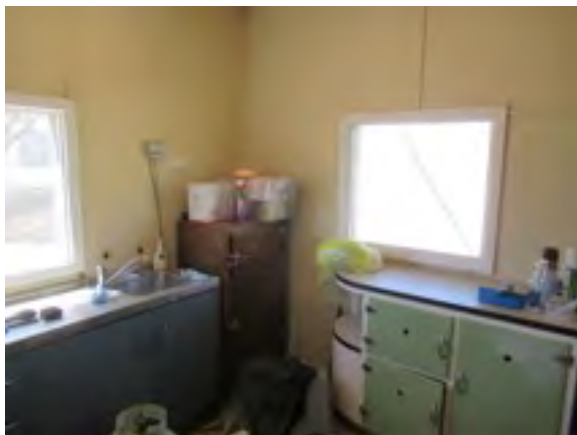
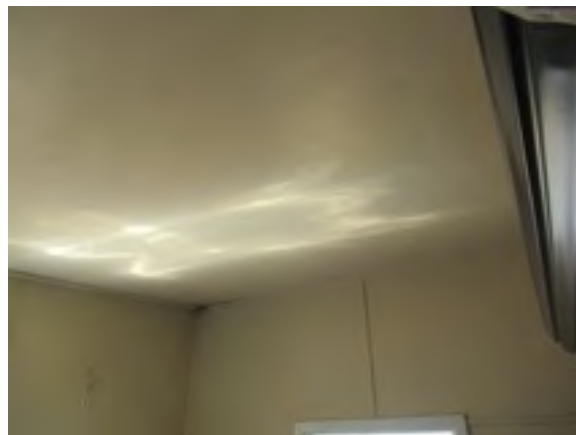
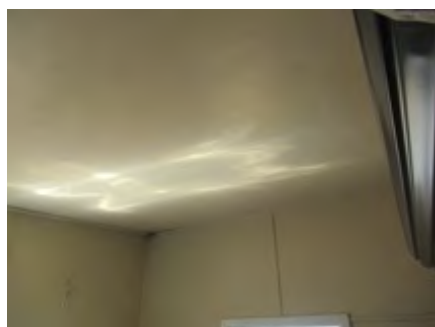
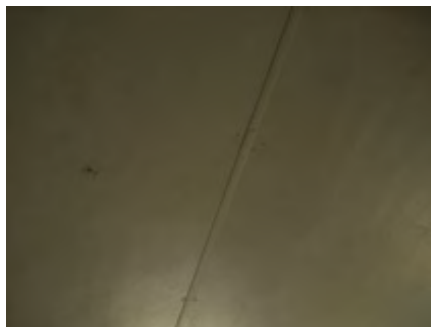
Area 18***Tennis: Kitchenette 1. The Walls and Ceiling (F C Sheeting) has Asbestos Containing Material (ACM) present.*****RISK ASSESSMENT**

Type of Asbestos or Hazardous Material	No sample taken - Visual ID	Condition	GOOD	Likelihood of Damage	L (Low) – possible
		Activity	Moderate		
		Sealed	Yes	Friability	Bonded (non-friable)
		Labelled	Y	Exposure Risk	Low - Negligible or low risk
		Quantity

Maintain paint or sealant

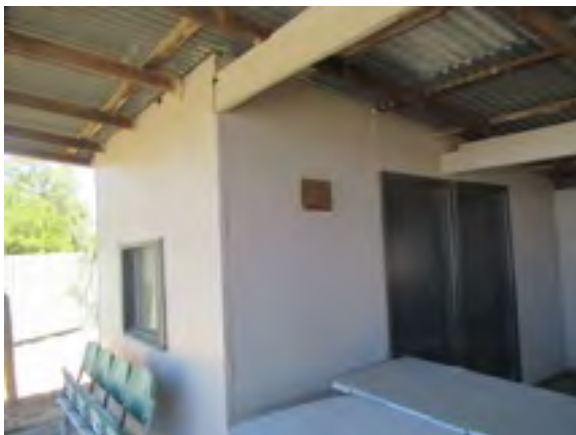
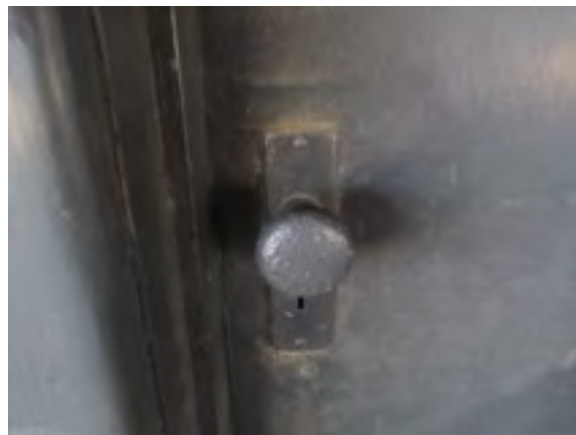
Area 12**Tennis: 3. Until the area is inspected, it should be managed as if it Asbestos Containing Material (ACM) is present.****RISK ASSESSMENT**

Type of Asbestos or Hazardous Material	No sample taken - No Access	Condition		Likelihood of Damage	
		Activity			
		Sealed		Friability	
		Labelled	Y	Exposure Risk	
		Quantity

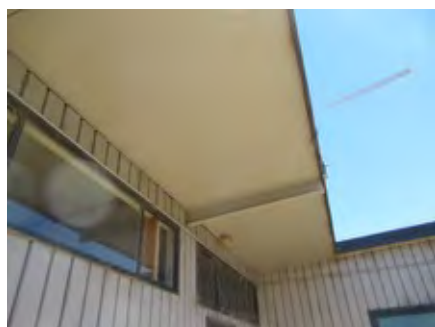
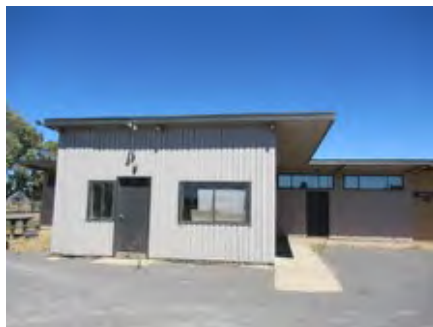
Area 14***Canteen: entire perimeter of building The Soffit (F C Sheeting) has Asbestos Containing Material (ACM) present.*****RISK ASSESSMENT**

Maintain paint or sealant

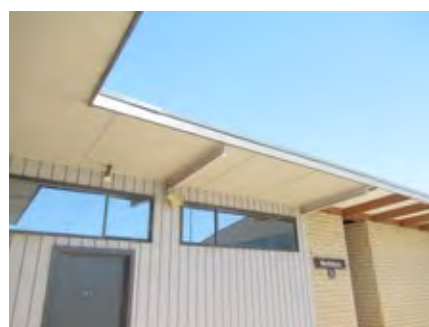
Type of Asbestos or Hazardous Material	No sample taken - Visual ID	Condition	GOOD	Likelihood of Damage	L (Low) – possible
		Activity	Moderate		
		Sealed	Yes	Friability	Bonded (non-friable)
		Labelled	Y	Exposure Risk	Low - Negligible or low risk
		Quantity

Maintain paint or sealant

Priority	MEDIUM	Label Required	Yes	Re- Audit Date	10 Feb 2022
Action	No remedial action required, unless disturbed				
Recommendation	Maintain paint or sealant to ACM surfaces. Particular attention should be given to side edges, ensure paint/sealant covers ALL exposed ACM surfaces.				
Legislative Requirements Victorian Regulation 2007	Warning labels should be affixed. Avoid mechanical damage and abrasion. Remove if refurbishment, structural alteration or demolition is to be carried out in this area. Re-inspect every 12 months or earlier if disturbed or removed in accordance with the Victorian OH&S Regulation 2017. All remedial/removal repairs require a Clearance Inspection & Certificate to be recorded by an approved and competent assessor.

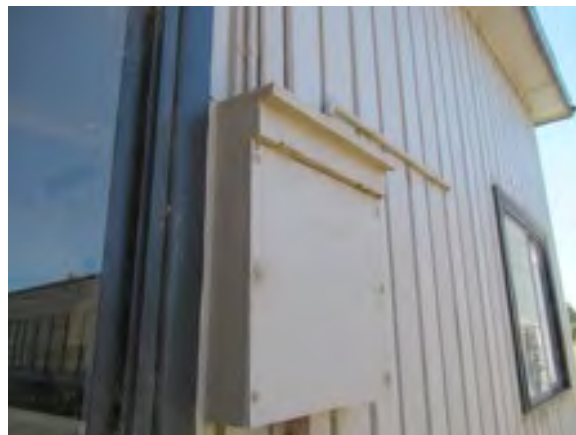
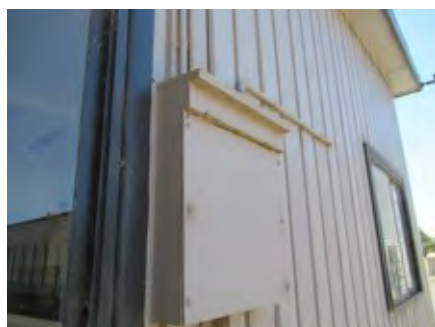
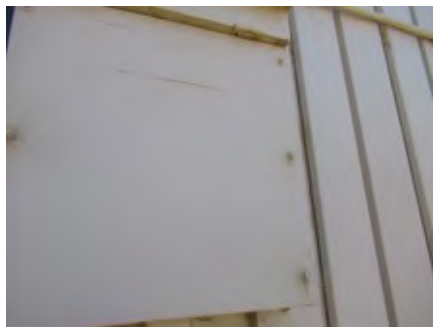
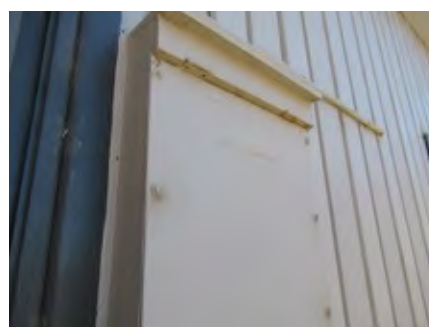
Type of Asbestos or Hazardous Material	No sample taken - Visual ID	Condition	GOOD	Likelihood of Damage	H (High) - almost certain
		Activity	Low		
		Sealed	Yes	Friability	Bonded (non-friable)
		Labelled	Y	Exposure Risk	Low - Negligible or low risk
		Quantity

Maintain paint or sealant

Priority	MEDIUM	Label Required	Yes	Re- Audit Date	10 Feb 2022
Action	No remedial action required, unless disturbed				
Recommendation	Maintain paint or sealant to ACM surfaces. Particular attention should be given to side edges, ensure paint/sealant covers ALL exposed ACM surfaces.				
Legislative Requirements Victorian Regulation 2007	Warning labels should be affixed. Avoid mechanical damage and abrasion. Remove if refurbishment, structural alteration or demolition is to be carried out in this area. Re-inspect every 12 months or earlier if disturbed or removed in accordance with the Victorian OH&S Regulation 2017. All remedial/removal repairs require a Clearance Inspection & Certificate to be recorded by an approved and competent assessor.

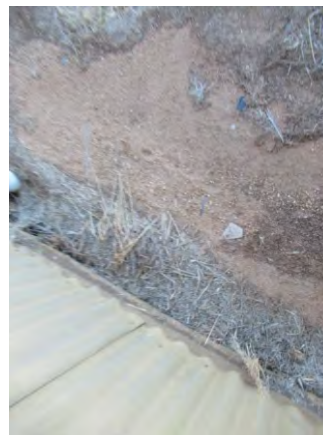
Area 1***Canteen: rear of building. The Debris - Broken (Contaminated Soil) has Asbestos Containing Material (ACM) present.*****RISK ASSESSMENT**

Type of Asbestos or Hazardous Material	No sample taken - Visual ID	Condition	POOR	Likelihood of Damage	H (High) - almost certain
		Activity	Moderate		
		Sealed	No	Friability	Exposed Fibres
		Labelled	No	Exposure Risk	Medium - Moderate risk
		Quantity

Priority	IMMEDIATE	Label Required	Yes	Re- Audit Date	10 Feb 2022
Action	Restrict access and target for imminent removal				
Recommendation	Debris on Surface - The Debris requires immediate cleanup and disposal with specialised equipment and with licensed removalist to safely remove the asbestos debris.				
Legislative Requirements Victorian Regulation 2007	ACM debris visible. Recommend cleanup by licensed Asbestos Removalist. Warning labels should be affixed. Avoid mechanical damage and abrasion. Remove if refurbishment, structural alteration or demolition is to be carried out in this area. Re-inspect every 12 months or earlier if disturbed or removed in accordance with the Victorian OH&S Regulation 2017. All remedial/removal repairs require a Clearance Inspection & Certificate to be recorded by an approved and competent assessor.

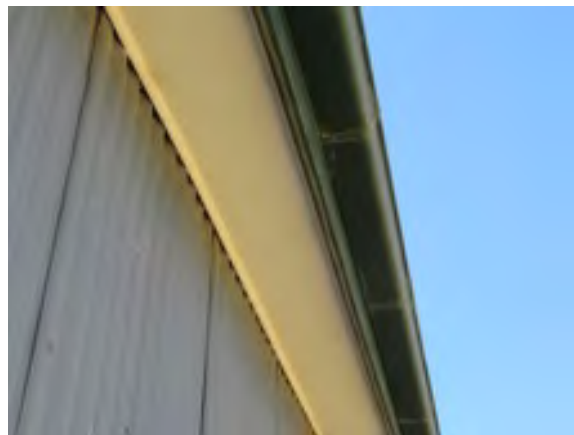
Type of Asbestos or Hazardous Material	No sample taken - Visual ID	Condition	POOR	Likelihood of Damage	L (Low) – possible
		Activity	Moderate		
		Sealed	Yes	Friability	Exposed Fibres
		Labelled	Y	Exposure Risk	Medium - Moderate risk
		Quantity

Priority	HIGH	Label Required	Yes	Re- Audit Date	10 Feb 2022
Action	Remedial repairs required - seal exposed edges or replace or laminate over damaged material				
Recommendation	Damaged material - The damaged area requires immediate remedial repairs. It is recommended the asbestos sheeting be replaced.				
Legislative Requirements Victorian Regulation 2007	Damaged ACM visible in area. Requires IMMEDIATE ATTENTION. WARNING labels should be affixed. Avoid mechanical damage and abrasion. Remove if refurbishment, structural alteration or demolition is to be carried out in this area. Re-inspect every 12 months or earlier if disturbed or removed in accordance with the Victorian OH&S Regulation 2017. All remedial/removal repairs require a Clearance Inspection & Certificate to be recorded by an approved and competent assessor.

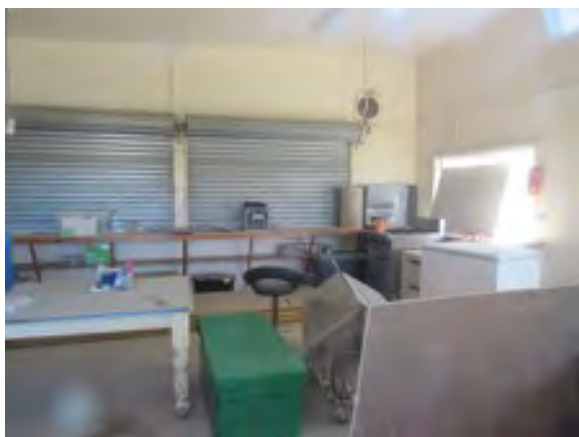
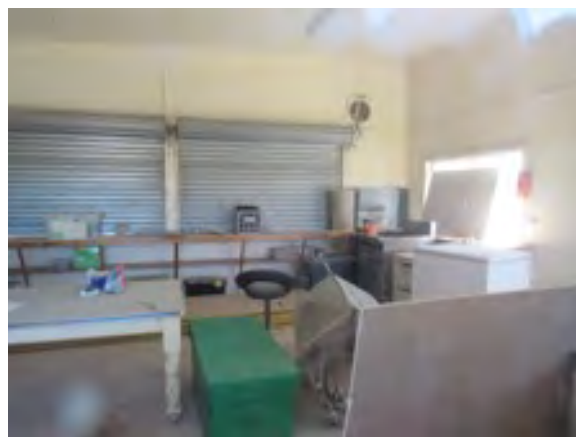
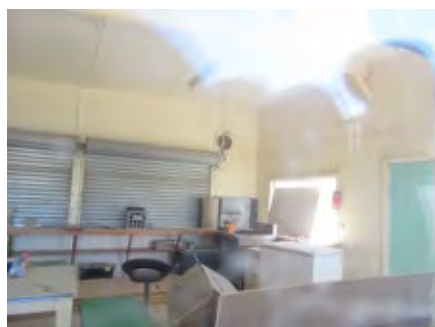
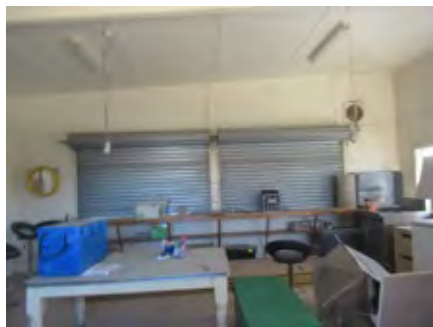
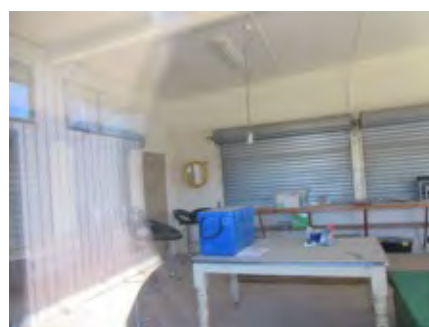
Area 5***Canteen: Internal. Until the area is inspected, it should be managed as if it Asbestos Containing Material (ACM) is present.*****RISK ASSESSMENT**

Type of Asbestos or Hazardous Material	No sample taken - No Access	Condition		Likelihood of Damage	
		Activity			
		Sealed		Friability	
		Labelled	No	Exposure Risk	
		Quantity

Priority	HIGH	Label Required	Yes	Re- Audit Date	10 Feb 2022
Action					
Recommendation					
Legislative Requirements Victorian Regulation 2007	Unable to Gain Access. Assume asbestos in area and provide monitoring if work undertaken in these areas. If access is made available, contact Global Asbestos Audits for re-inspection

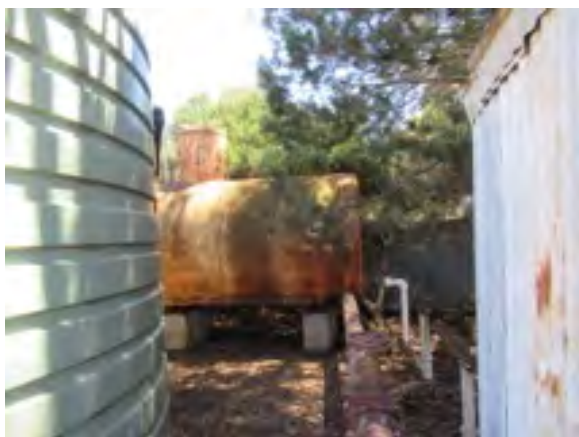
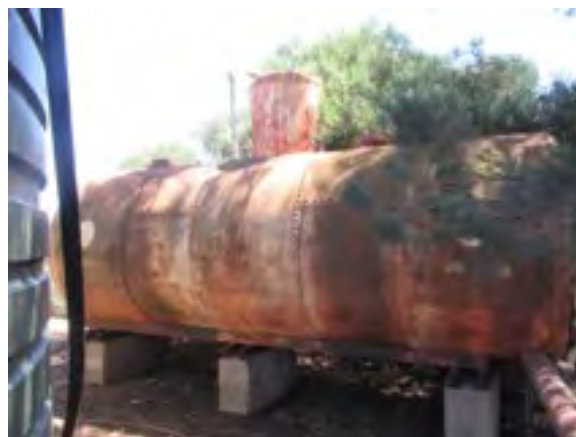
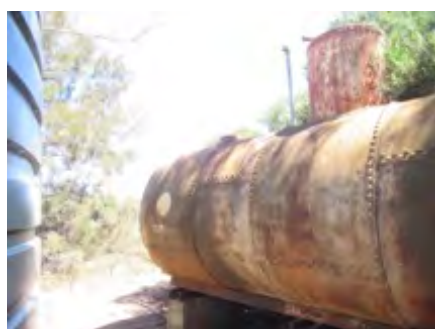
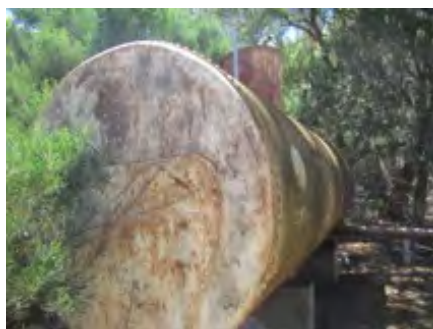
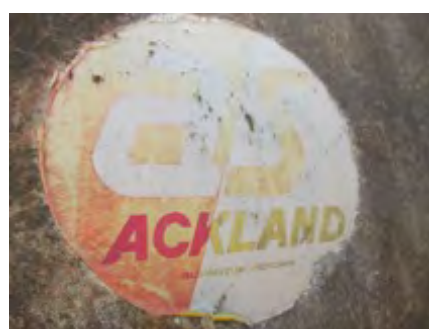
Area 16***Pump Shed & Power Pole: Water Tank. The Seals & Insulation (Fire Retardant) has Asbestos Containing Material (ACM) present.*****RISK ASSESSMENT**

Type of Asbestos or Hazardous Material	No sample taken - Visual ID	Condition	GOOD	Likelihood of Damage	VL (Very Low)- unlikely or rare
		Activity	Low		
		Sealed	Yes	Friability	Bonded (non-friable)
		Labelled	Y	Exposure Risk	Low - Negligible or low risk
		Quantity

Maintain paint or sealant

Priority	MEDIUM	Label Required	Yes	Re- Audit Date	10 Feb 2022
Action	No remedial action required, unless disturbed				
Recommendation	Maintain paint or sealant to ACM surfaces. Particular attention should be given to side edges, ensure paint/sealant covers ALL exposed ACM surfaces.				
Legislative Requirements Victorian Regulation 2007	Warning labels should be affixed. Avoid mechanical damage and abrasion. Remove if refurbishment, structural alteration or demolition is to be carried out in this area. Re-inspect every 12 months or earlier if disturbed or removed in accordance with the Victorian OH&S Regulation 2017. All remedial/removal repairs require a Clearance Inspection & Certificate to be recorded by an approved and competent assessor.

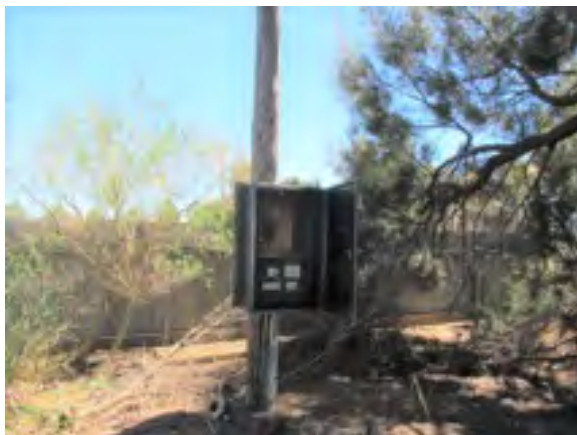
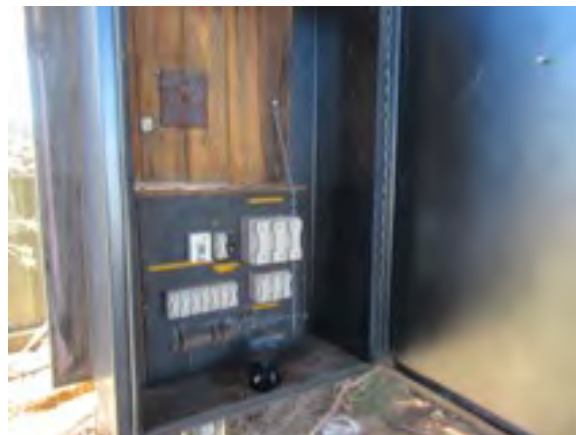
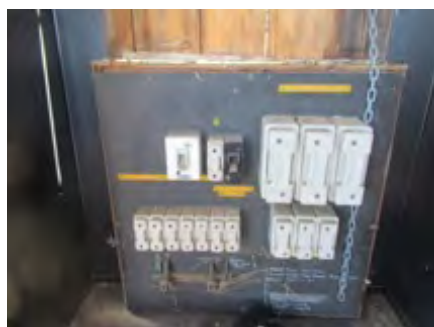
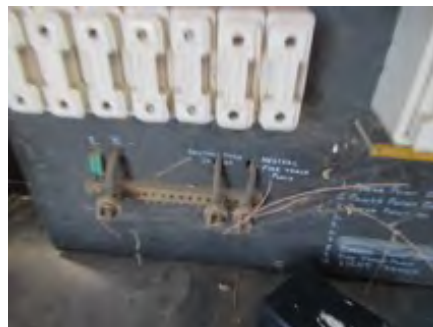
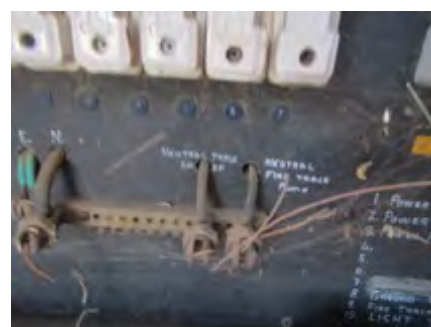
Area 10***Pump Shed & Power Pole: Power Board (on Pole). The A: Electrical board; B: Ceramic Fuses (A: Zelemite; B: Cloth Inserts) has Asbestos Containing Material (ACM) present.*****RISK ASSESSMENT**

Type of Asbestos or Hazardous Material	Chrysotile	Condition	AVERAGE	Likelihood of Damage	L (Low) – possible
	Sample taken 62112-010	Activity	Moderate		
	A: Zelemite;	Sealed	Yes	Friability	Exposed Fibres
		Labelled	Y	Exposure Risk	Medium - Moderate risk
		Quantity

Penetration Holes

Priority	HIGH	Label Required	Yes	Re- Audit Date	10 Feb 2022
Action	Remedial repairs required - seal raw material / edges				
Recommendation	Penetration Holes - The exposed edges require approved sealant. It is further recommended the gaps be filled with sealant. Do not remove the fuses without asbestos controls - test for cloth inserts				
Legislative Requirements Victorian Regulation 2007	Damaged ACM visible in area. Requires IMMEDIATE ATTENTION. WARNING labels should be affixed. Avoid mechanical damage and abrasion. Remove if refurbishment, structural alteration or demolition is to be carried out in this area. Re-inspect every 12 months or earlier if disturbed or removed in accordance with the Victorian OH&S Regulation 2017. All remedial/removal repairs require a Clearance Inspection & Certificate to be recorded by an approved and competent assessor.

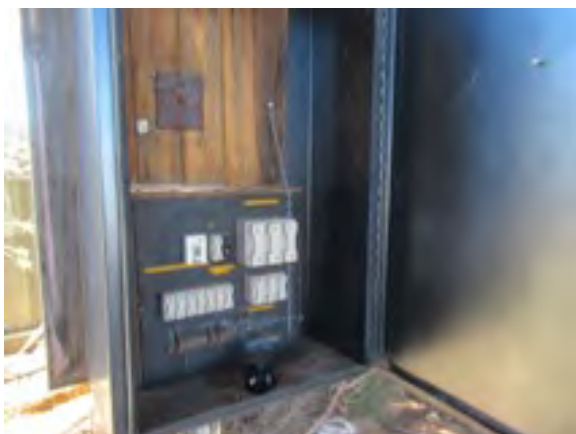
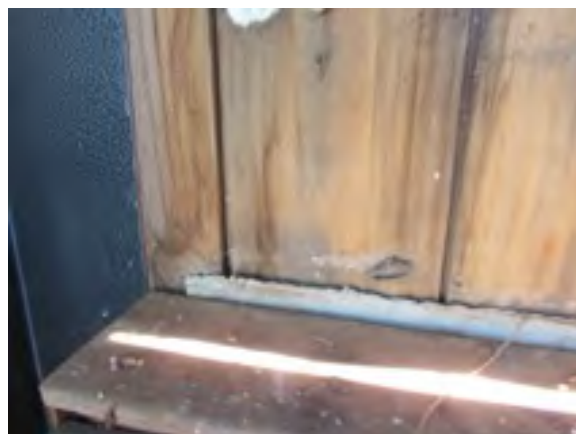
Area 3***Pump Shed & Power Pole: Power Board (on Pole). The Electrical Cabinet - lining (F C Sheeting/Board (LDB)) has Asbestos Containing Material (ACM) present.*****RISK ASSESSMENT**

Type of Asbestos or Hazardous Material	Chrysotile	Condition	POOR	Likelihood of Damage	H (High) - almost certain
	Sample taken 62112-011	Activity	Moderate		
		Sealed	No	Friability	Friable
		Labelled	Y	Exposure Risk	High - Short term exposure risk
		Quantity

Priority	IMMEDIATE	Label Required	Yes	Re- Audit Date	10 Feb 2022
Action	Restrict access and target for imminent removal				
Recommendation	<p>The material is Low Density Board (LDB) - if disturbed will cause airborne fibres.</p> <p>Damaged material - The damaged area requires immediate remedial repairs. It is recommended the asbestos sheeting be replaced.</p>				
Legislative Requirements Victorian Regulation 2007	<p>URGENT - ACM visible in area. The ACM appears to be of a friable nature. The services of an "A" class Asbestos removal consultant are urgently required. Immediately cease any access to the area and affix warning signs to all entry points. Avoid physical and mechanical damage. Avoid mechanical damage and abrasion. Re-inspect every 12 months or earlier if disturbed or removed in accordance with the Victorian OH&S Regulation 2017.</p> <p>All remedial/removal repairs require a Clearance Inspection & Certificate to be recorded by an approved and competent assessor.</p>

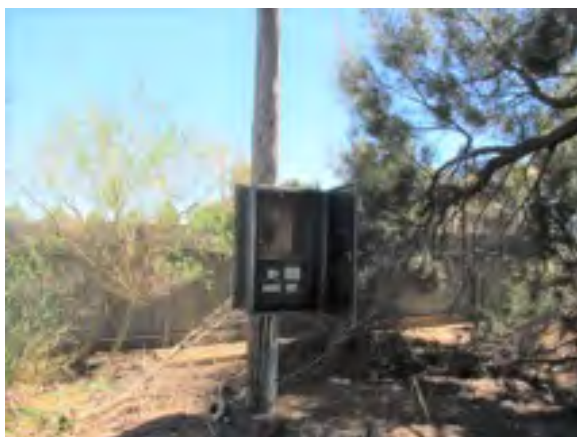
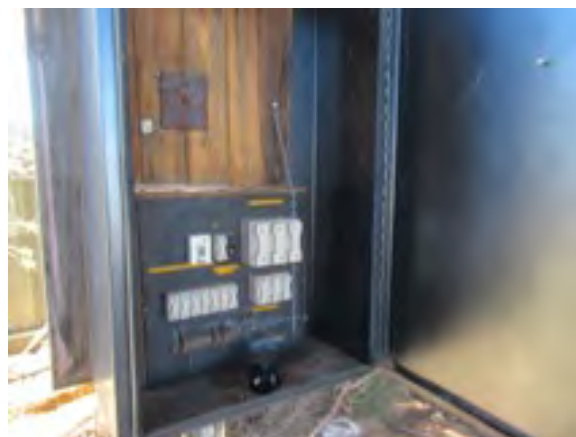
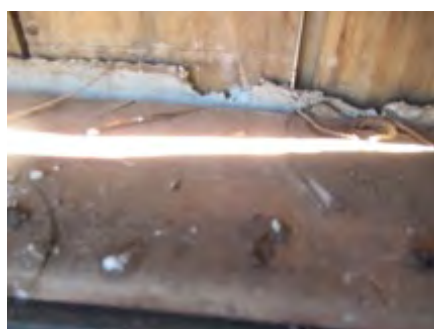
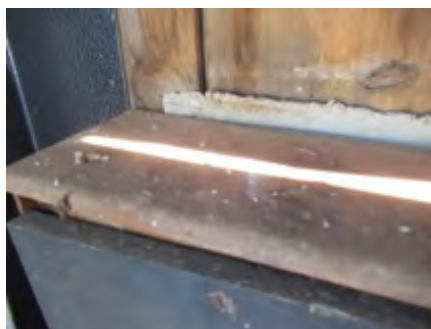
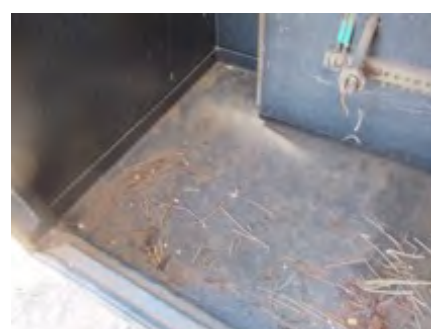
Area 4***Pump Shed & Power Pole: Power Board (on Pole). The Electrical Cabinet (Debris - LDB) has Asbestos Containing Material (ACM) present.*****RISK ASSESSMENT**

Type of Asbestos or Hazardous Material	Chrysotile	Condition	POOR	Likelihood of Damage	H (High) - almost certain
	Same as Sample - 62112 -011	Activity	Low		
		Sealed	No	Friability	Friable
		Labelled	Y	Exposure Risk	High - Short term exposure risk
		Quantity

Debris on Surface

Priority	IMMEDIATE	Label Required	Yes	Re- Audit Date	10 Feb 2022
Action	Restrict access and target for imminent removal				
Recommendation	<p>The material is Low Density Board (LDB) - if disturbed will cause airborne fibres.</p> <p>Debris on Surface - The Debris requires immediate cleanup and disposal with specialised equipment and with licensed removalist to safely remove the asbestos debris.</p>				
Legislative Requirements Victorian Regulation 2007	<p>URGENT - ACM visible in area. The ACM appears to be of a friable nature. The services of an "A" class Asbestos removal consultant are urgently required. Immediately cease any access to the area and affix warning signs to all entry points. Avoid physical and mechanical damage. Avoid mechanical damage and abrasion. Re-inspect every 12 months or earlier if disturbed or removed in accordance with the Victorian OH&S Regulation 2017.</p> <p>All remedial/removal repairs require a Clearance Inspection & Certificate to be recorded by an approved and competent assessor.</p>

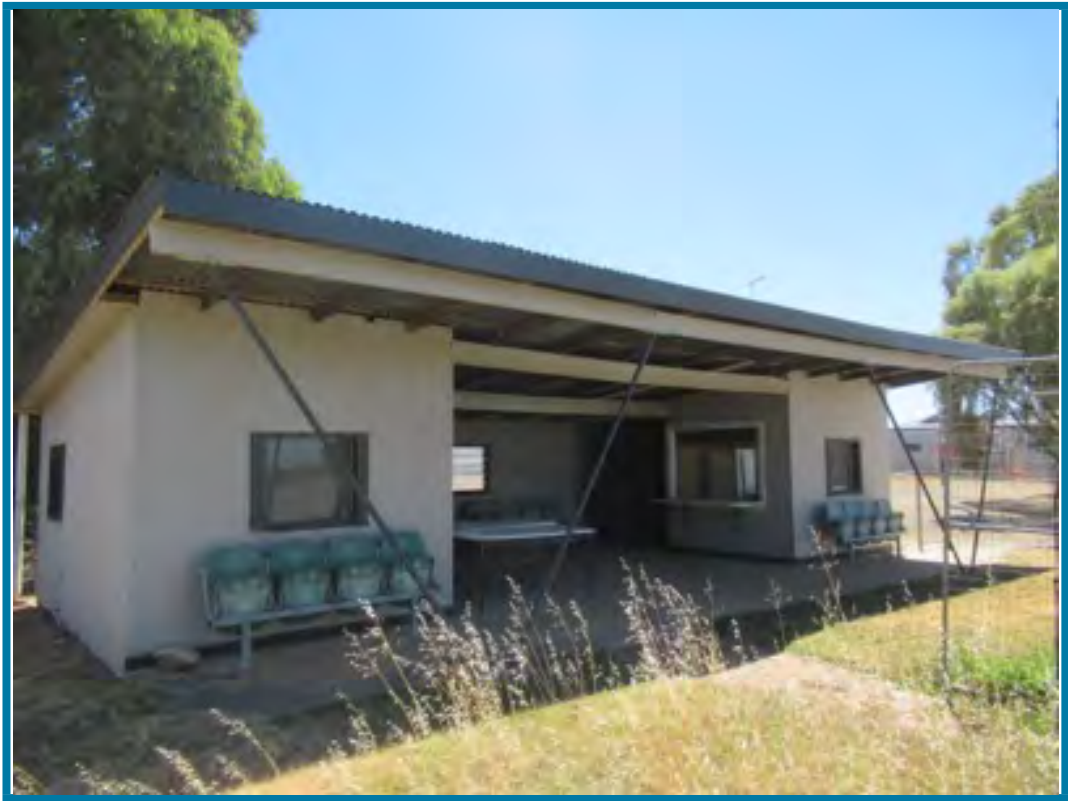
Location	Area	Component Materials	ACM Identified	Type Asbestos Assessment	ConditionPriority	Signage Required
Tennis - entire perimeter of building.	Walls	F C Sheeting	Yes	No sample taken - Visual ID	GOOD MEDIUM	Yes

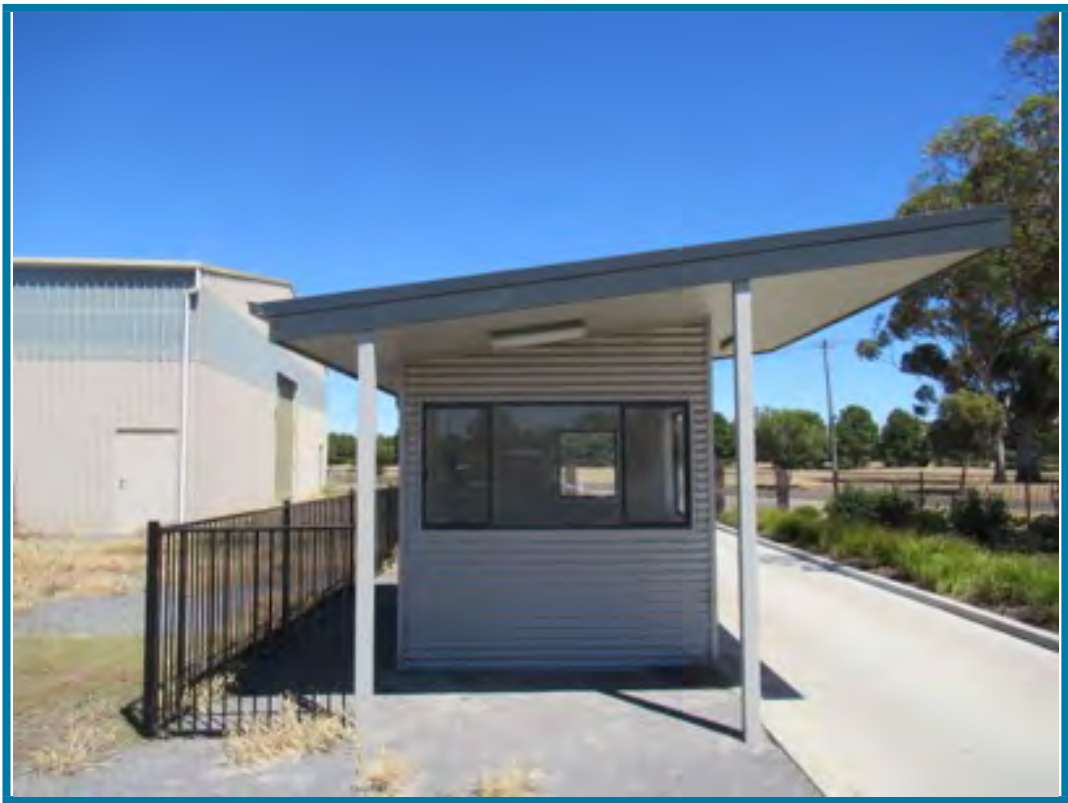
Location	Area	Component Materials	ACM Identified	Type Asbestos Assessment	Condition	Priority	Signage Required
Ticket office - entire perimeter of building.		No Asbestos Materials	No	No sample taken - Visual ID

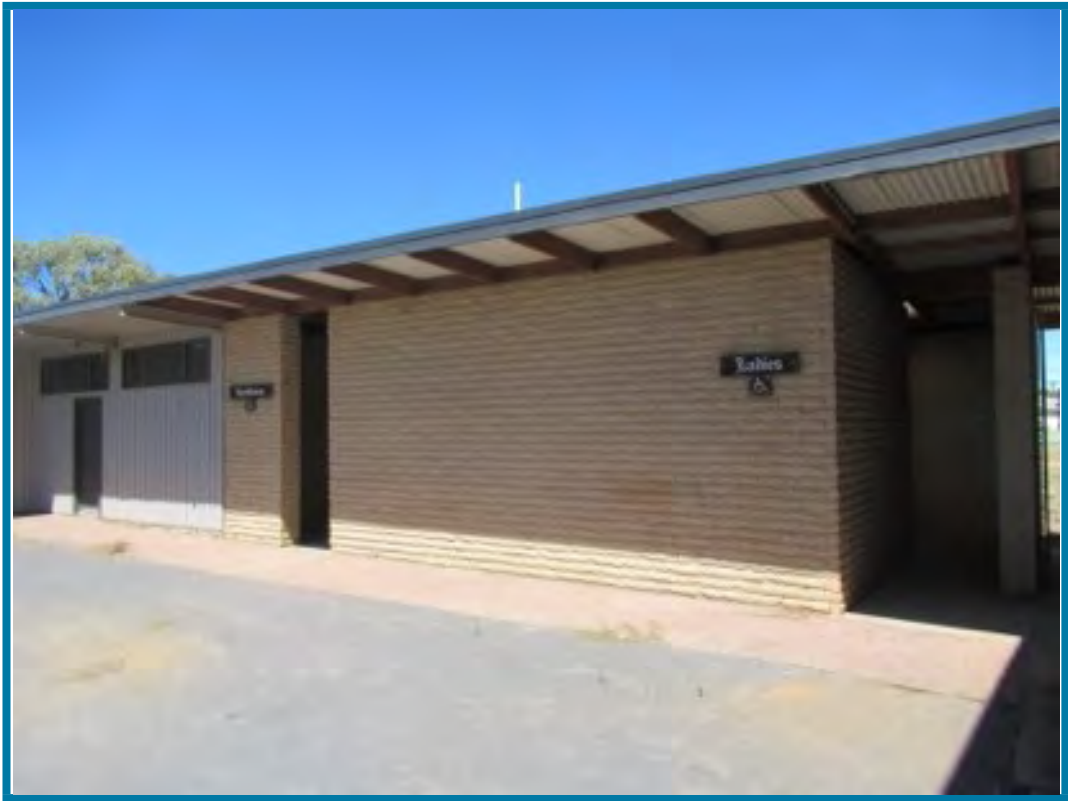
Location	Area	Component Materials	ACM Identified	Type Asbestos Assessment	Condition	Priority	Signage Required
Toilet Block - front of building.		No Asbestos Materials	No	No sample taken - Visual ID

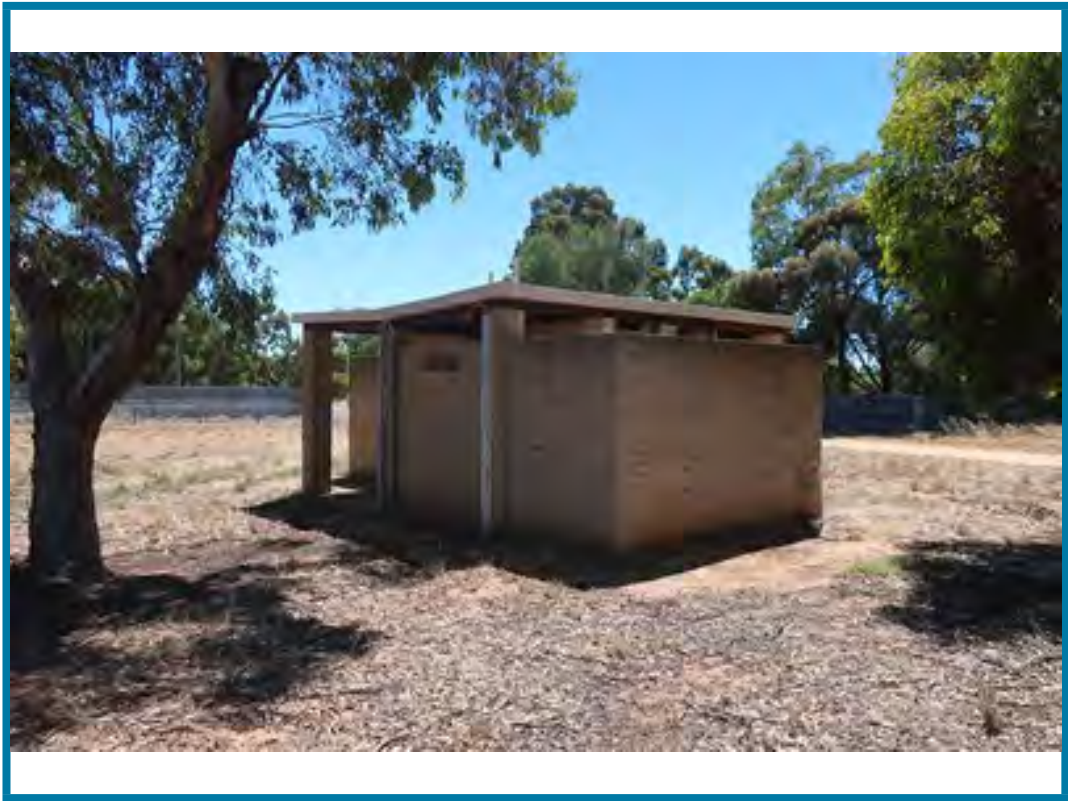
Location	Area	Component Materials	ACM Identified	Type Asbestos Assessment	Condition	Priority	Signage Required
Toilets - entire perimeter of building.		No Asbestos Materials	No	No sample taken - Visual ID
