# Asbestos Report

YARRIAMBIACK SHIRE COUNCIL

PROPERTY ADDRESS:  
LB54A SHIRE OFFICES  
59 CROMIE STREET  
RUPANYUP VIC 3388

INSPECTION DATE: 10 FEBRUARY 2021  
REFERENCE NUMBER: 62115

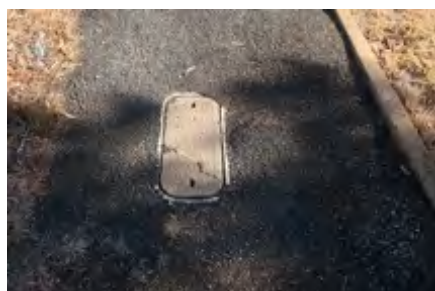
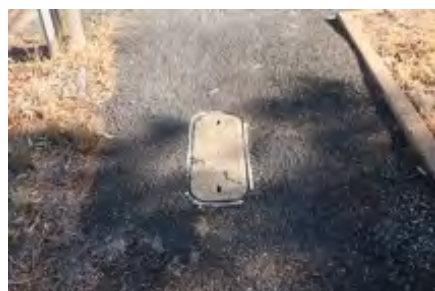
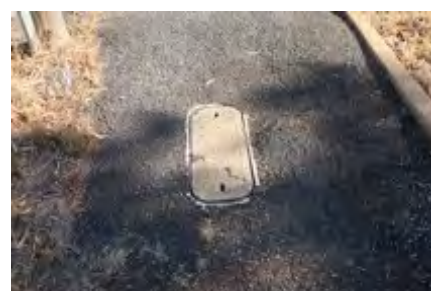
Raw Material Edges

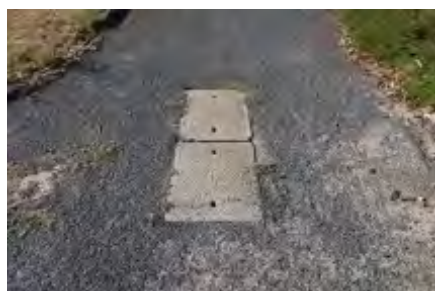
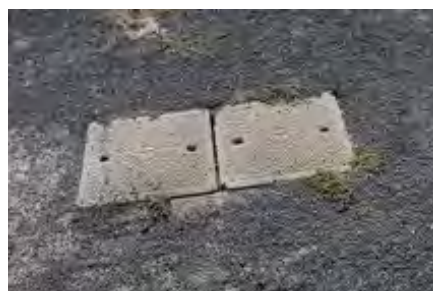
Raw Material Edges

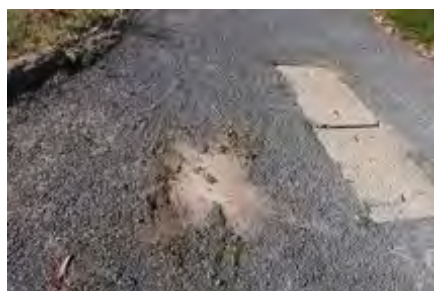
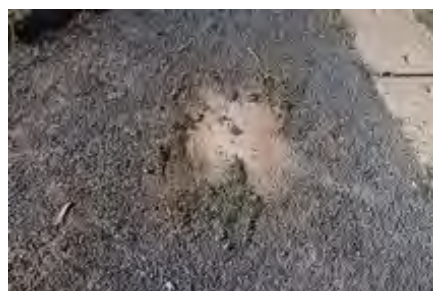
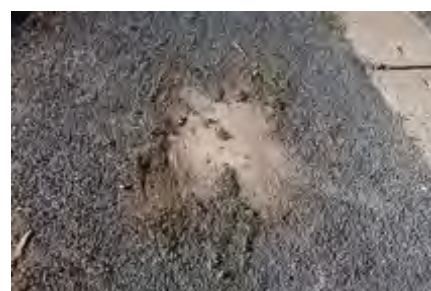
Raw Material Edges

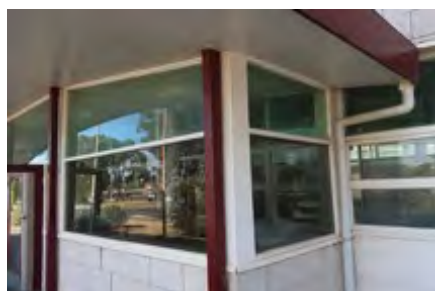
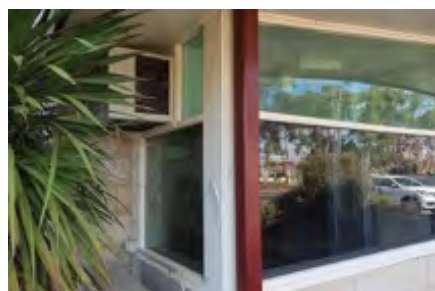
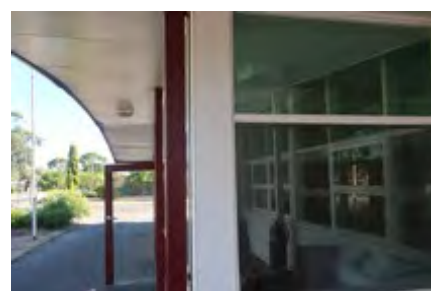
Maintain paint or sealant

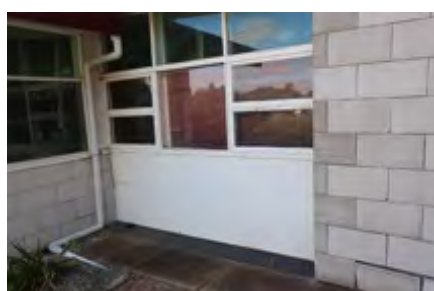
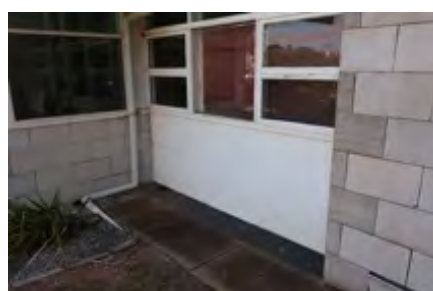
Maintain paint or sealant

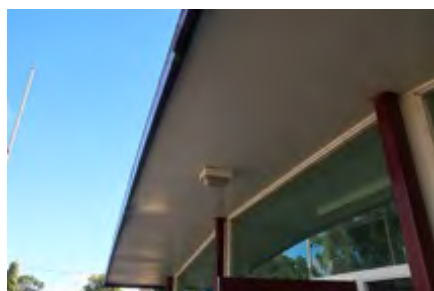
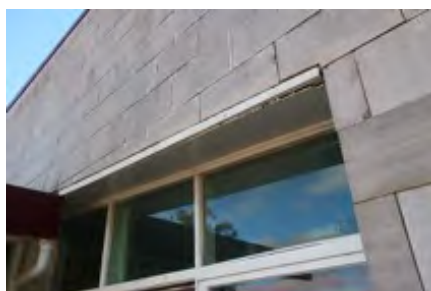
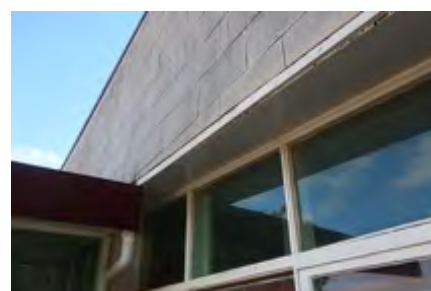
Maintain paint or sealant

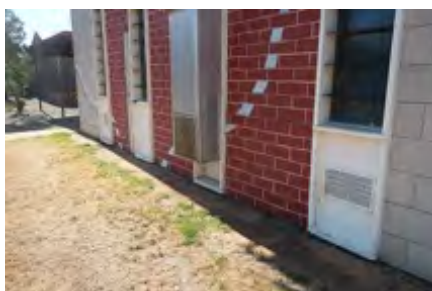
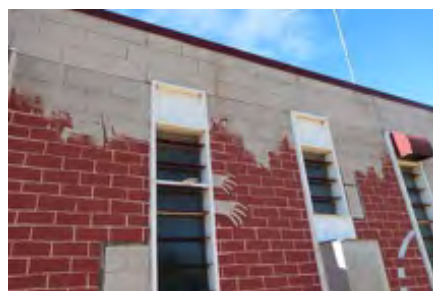
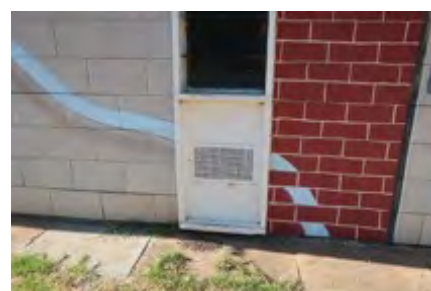
Maintain paint or sealant

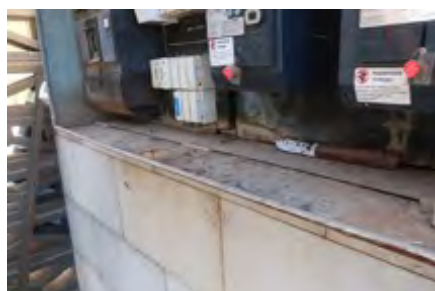
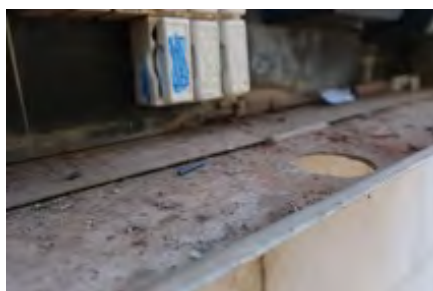
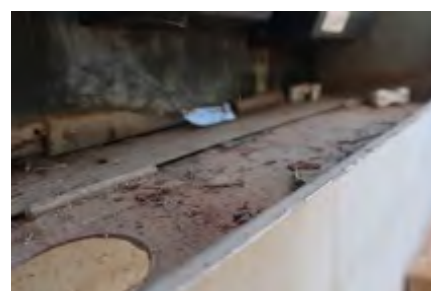
Debris on Surface

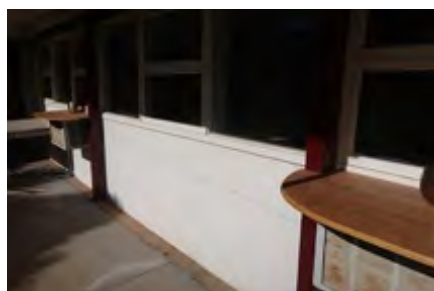
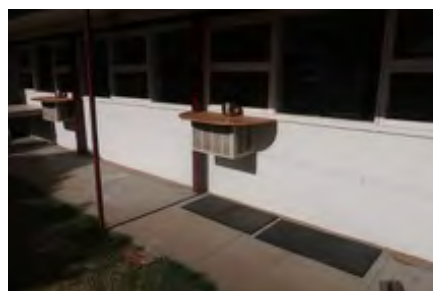
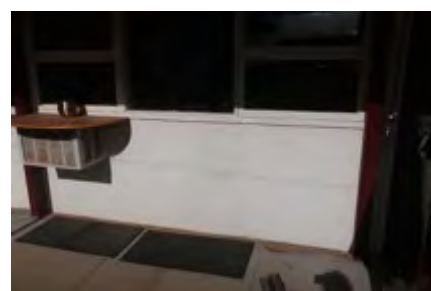
Maintain paint or sealant

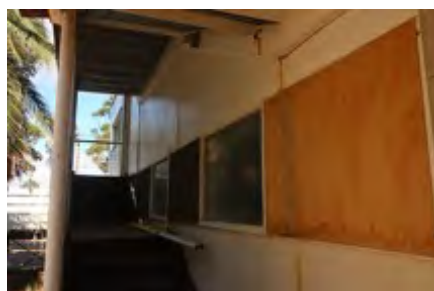
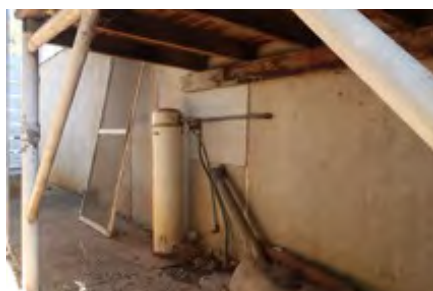
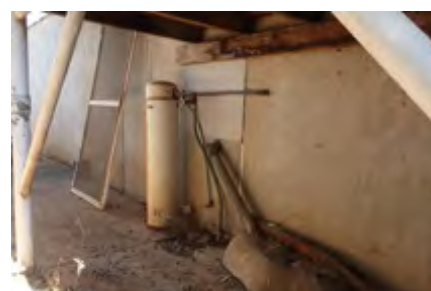
Raw Material

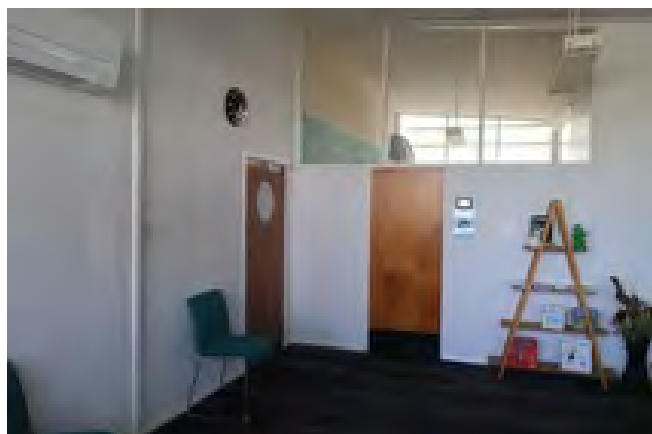
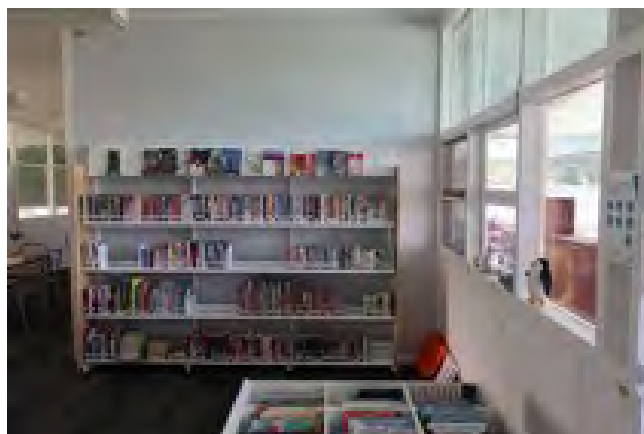
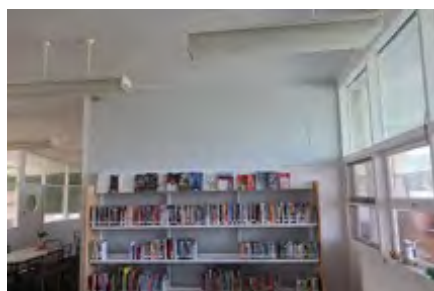
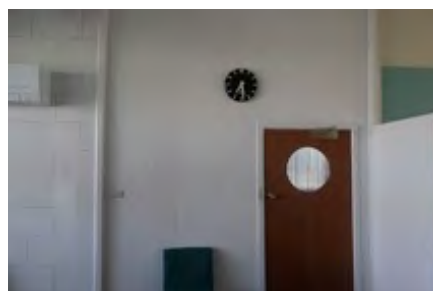
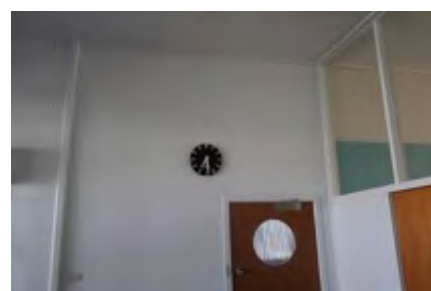
**Area 20****Office Block LB54A Shire Offices: Ground Floor Library 2. The Walls x2 (F C Sheeting) has Asbestos Containing Material (ACM) present.****RISK ASSESSMENT**

<b>Type of Asbestos or Hazardous Material</b>	No sample taken - Visual ID	<b>Condition</b>	GOOD	<b>Likelihood of Damage</b>	L (Low) – possible
		<b>Activity</b>	Moderate		
		<b>Sealed</b>	Yes	<b>Friability</b>	Bonded (non-friable)
		<b>Labelled</b>	Y	<b>Exposure Risk</b>	Low - Negligible or low risk
		<b>Quantity</b>

Maintain paint or sealant

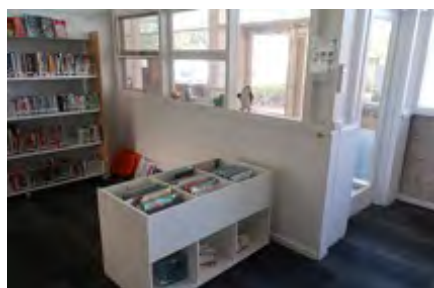
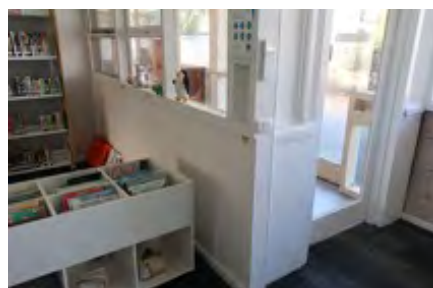
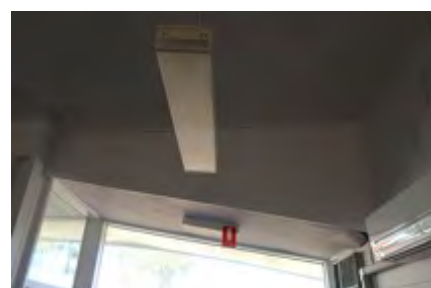
Maintain paint or sealant

<b>Priority</b>	MEDIUM	<b>Label Required</b>	Yes	<b>Re- Audit Date</b>	10 Feb 2022
<b>Action</b>	No remedial action required, unless disturbed				
<b>Recommendation</b>	Maintain paint or sealant to ACM surfaces. Particular attention should be given to side edges, ensure paint/sealant covers ALL exposed ACM surfaces.				
<b>Legislative Requirements Victorian Regulation 2007</b>	Warning labels should be affixed. Avoid mechanical damage and abrasion. Remove if refurbishment, structural alteration or demolition is to be carried out in this area. Re-inspect every 12 months or earlier if disturbed or removed in accordance with the Victorian OH&S Regulation 2017. <b>All remedial/removal repairs require a Clearance Inspection &amp; Certificate to be recorded by an approved and competent assessor.</b>

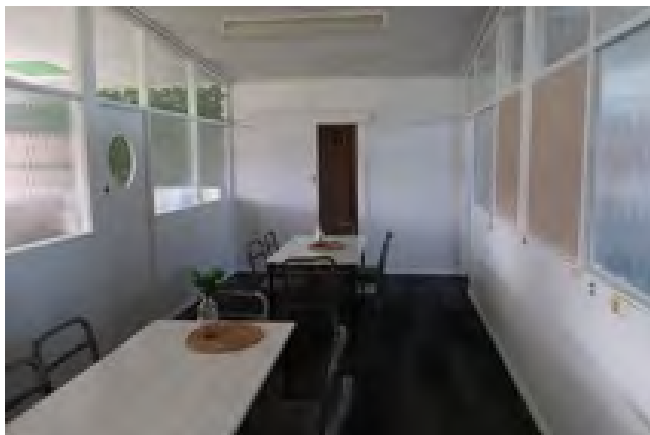
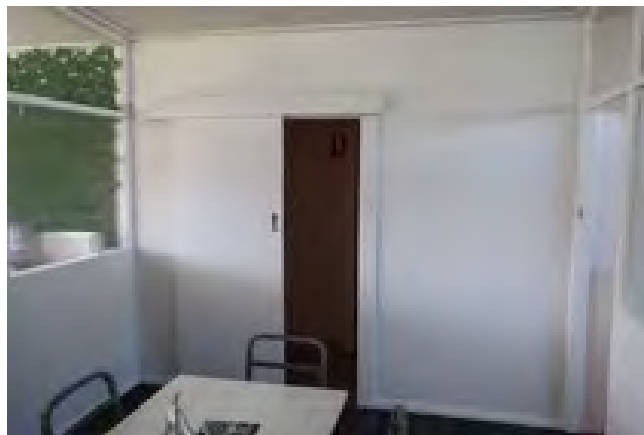
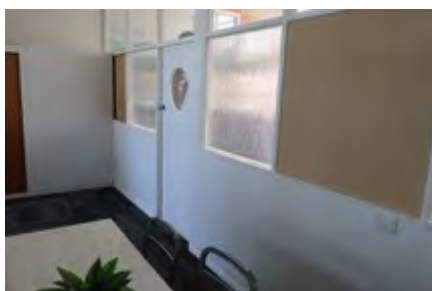
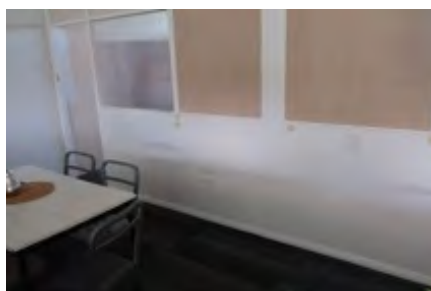
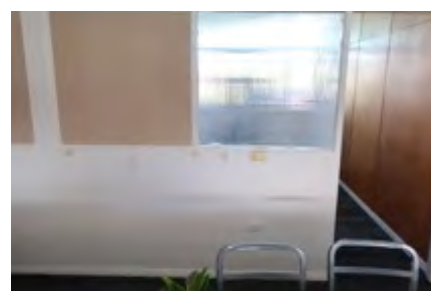
**Area 21****Office Block LB54A Shire Offices: Ground Floor Lunch room 3. The Infill panel/s below windows (F C Sheeting) has Asbestos Containing Material (ACM) present.****RISK ASSESSMENT**

<b>Type of Asbestos or Hazardous Material</b>	Chrysotile  Same as Sample - 62115-009	<b>Condition</b>	GOOD	<b>Likelihood of Damage</b>	L (Low) – possible
		<b>Activity</b>	Moderate		
		<b>Sealed</b>	Yes	<b>Friability</b>	Bonded (non-friable)
		<b>Labelled</b>	Y	<b>Exposure Risk</b>	Low - Negligible or low risk
		<b>Quantity</b>

Maintain paint or sealant

<b>Priority</b>	MEDIUM	<b>Label Required</b>	Yes	<b>Re- Audit Date</b>	10 Feb 2022
<b>Action</b>	No remedial action required, unless disturbed				
<b>Recommendation</b>	Maintain paint or sealant to ACM surfaces. Particular attention should be given to side edges, ensure paint/sealant covers ALL exposed ACM surfaces.				
<b>Legislative Requirements Victorian Regulation 2007</b>	Warning labels should be affixed. Avoid mechanical damage and abrasion. Remove if refurbishment, structural alteration or demolition is to be carried out in this area. Re-inspect every 12 months or earlier if disturbed or removed in accordance with the Victorian OH&S Regulation 2017. <b>All remedial/removal repairs require a Clearance Inspection &amp; Certificate to be recorded by an approved and competent assessor.</b>

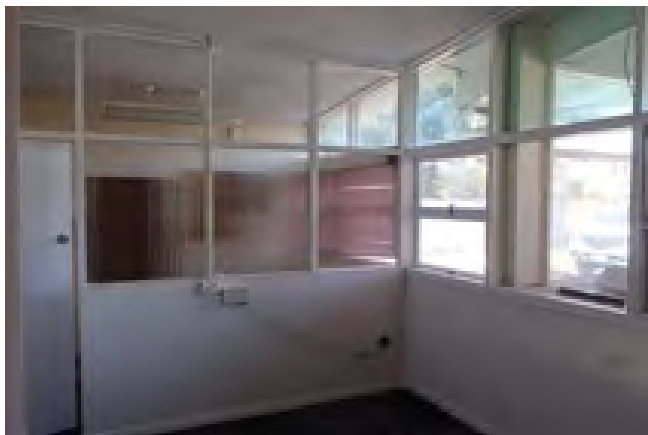
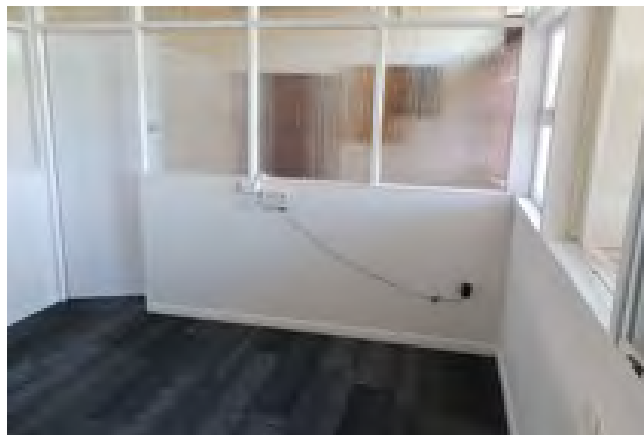
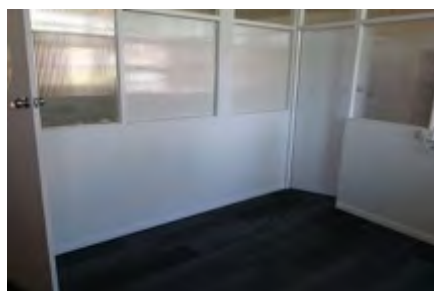
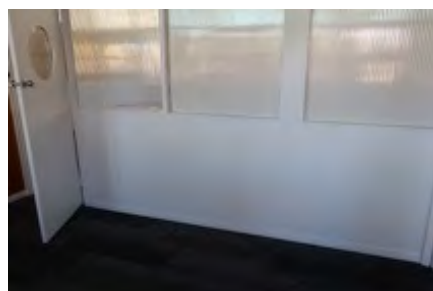
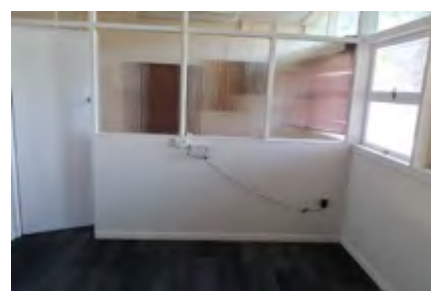
**Area 22****Office Block LB54A Shire Offices: Ground Floor Office 4. The Infill panel/s below windows (F C Sheeting) has Asbestos Containing Material (ACM) present.****RISK ASSESSMENT**

<b>Type of Asbestos or Hazardous Material</b>	Chrysotile	<b>Condition</b>	GOOD	<b>Likelihood of Damage</b>	L (Low) – possible
	Same as Sample - 62115 -009	<b>Activity</b>	Moderate		
		<b>Sealed</b>	Yes	<b>Friability</b>	Bonded (non-friable)
		<b>Labelled</b>	Y	<b>Exposure Risk</b>	Low - Negligible or low risk
		<b>Quantity</b>

Maintain paint or sealant

<b>Priority</b>	MEDIUM	<b>Label Required</b>	Yes	<b>Re- Audit Date</b>	10 Feb 2022
<b>Action</b>	No remedial action required, unless disturbed				
<b>Recommendation</b>	Maintain paint or sealant to ACM surfaces. Particular attention should be given to side edges, ensure paint/sealant covers ALL exposed ACM surfaces.				
<b>Legislative Requirements Victorian Regulation 2007</b>	Warning labels should be affixed. Avoid mechanical damage and abrasion. Remove if refurbishment, structural alteration or demolition is to be carried out in this area. Re-inspect every 12 months or earlier if disturbed or removed in accordance with the Victorian OH&S Regulation 2017. <b>All remedial/removal repairs require a Clearance Inspection &amp; Certificate to be recorded by an approved and competent assessor.</b>

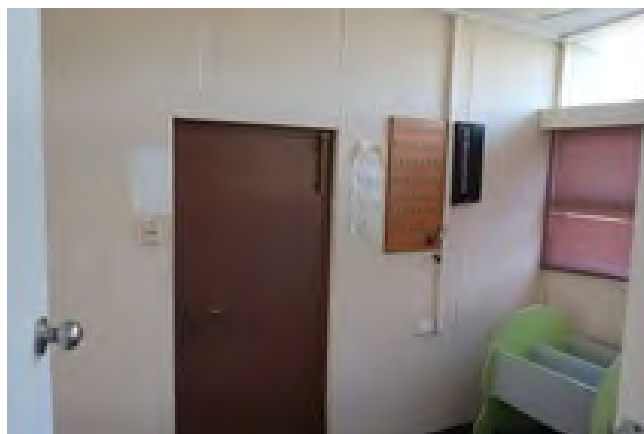
Type of Asbestos or Hazardous Material	No sample taken - Visual ID	Condition	AVERAGE	Likelihood of Damage	L (Low) – possible
		Activity	Moderate		
		Sealed	Yes	Friability	Exposed Fibres
		Labelled	Y	Exposure Risk	Medium - Moderate risk
		Quantity

Priority	HIGH	Label Required	Yes	Re- Audit Date	10 Feb 2022
Action	Remedial repairs required - seal raw material / edges				
Recommendation	Crack - The damaged area requires immediate remedial repairs. It is recommended the asbestos sheeting be replaced (preferred) or edges sealed with approved sealant and then the area be concealed by laminating (sheeting).				
Legislative Requirements Victorian Regulation 2007	Damaged ACM visible in area. Requires IMMEDIATE ATTENTION. WARNING labels should be affixed. Avoid mechanical damage and abrasion. Remove if refurbishment, structural alteration or demolition is to be carried out in this area. Re-inspect every 12 months or earlier if disturbed or removed in accordance with the Victorian OH&S Regulation 2017. <b>All remedial/removal repairs require a Clearance Inspection &amp; Certificate to be recorded by an approved and competent assessor.</b>

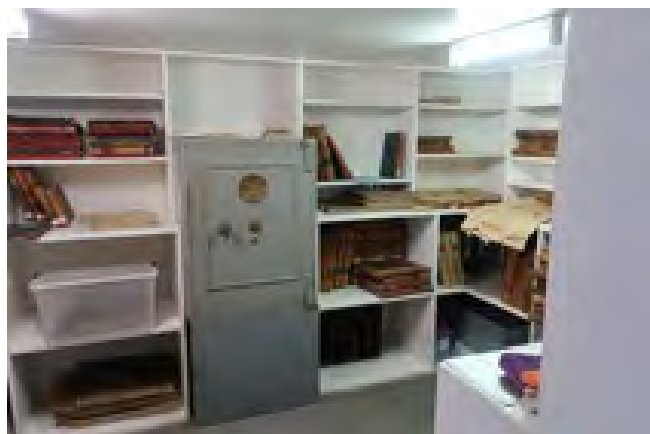
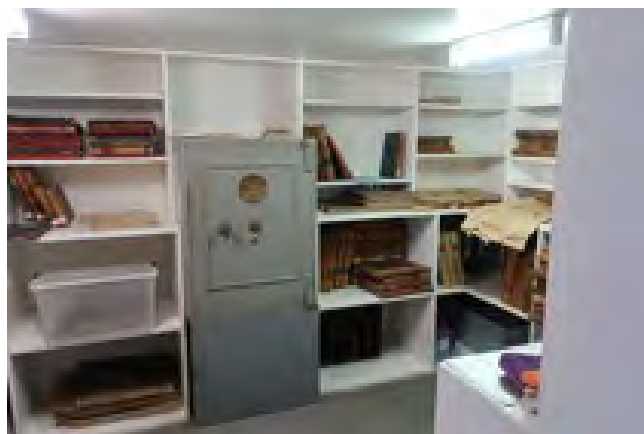
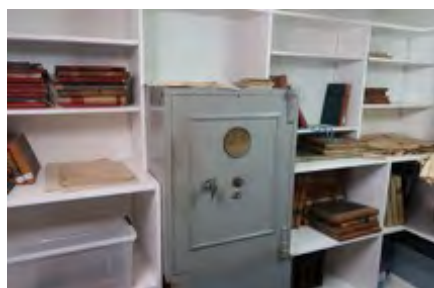
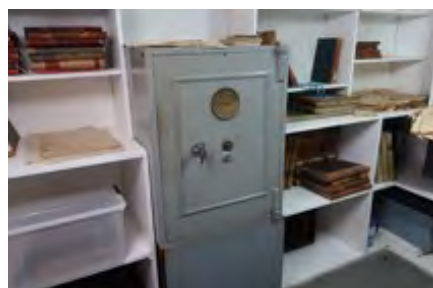
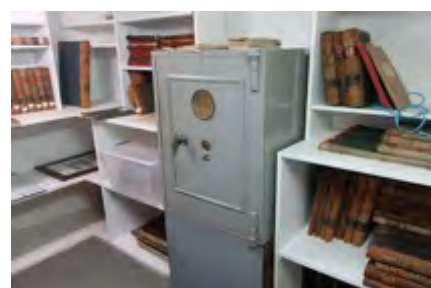
**Area 23****Office Block LB54A Shire Offices: Ground Floor Strong room 6. The Safe (Walls & Doors) (Fire Retardant core) has Asbestos Containing Material (ACM) present.****RISK ASSESSMENT**

<b>Type of Asbestos or Hazardous Material</b>	No sample taken - Visual ID	<b>Condition</b>	GOOD	<b>Likelihood of Damage</b>	L (Low) – possible
		<b>Activity</b>	Moderate		
		<b>Sealed</b>	Yes	<b>Friability</b>	Bonded (non-friable)
		<b>Labelled</b>	Y	<b>Exposure Risk</b>	Low - Negligible or low risk
		<b>Quantity</b>

Maintain paint or sealant

<b>Priority</b>	MEDIUM	<b>Label Required</b>	Yes	<b>Re- Audit Date</b>	10 Feb 2022
<b>Action</b>	No remedial action required, unless disturbed				
<b>Recommendation</b>	Maintain paint or sealant to ACM surfaces. Particular attention should be given to side edges, ensure paint/sealant covers ALL exposed ACM surfaces.				
<b>Legislative Requirements Victorian Regulation 2007</b>	Warning labels should be affixed. Avoid mechanical damage and abrasion. Remove if refurbishment, structural alteration or demolition is to be carried out in this area. Re-inspect every 12 months or earlier if disturbed or removed in accordance with the Victorian OH&S Regulation 2017. <b>All remedial/removal repairs require a Clearance Inspection &amp; Certificate to be recorded by an approved and competent assessor.</b>

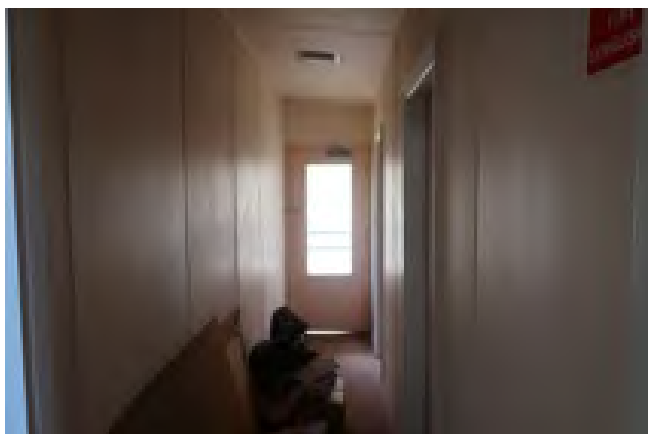
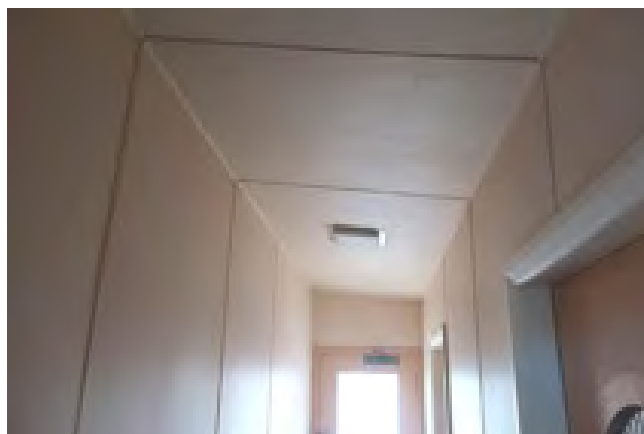
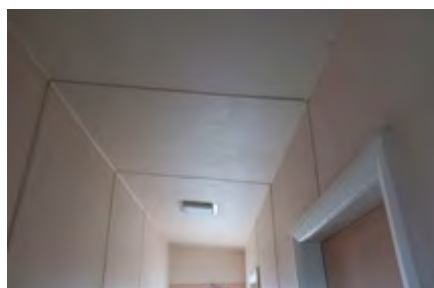
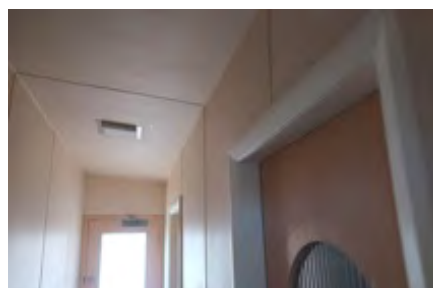
**Area 18****Office Block LB54A Shire Offices: Ground Floor Hallway 8. The Walls and Ceiling (F C Sheeting) has Asbestos Containing Material (ACM) present.****RISK ASSESSMENT**

Type of Asbestos or Hazardous Material	No sample taken - Visual ID	Condition	GOOD	Likelihood of Damage	L (Low) – possible
		Activity	Moderate		
		Sealed	Yes	Friability	Bonded (non-friable)
		Labelled	Y	Exposure Risk	Low - Negligible or low risk
		Quantity

Maintain paint or sealant

Priority	MEDIUM	Label Required	Yes	Re- Audit Date	10 Feb 2022
Action	No remedial action required, unless disturbed				
Recommendation	Maintain paint or sealant to ACM surfaces. Particular attention should be given to side edges, ensure paint/sealant covers ALL exposed ACM surfaces.				
Legislative Requirements Victorian Regulation 2007	Warning labels should be affixed. Avoid mechanical damage and abrasion. Remove if refurbishment, structural alteration or demolition is to be carried out in this area. Re-inspect every 12 months or earlier if disturbed or removed in accordance with the Victorian OH&S Regulation 2017. <b>All remedial/removal repairs require a Clearance Inspection &amp; Certificate to be recorded by an approved and competent assessor.</b>

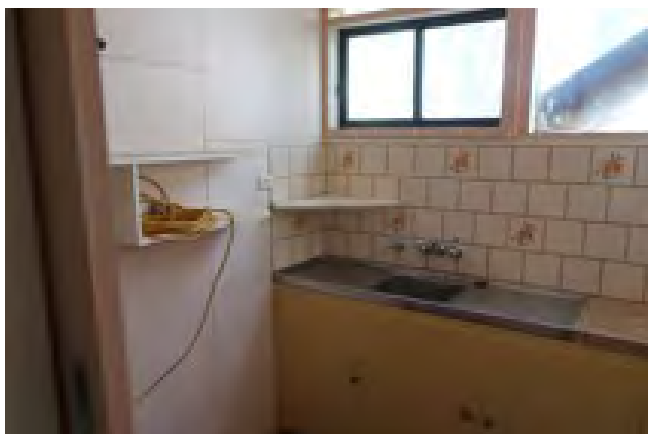
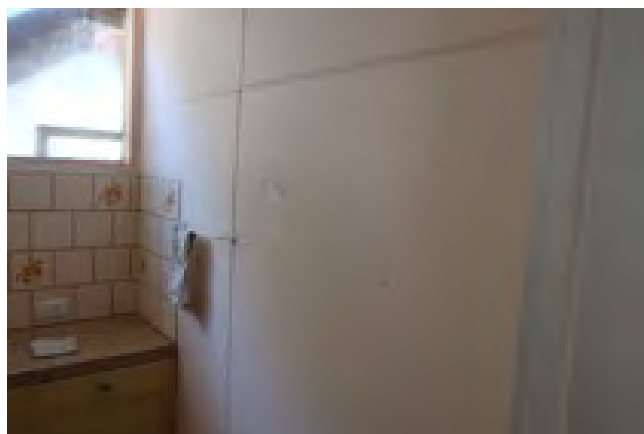
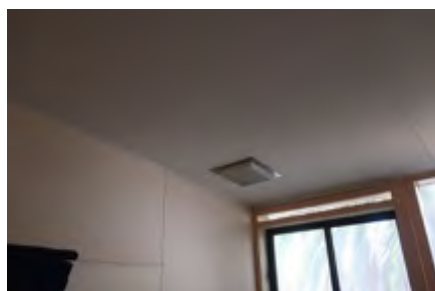
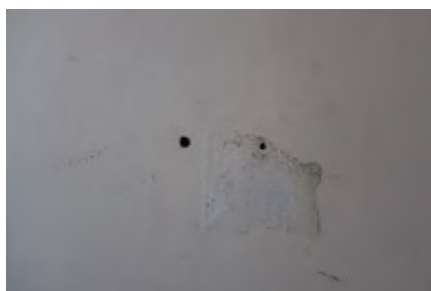
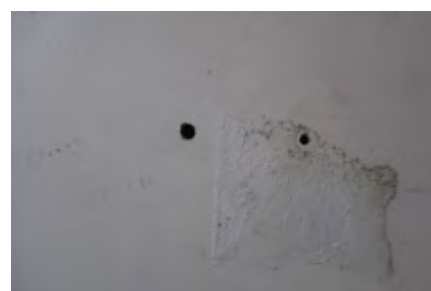
**Area 10****Office Block LB54A Shire Offices: Ground Floor Wash room 9. The Walls and Ceiling (F C Sheeting) has Asbestos Containing Material (ACM) present.****RISK ASSESSMENT**

Type of Asbestos or Hazardous Material	No sample taken - Visual ID	Condition	AVERAGE	Likelihood of Damage	L (Low) – possible
		Activity	Moderate		
		Sealed	Yes	Friability	Exposed Fibres
		Labelled	Y	Exposure Risk	Medium - Moderate risk
		Quantity

Penetration Holes

Priority	HIGH	Label Required	Yes	Re- Audit Date	10 Feb 2022
Action	Remedial repairs required - seal raw material / edges				
Recommendation	Penetration Holes - The exposed edges require approved sealant. It is further recommended the gaps be filled with sealant.				
Legislative Requirements Victorian Regulation 2007	Damaged ACM visible in area. Requires IMMEDIATE ATTENTION. WARNING labels should be affixed. Avoid mechanical damage and abrasion. Remove if refurbishment, structural alteration or demolition is to be carried out in this area. Re-inspect every 12 months or earlier if disturbed or removed in accordance with the Victorian OH&S Regulation 2017. <b>All remedial/removal repairs require a Clearance Inspection &amp; Certificate to be recorded by an approved and competent assessor.</b>

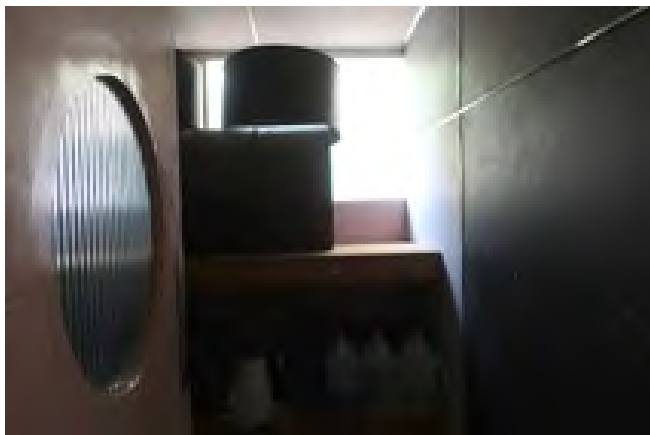
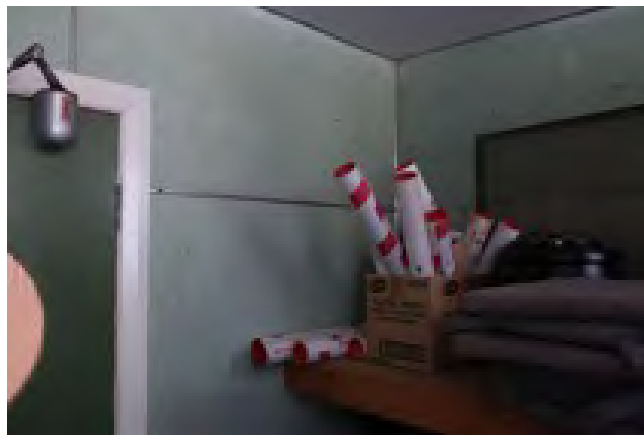
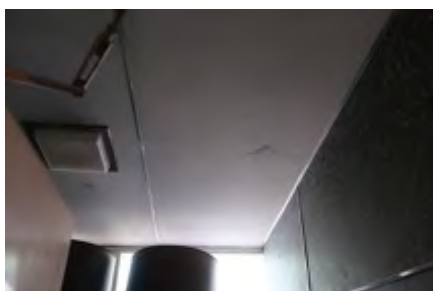
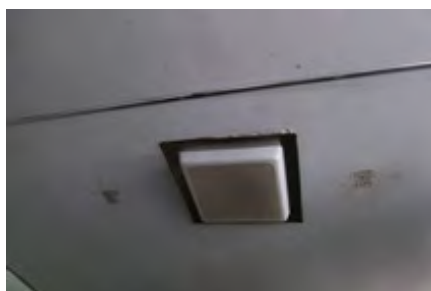
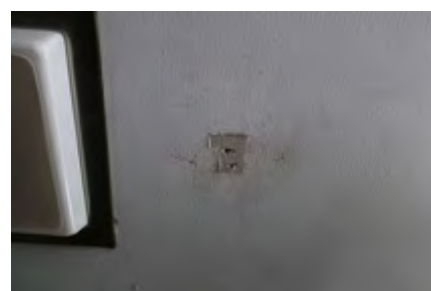
**Area 7****Office Block LB54A Shire Offices: Ground Floor Cleaners room 10. The Walls and Ceiling (F C Sheeting) has Asbestos Containing Material (ACM) present.****RISK ASSESSMENT**

Type of Asbestos or Hazardous Material	No sample taken - Visual ID	Condition	AVERAGE	Likelihood of Damage	L (Low) – possible
		Activity	Moderate		
		Sealed	Yes	Friability	Exposed Fibres
		Labelled	Y	Exposure Risk	Medium - Moderate risk
		Quantity

Penetration Holes

Priority	HIGH	Label Required	Yes	Re- Audit Date	10 Feb 2022
Action	Remedial repairs required - seal raw material / edges				
Recommendation	Penetration Holes - The exposed edges require approved sealant. It is further recommended the gaps be filled with sealant.				
Legislative Requirements Victorian Regulation 2007	Damaged ACM visible in area. Requires IMMEDIATE ATTENTION. WARNING labels should be affixed. Avoid mechanical damage and abrasion. Remove if refurbishment, structural alteration or demolition is to be carried out in this area. Re-inspect every 12 months or earlier if disturbed or removed in accordance with the Victorian OH&S Regulation 2017. <b>All remedial/removal repairs require a Clearance Inspection &amp; Certificate to be recorded by an approved and competent assessor.</b>

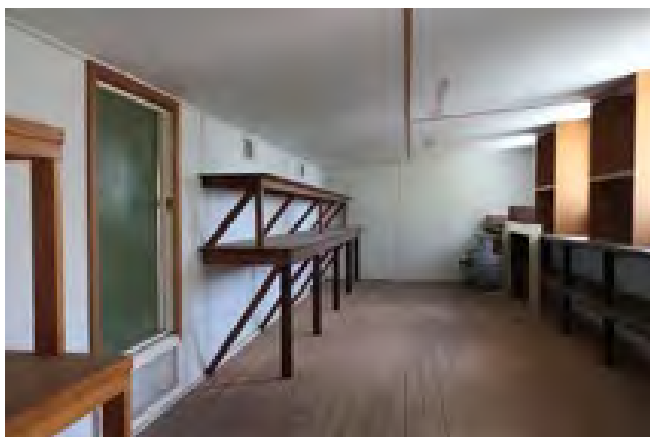
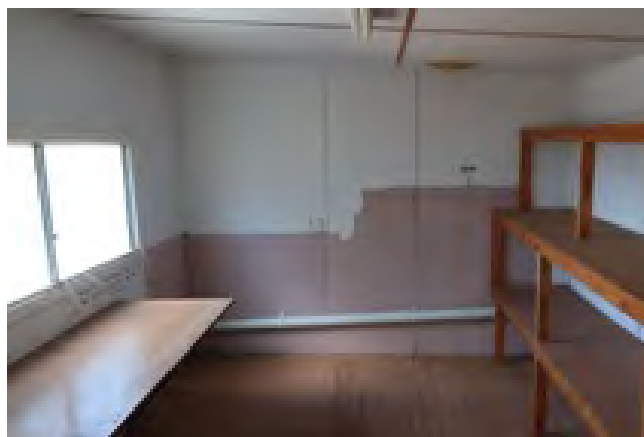
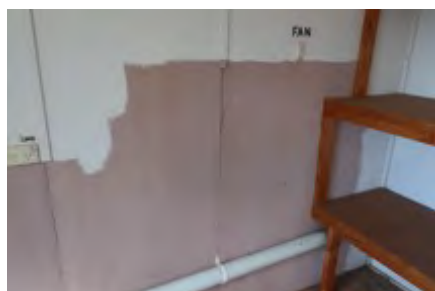
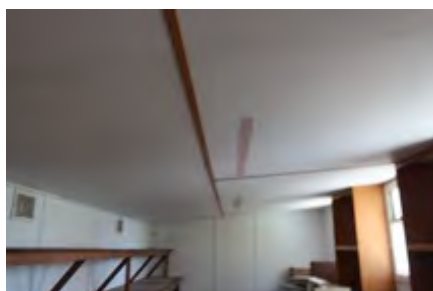
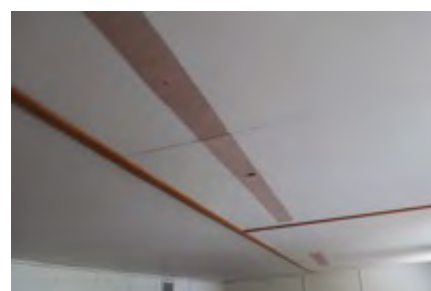
**Area 11****Office Block LB54A Shire Offices: Level 1 Open room 14. The Walls and Ceiling (F C Sheeting) has Asbestos Containing Material (ACM) present.****RISK ASSESSMENT**

<b>Type of Asbestos or Hazardous Material</b>	No sample taken - Visual ID	<b>Condition</b>	AVERAGE	<b>Likelihood of Damage</b>	L (Low) – possible
		<b>Activity</b>	Moderate		
		<b>Sealed</b>	No	<b>Friability</b>	Bonded (non-friable)
		<b>Labelled</b>	No	<b>Exposure Risk</b>	Medium - Moderate risk
		<b>Quantity</b>

Raw Material

<b>Priority</b>	HIGH	<b>Label Required</b>	Yes	<b>Re- Audit Date</b>	10 Feb 2022
<b>Action</b>	Remedial repairs required - seal raw material / edges				
<b>Recommendation</b>	Raw material sheeting - The area requires immediate remedial repairs. It is recommended the asbestos material be sealed with an approved membrane.				
<b>Legislative Requirements Victorian Regulation 2007</b>	<p>Damaged ACM visible in area. Requires IMMEDIATE ATTENTION. WARNING labels should be affixed. Avoid mechanical damage and abrasion. Remove if refurbishment, structural alteration or demolition is to be carried out in this area. Re-inspect every 12 months or earlier if disturbed or removed in accordance with the Victorian OH&amp;S Regulation 2017.</p> <p><b>All remedial/removal repairs require a Clearance Inspection &amp; Certificate to be recorded by an approved and competent assessor.</b></p>

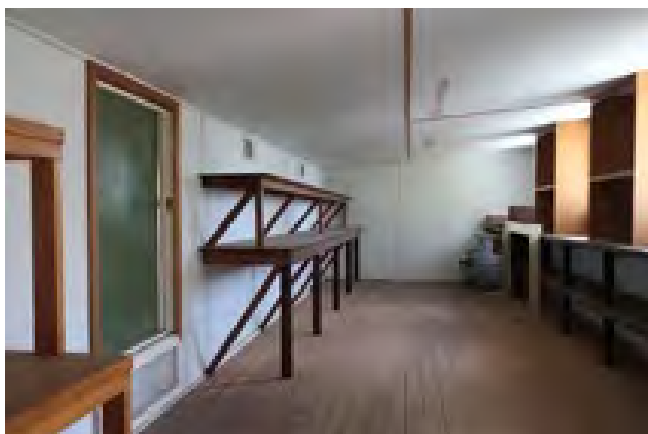
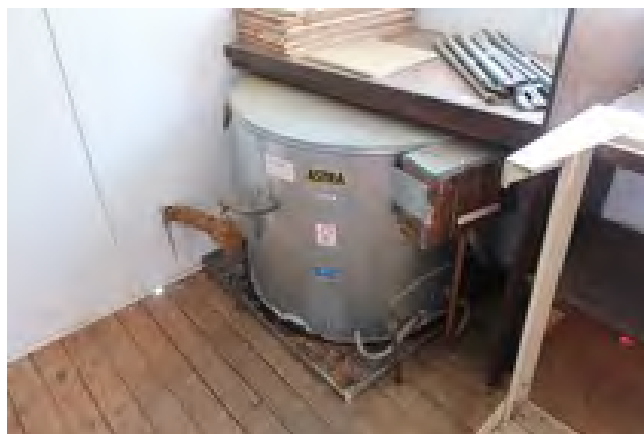
**Area 25****Office Block LB54A Shire Offices: Level 1 Open room 14. The Hot water system (Insulation - encapsulated) has Asbestos Containing Material (ACM) present.****RISK ASSESSMENT**

Type of Asbestos or Hazardous Material	No sample taken - Visual ID	Condition	GOOD	Likelihood of Damage	L (Low) – possible
		Activity	Moderate		
		Sealed	Yes	Friability	Bonded (non-friable)
		Labelled	Y	Exposure Risk	Low - Negligible or low risk
		Quantity

Priority	MEDIUM	Label Required	Yes	Re- Audit Date	10 Feb 2022
Action	No remedial action required, unless disturbed				
Recommendation	Maintain paint or sealant to ACM surfaces. Particular attention should be given to side edges, ensure paint/sealant covers ALL exposed ACM surfaces.				
Legislative Requirements Victorian Regulation 2007	Warning labels should be affixed. Avoid mechanical damage and abrasion. Remove if refurbishment, structural alteration or demolition is to be carried out in this area. Re-inspect every 12 months or earlier if disturbed or removed in accordance with the Victorian OH&S Regulation 2017. <b>All remedial/removal repairs require a Clearance Inspection &amp; Certificate to be recorded by an approved and competent assessor.</b>

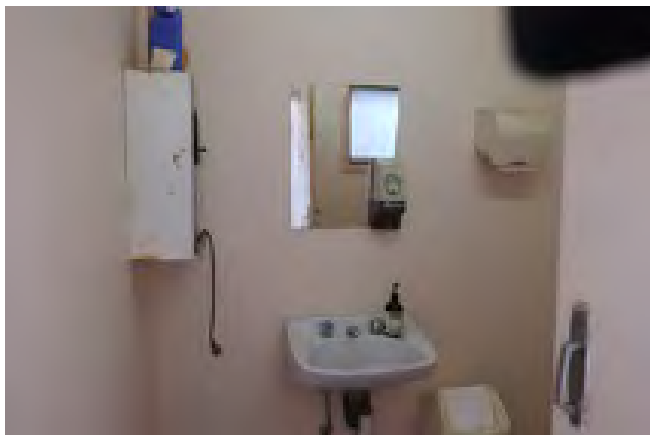
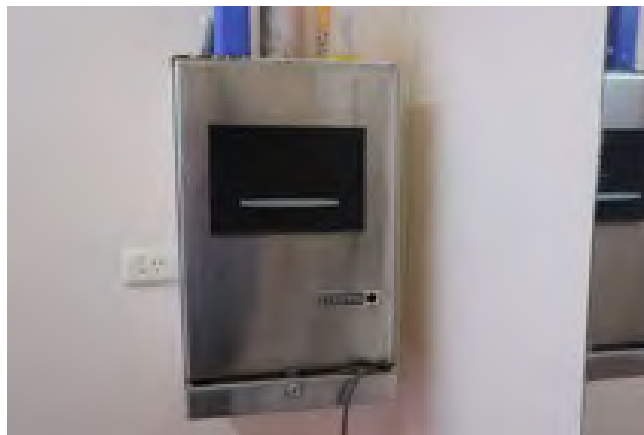
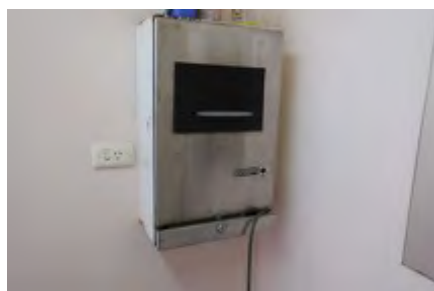
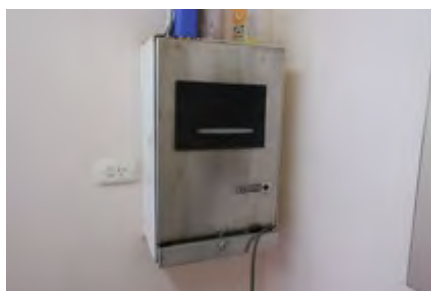
**Area 27****Toilet: Female bathroom 1. The Incinerator (Fire Retardant & element) has Asbestos Containing Material (ACM) present.****RISK ASSESSMENT**

<b>Type of Asbestos or Hazardous Material</b>	No sample taken - Visual ID	<b>Condition</b>	GOOD	<b>Likelihood of Damage</b>	L (Low) – possible
		<b>Activity</b>	Moderate		
		<b>Sealed</b>	Yes	<b>Friability</b>	Bonded (non-friable)
		<b>Labelled</b>	Y	<b>Exposure Risk</b>	Low - Negligible or low risk
		<b>Quantity</b>

Maintain seals

<b>Priority</b>	MEDIUM	<b>Label Required</b>	Yes	<b>Re- Audit Date</b>	10 Feb 2022
<b>Action</b>	No remedial action required, unless disturbed				
<b>Recommendation</b>	Maintain paint or sealant to ACM surfaces. Particular attention should be given to side edges, ensure paint/sealant covers ALL exposed ACM surfaces.				
<b>Legislative Requirements Victorian Regulation 2007</b>	Warning labels should be affixed. Avoid mechanical damage and abrasion. Remove if refurbishment, structural alteration or demolition is to be carried out in this area. Re-inspect every 12 months or earlier if disturbed or removed in accordance with the Victorian OH&S Regulation 2017. <b>All remedial/removal repairs require a Clearance Inspection &amp; Certificate to be recorded by an approved and competent assessor.</b>

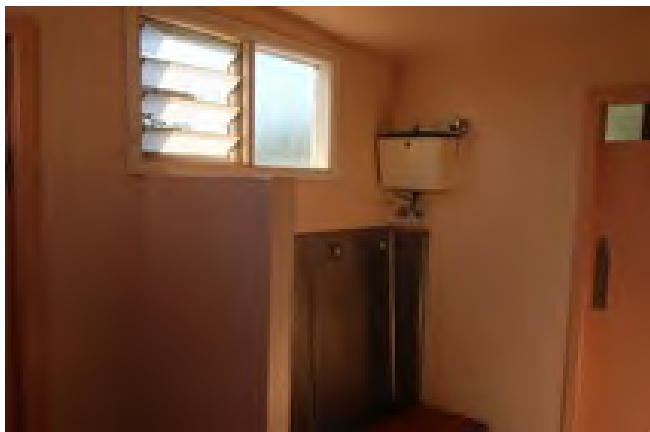
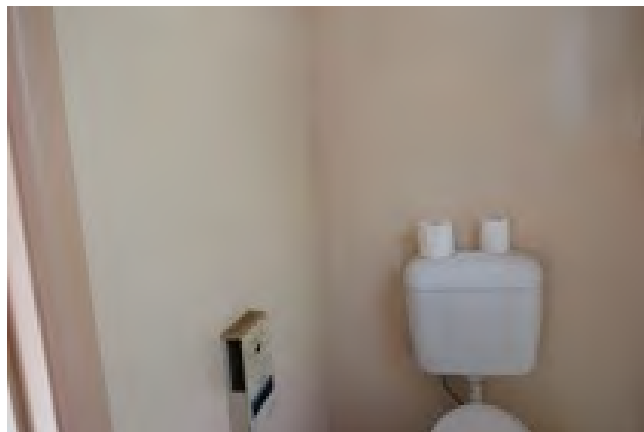
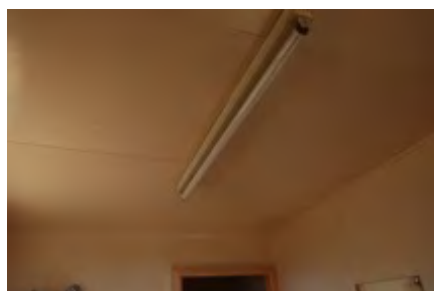
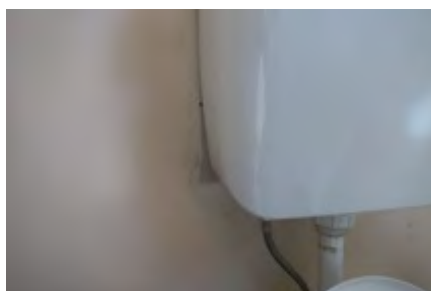
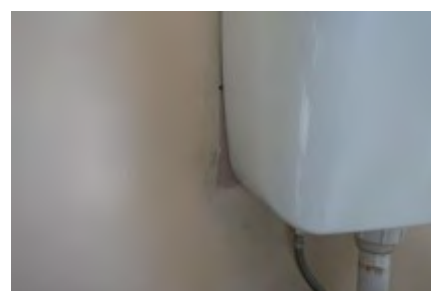
**Area 13****Toilet: Male bathroom 2. The Walls and Ceiling (F C Sheeting) has Asbestos Containing Material (ACM) present.****RISK ASSESSMENT**

<b>Type of Asbestos or Hazardous Material</b>	No sample taken - Visual ID	<b>Condition</b>	AVERAGE	<b>Likelihood of Damage</b>	L (Low) – possible
		<b>Activity</b>	Moderate		
		<b>Sealed</b>	No	<b>Friability</b>	Bonded (non-friable)
		<b>Labelled</b>	No	<b>Exposure Risk</b>	Medium - Moderate risk
		<b>Quantity</b>

Raw Material

<b>Priority</b>	HIGH	<b>Label Required</b>	Yes	<b>Re- Audit Date</b>	10 Feb 2022
<b>Action</b>	Remedial repairs required - seal raw material / edges				
<b>Recommendation</b>	Raw material sheeting - The area requires immediate remedial repairs. It is recommended the asbestos material be sealed with an approved membrane.				
<b>Legislative Requirements Victorian Regulation 2007</b>	Damaged ACM visible in area. Requires IMMEDIATE ATTENTION. WARNING labels should be affixed. Avoid mechanical damage and abrasion. Remove if refurbishment, structural alteration or demolition is to be carried out in this area. Re-inspect every 12 months or earlier if disturbed or removed in accordance with the Victorian OH&S Regulation 2017. <b>All remedial/removal repairs require a Clearance Inspection &amp; Certificate to be recorded by an approved and competent assessor.</b>

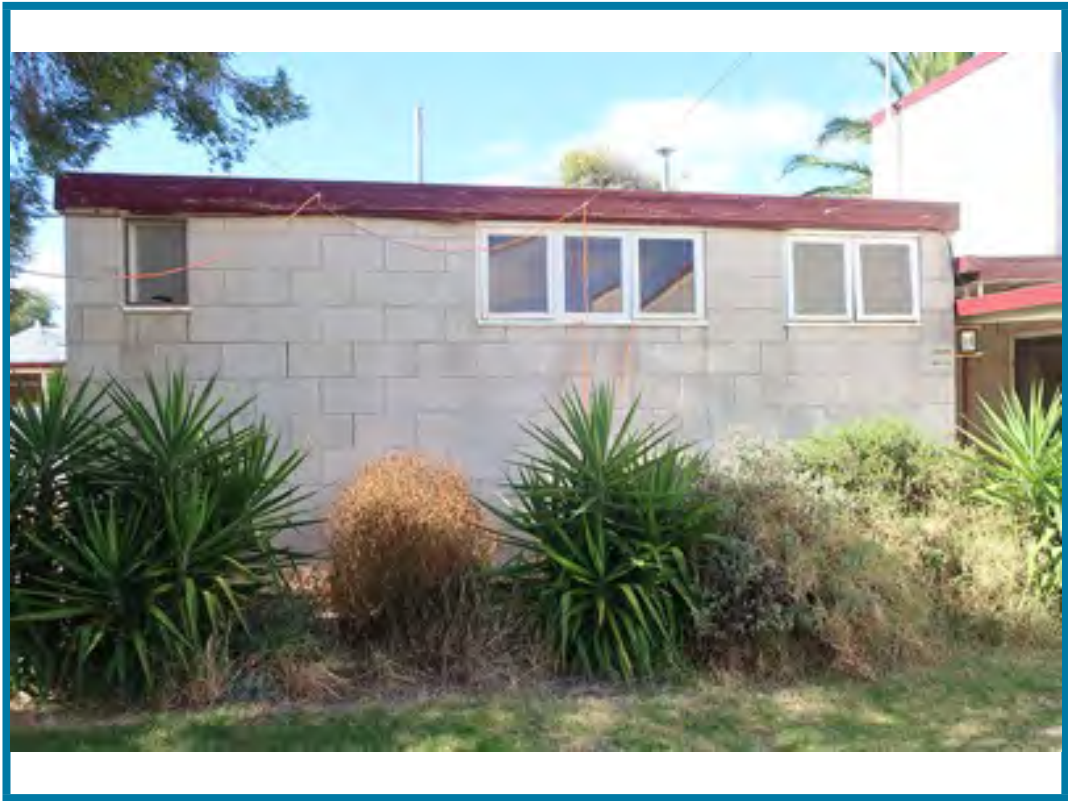
Location	Area	Component Materials	ACM Identified	Type Asbestos Assessment	ConditionPriority	Signage Required
Toilet - entire perimeter of building.		No Asbestos Materials	No	No sample taken - Visual ID
