# **Asbestos Report**

## YARRIAMBIACK SHIRE COUNCIL

PROPERTY ADDRESS: LB66 TENNIS SHED 2123 SUNRAYSIA HIGHWAY TURRIF VIC 3488

INSPECTION DATE: 11 FEBRUARY 2021 REFERENCE NUMBER: 62122

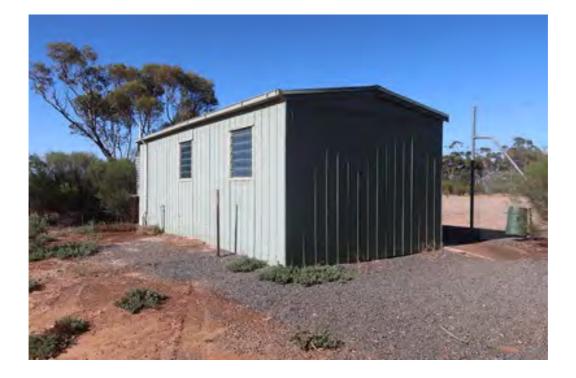
## 1 Tennis Shed: front of building. The Debris - Broken (Debris) has Asbestos Containing Material (ACM) present.

Analysis Result		
SampleID	Location Description	Type of Asbestos Present	Other Fibres (Organic/MMMF)	
62122-001	Tennis Shed - front of building. Debris - Broken	Chrysotile Amosite

The Asbestos Inspection identified that asbestos material is present within the building, under legislation, you are required to implement an Asbestos Management Plan. An annual Re-Audit and review of that material is recommended until all asbestos materials have been removed from the premises

#### RE AUDIT RECOMMENDED: 11/02/2022
