Asbestos Report

YARRIAMBIACK SHIRE COUNCIL

PROPERTY ADDRESS:
LB102 SHIRE DEPOT - SHIPPING CONTAINERS
X 3
9009 STAWELL WARRACKNABEAL ROAD
WARRACKNABEAL VIC 3393

INSPECTION DATE: 16 FEBRUARY 2021
REFERENCE NUMBER: 62140

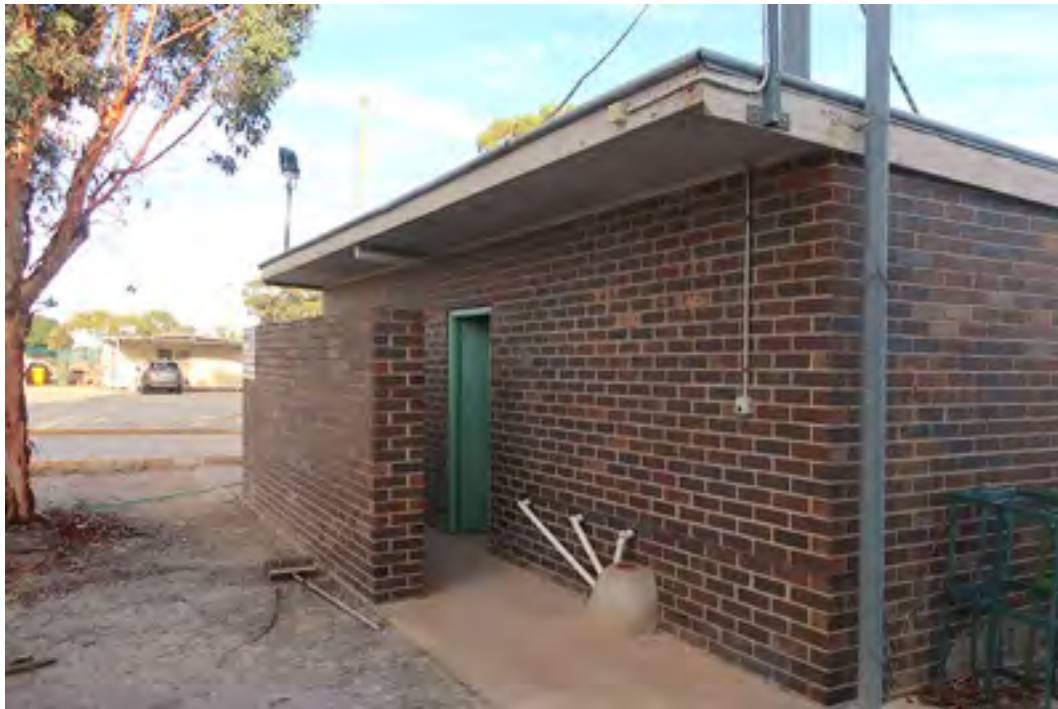
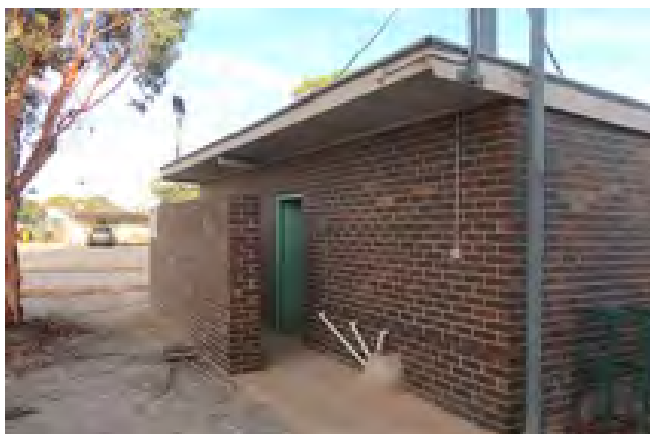
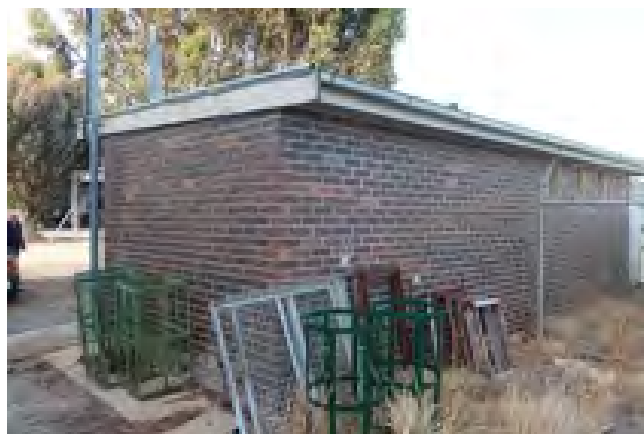
Area 4

Type of Asbestos or Hazardous Material	No sample taken - Visual ID	Condition	POOR	Likelihood of Damage	L (Low) – possible
		Activity	Moderate		
		Sealed	Yes	Friability	Exposed Fibres
		Labelled	No	Exposure Risk	High - Short term exposure risk
		Quantity

Damaged material

Priority	IMMEDIATE	Label Required	Yes	Re- Audit Date	16 Feb 2022
Action	Remedial repairs required - seal exposed edges or replace or laminate over damaged material				
Recommendation	Damaged material - The damaged area requires immediate remedial repairs. It is recommended the asbestos sheeting be replaced.				
Legislative Requirements Victorian Regulation 2007	<p>URGENT - ACM visible in area. The ACM appears to be of a friable nature. The services of an "A" class Asbestos removal consultant are urgently required. Immediately cease any access to the area and affix warning signs to all entry points. Avoid physical and mechanical damage. Avoid mechanical damage and abrasion. Re-inspect every 12 months or earlier if disturbed or removed in accordance with the Victorian OH&S Regulation 2017.</p> <p>All remedial/removal repairs require a Clearance Inspection & Certificate to be recorded by an approved and competent assessor.</p>

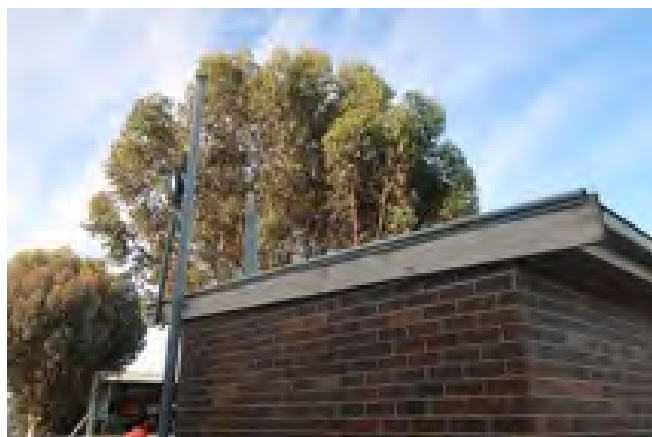
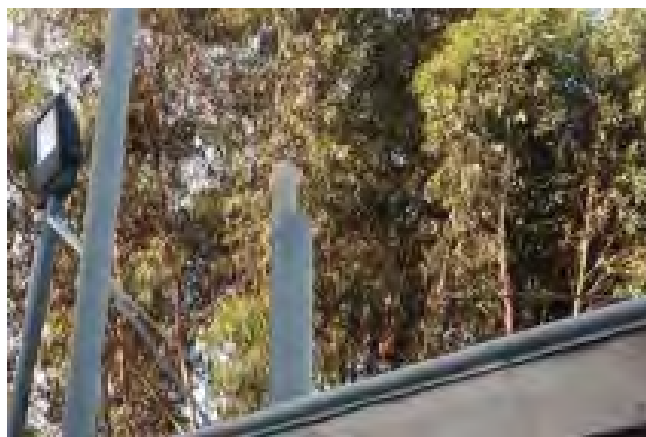
Type of Asbestos or Hazardous Material	No sample taken - Visual ID	Condition	AVERAGE	Likelihood of Damage	L (Low) – possible
		Activity	Low		
		Sealed	No	Friability	Bonded (non-friable)
		Labelled	No	Exposure Risk	Medium - Moderate risk
		Quantity

Priority	HIGH	Label Required	Yes	Re- Audit Date	16 Feb 2022
Action	Remedial repairs required - seal raw material / edges				
Recommendation	Raw material sheeting - The area requires immediate remedial repairs. It is recommended the asbestos material be sealed with an approved membrane.				
Legislative Requirements Victorian Regulation 2007	<p>Damaged ACM visible in area. Requires IMMEDIATE ATTENTION. WARNING labels should be affixed. Avoid mechanical damage and abrasion. Remove if refurbishment, structural alteration or demolition is to be carried out in this area. Re-inspect every 12 months or earlier if disturbed or removed in accordance with the Victorian OH&S Regulation 2017.</p> <p>All remedial/removal repairs require a Clearance Inspection & Certificate to be recorded by an approved and competent assessor.</p>

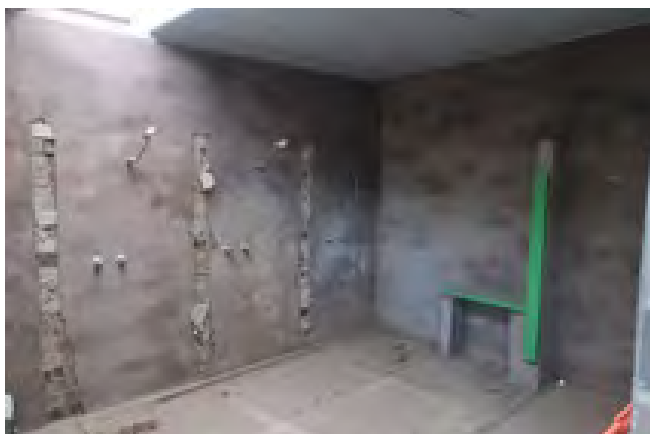
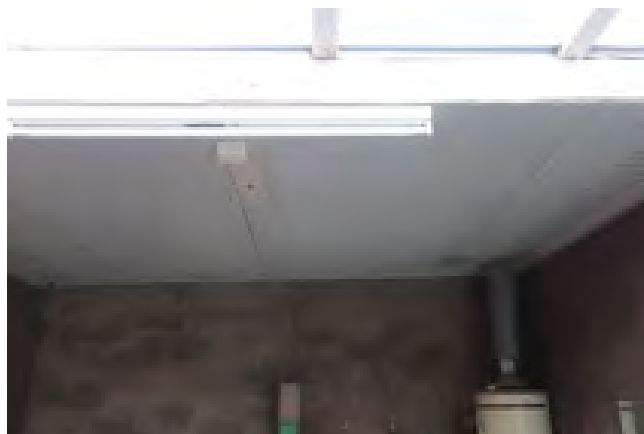
Type of Asbestos or Hazardous Material	Chrysotile	Condition	AVERAGE	Likelihood of Damage	L (Low) – possible
	Same as Sample - 62140 -001	Activity	Moderate		
		Sealed	Yes	Friability	Exposed Fibres
		Labelled	Y	Exposure Risk	Medium - Moderate risk
		Quantity

Priority	HIGH	Label Required	Yes	Re- Audit Date	16 Feb 2022
Action	Remedial repairs required - seal exposed edges or replace or laminate over damaged material				
Recommendation	Holes (impact) - The damaged area requires immediate remedial repairs. It is recommended the asbestos sheeting be replaced (preferred) or edges sealed with approved sealant and then the area be concealed by laminating (sheeting).				
Legislative Requirements Victorian Regulation 2007	<p>Damaged ACM visible in area. Requires IMMEDIATE ATTENTION. WARNING labels should be affixed. Avoid mechanical damage and abrasion. Remove if refurbishment, structural alteration or demolition is to be carried out in this area. Re-inspect every 12 months or earlier if disturbed or removed in accordance with the Victorian OH&S Regulation 2017.</p> <p>All remedial/removal repairs require a Clearance Inspection & Certificate to be recorded by an approved and competent assessor.</p>

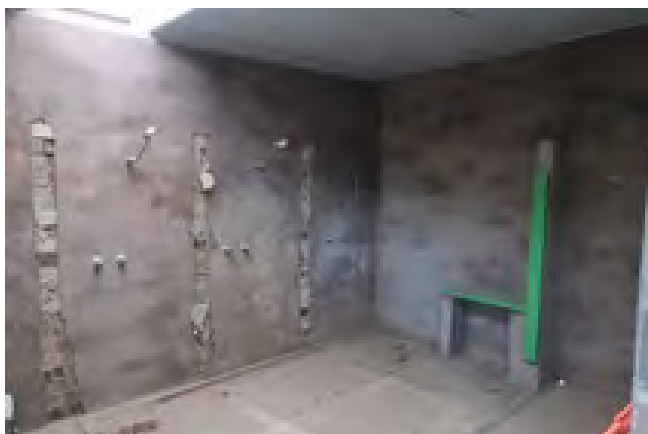
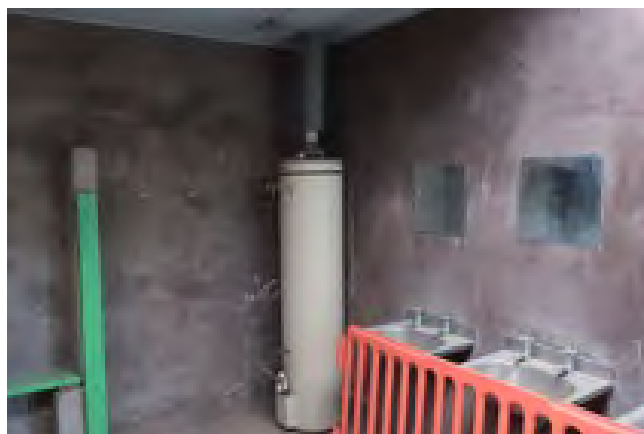
Type of Asbestos or Hazardous Material	No sample taken - Visual ID	Condition	AVERAGE	Likelihood of Damage	L (Low) – possible
		Activity	Low		
		Sealed	No	Friability	Bonded (non-friable)
		Labelled	No	Exposure Risk	Medium - Moderate risk
		Quantity

Priority	HIGH	Label Required	Yes	Re- Audit Date	16 Feb 2022
Action	Remedial repairs required - seal raw material / edges				
Recommendation	Raw material sheeting - The area requires immediate remedial repairs. It is recommended the asbestos material be sealed with an approved membrane.				
Legislative Requirements Victorian Regulation 2007	<p>Damaged ACM visible in area. Requires IMMEDIATE ATTENTION. WARNING labels should be affixed. Avoid mechanical damage and abrasion. Remove if refurbishment, structural alteration or demolition is to be carried out in this area. Re-inspect every 12 months or earlier if disturbed or removed in accordance with the Victorian OH&S Regulation 2017.</p> <p>All remedial/removal repairs require a Clearance Inspection & Certificate to be recorded by an approved and competent assessor.</p>

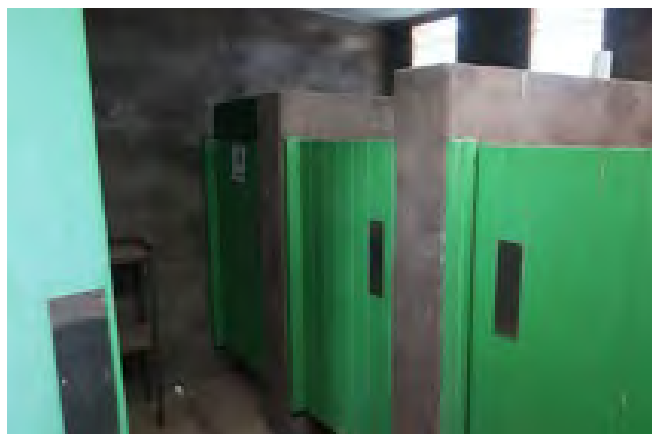
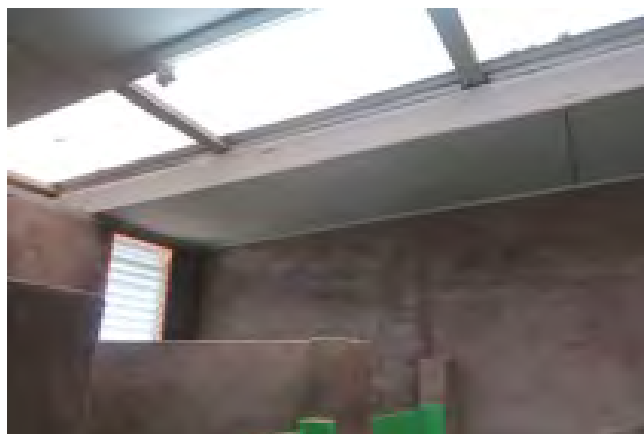
Type of Asbestos or Hazardous Material	Chrysotile	Condition	AVERAGE	Likelihood of Damage	L (Low) – possible
	Sample taken 62140-001	Activity	Moderate		
		Sealed	Yes	Friability	Exposed Fibres
		Labelled	Y	Exposure Risk	Medium - Moderate risk
		Quantity

Priority	HIGH	Label Required	Yes	Re- Audit Date	16 Feb 2022
Action	Remedial repairs required - seal raw material / edges				
Recommendation	Penetration Holes - The exposed edges require approved sealant. It is further recommended the gaps be filled with sealant.				
Legislative Requirements Victorian Regulation 2007	<p>Damaged ACM visible in area. Requires IMMEDIATE ATTENTION. WARNING labels should be affixed. Avoid mechanical damage and abrasion. Remove if refurbishment, structural alteration or demolition is to be carried out in this area. Re-inspect every 12 months or earlier if disturbed or removed in accordance with the Victorian OH&S Regulation 2017.</p> <p>All remedial/removal repairs require a Clearance Inspection & Certificate to be recorded by an approved and competent assessor.</p>

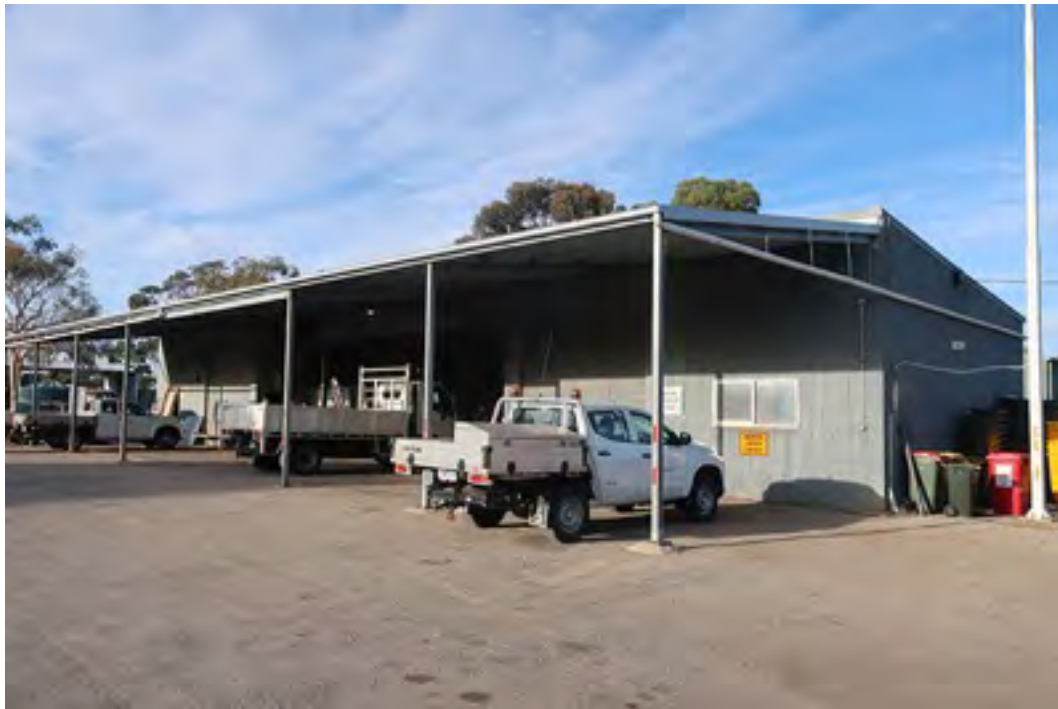
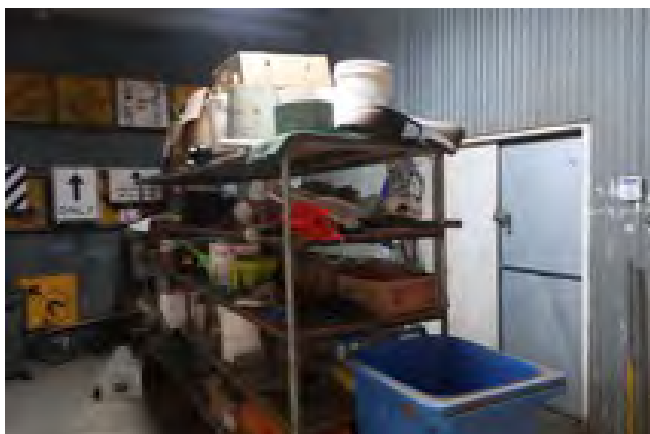
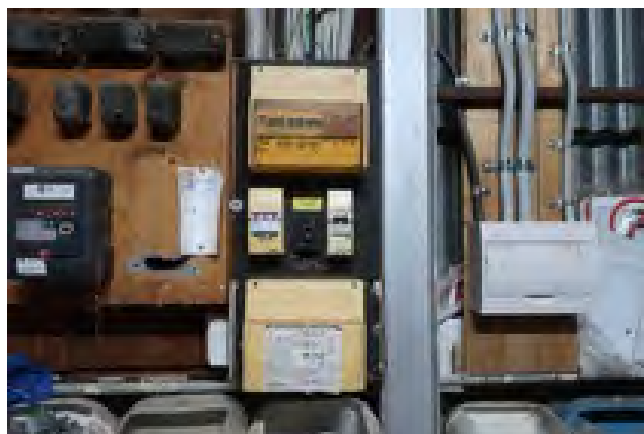
Area 5

Type of Asbestos or Hazardous Material	No sample taken - Visual ID	Condition	AVERAGE	Likelihood of Damage	L (Low) – possible
		Activity	Moderate		
		Sealed	Yes	Friability	Exposed Fibres
		Labelled	Y	Exposure Risk	Medium - Moderate risk
		Quantity

Broken sections

Priority	HIGH	Label Required	Yes	Re- Audit Date	16 Feb 2022
Action	Remedial repairs required - seal exposed edges or replace or laminate over damaged material				
Recommendation	Broken sections - The damaged area requires immediate remedial repairs. It is recommended the asbestos sheeting be replaced (preferred) or edges sealed with approved sealant and then the area be concealed by laminating (sheeting).				
Legislative Requirements Victorian Regulation 2007	<p>Damaged ACM visible in area. Requires IMMEDIATE ATTENTION. WARNING labels should be affixed. Avoid mechanical damage and abrasion. Remove if refurbishment, structural alteration or demolition is to be carried out in this area. Re-inspect every 12 months or earlier if disturbed or removed in accordance with the Victorian OH&S Regulation 2017.</p> <p>All remedial/removal repairs require a Clearance Inspection & Certificate to be recorded by an approved and competent assessor.</p>

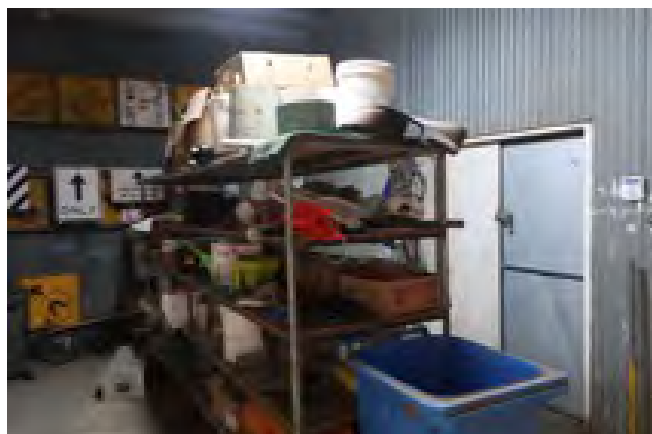
Type of Asbestos or Hazardous Material	Chrysotile	Condition	POOR	Likelihood of Damage	H (High) - almost certain
	Sample taken 62140-002	Activity	Moderate		
		Sealed	No	Friability	Friable
		Labelled	Y	Exposure Risk	High - Short term exposure risk
		Quantity

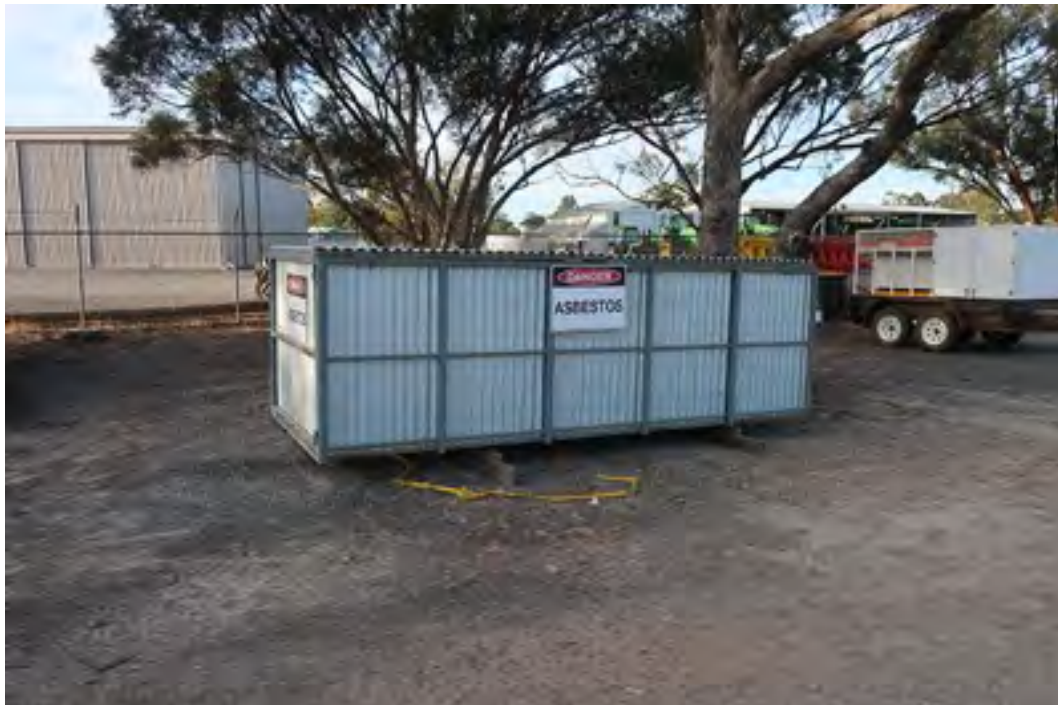
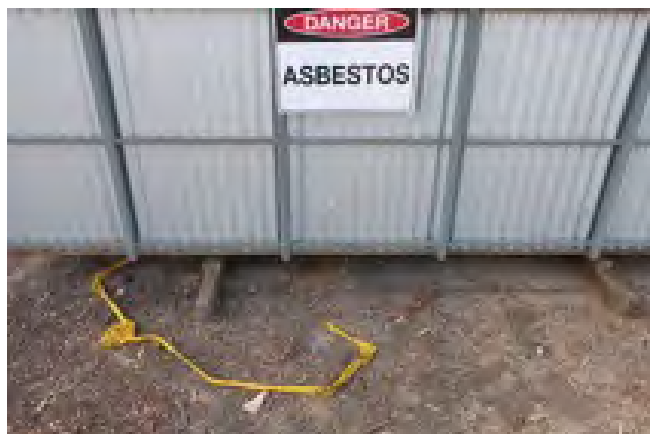
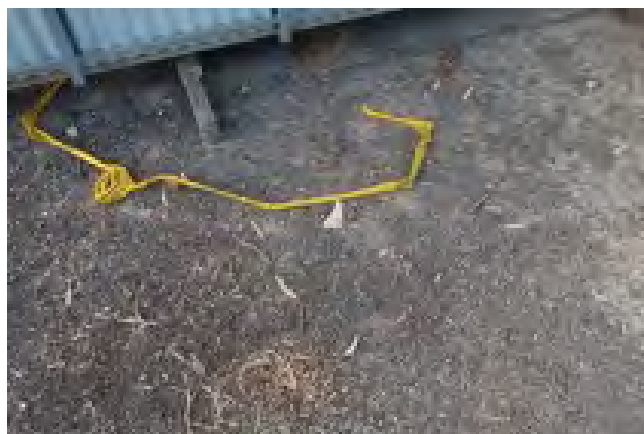
Area 2

| 2 | Asbestos Waste: entire perimeter of container. The Debris - Broken (Debris) has Asbestos Containing Material (ACM) present. | |

Type of Asbestos or Hazardous Material	No sample taken - Visual ID	Condition	POOR	Likelihood of Damage	H (High) - almost certain
		Activity	Moderate		
		Sealed	No	Friability	Exposed Fibres
		Labelled	Y	Exposure Risk	High - Short term exposure risk
		Quantity

Recommend to place waste skip on Hard stand to prevent contamination of surrounding soil.

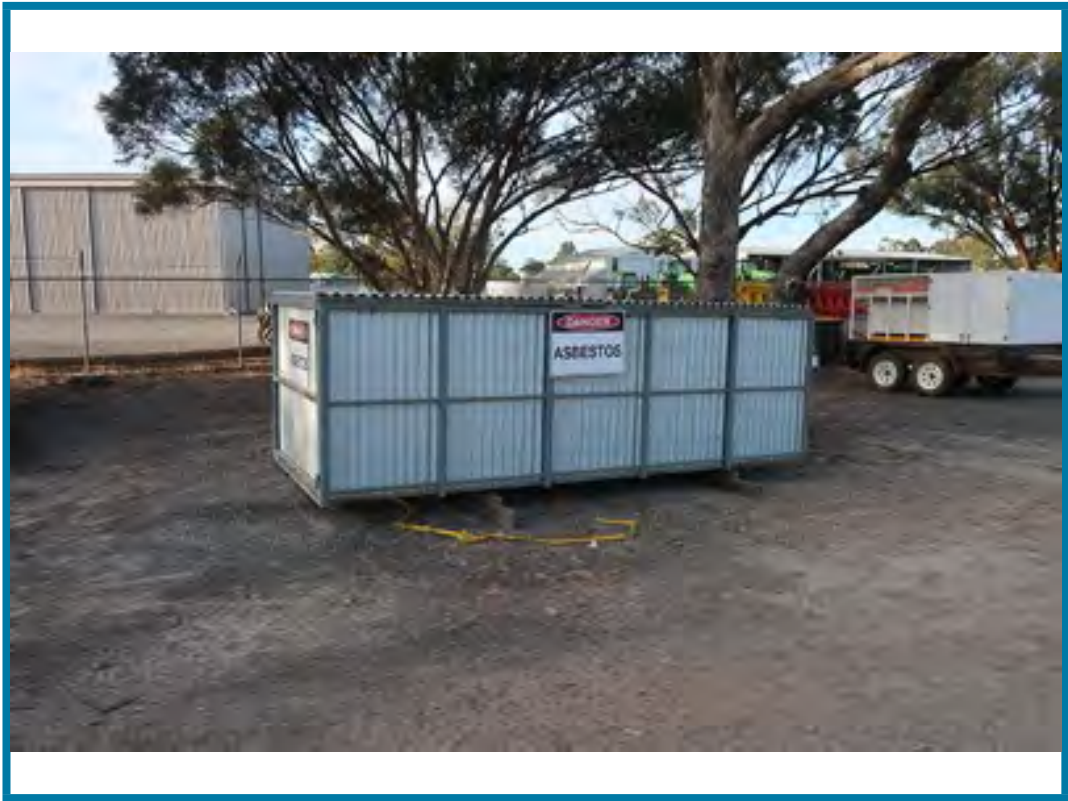
Location	Area	Component Materials	ACM Identified	Type Asbestos Assessment	Condition	Priority	Signage Required
Asbestos Waste - entire perimeter of container.	Debris - Broken	Debris	Yes	No sample taken - Visual ID			
					POOR IMMEDIATE	Yes	
				Refer to the Abestos Register for more information.			
Asbestos Waste - Container.	Asbestos waste	Fibrous Material	Yes	No sample taken - Visual ID			
					GOOD MEDIUM	Yes	
				Refer to the Abestos Register for more information.			
Asbestos Waste - Container.	Uncontained Asbestos Waste	Debris	Yes	No sample taken - Visual ID			
					POOR IMMEDIATE	Yes	
				Refer to the Abestos Register for more information.

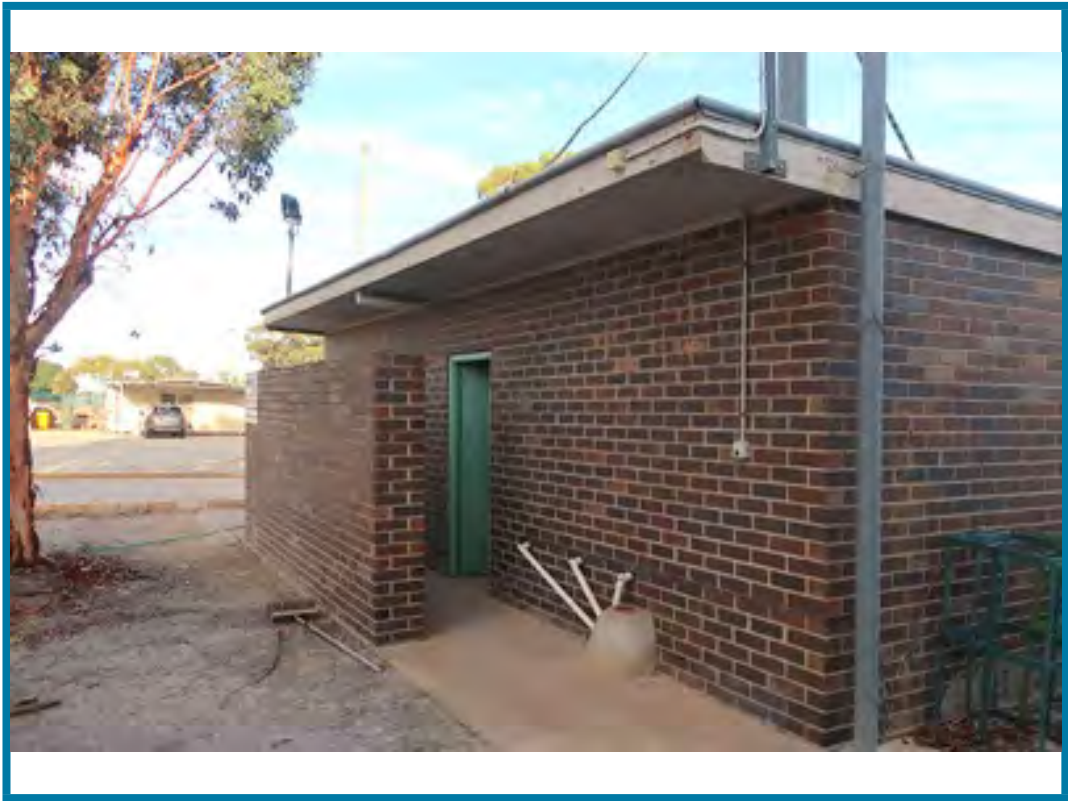
Location	Area	Component Materials	ACM Identified	Type Asbestos Assessment	Condition	Priority	Signage Required
Toilet block - front & rear of building.	Soffit	F C Sheeting	Yes	No sample taken - Visual ID			
				POOR IMMEDIATE			Yes
				Refer to the Abestos Register for more information.			
Toilet block - roof of building.	Vent Pipe	Fibrous Cement Product	Yes	No sample taken - Visual ID			
				AVERAGE HIGH			Yes
				Refer to the Abestos Register for more information.			
Toilet block - left & right side of building.		No Asbestos Materials	No	No sample taken - Visual ID			
				Image not available			
Toilet block - Showers 1.	Ceiling	F C Sheeting	Yes	Chrysotile			
				Same as Sample - 62140-001			
				AVERAGE HIGH			Yes
				Refer to the Abestos Register for more information.			
Toilet block - Showers 1.	Vent Pipe	Fibrous Cement Product	Yes	No sample taken - Visual ID			
				AVERAGE HIGH			Yes
				Refer to the Abestos Register for more information.
