Asbestos Report

YARRIAMBIACK SHIRE COUNCIL

PROPERTY ADDRESS:
LR15A SHIRE OFFICE
34 LYLE STREET
WARRACKNABEAL VIC 3393

INSPECTION DATE: 16 FEBRUARY 2021
REFERENCE NUMBER: 62142

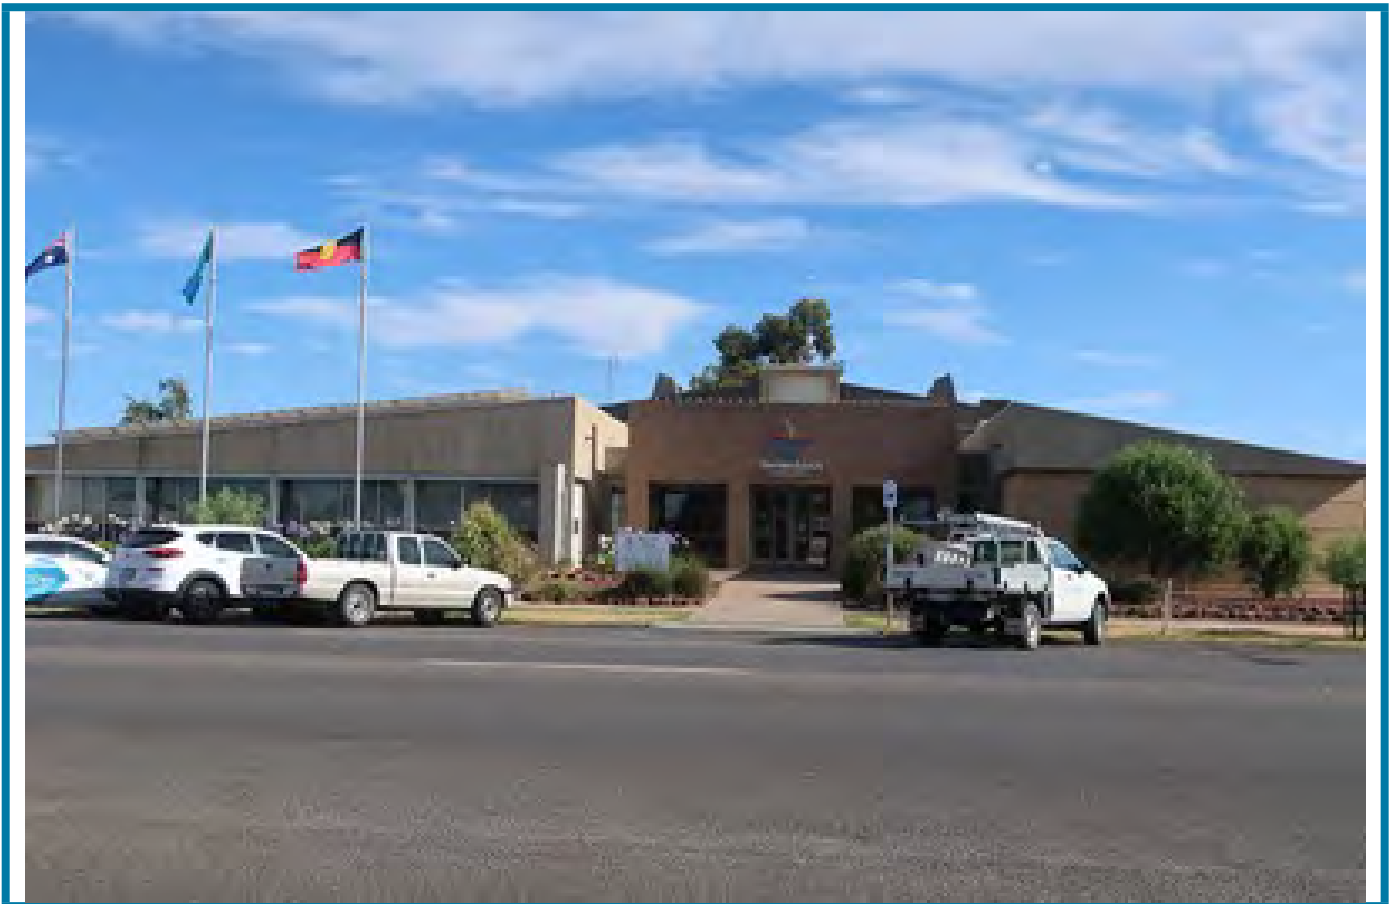
ASBESTOS SURVEY: Lr15a Shire Office, 34 Lyle Street, Warracknabeal Vic 3393

Location	Area	Component Materials	ACM Identified	Type Asbestos Assessment	ConditionPriority	Signage Required
LR15A Shire Office - front of building.	Fascia	F C Sheeting	No	No sample taken - Visual ID

All areas of the site were accessed during the inspection process. Refer to the Asbestos Survey for a full photographic listing of all areas accessed.
