Asbestos Report

YARRIAMBIACK SHIRE COUNCIL

PROPERTY ADDRESS:
LB15 HISTORICAL CENTRE
81 SCOTT STREET
WARRACKNABEAL VIC 3393

INSPECTION DATE: 16 FEBRUARY 2021
REFERENCE NUMBER: 62128

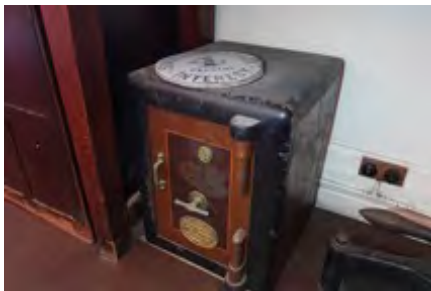
Maintain seals

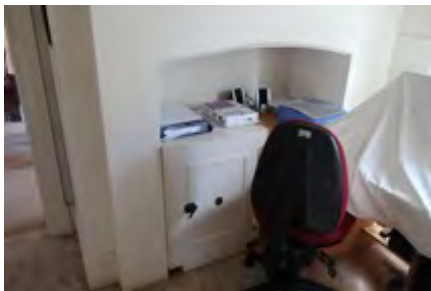
Maintain seals

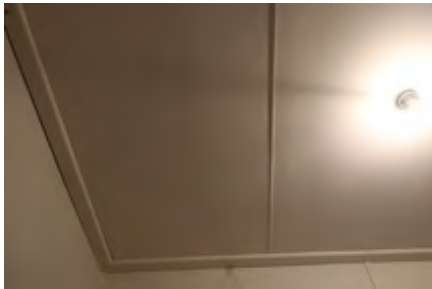
Maintain paint or sealant

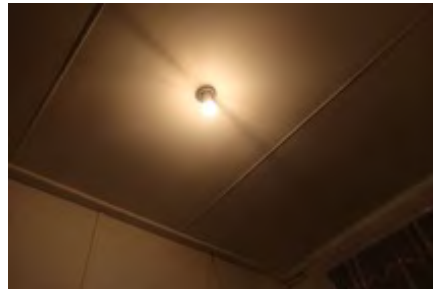
Maintain paint or sealant

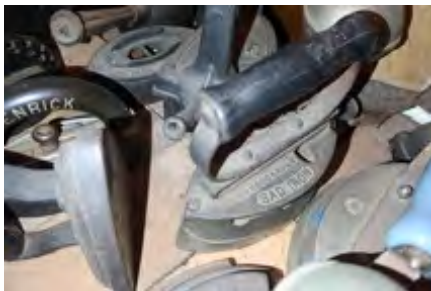
Not in-situ

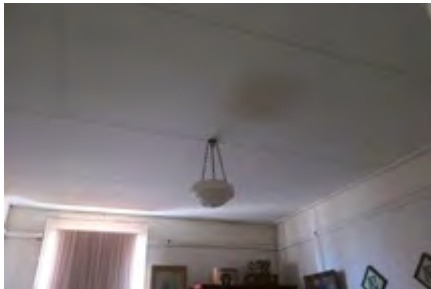
Maintain paint or sealant

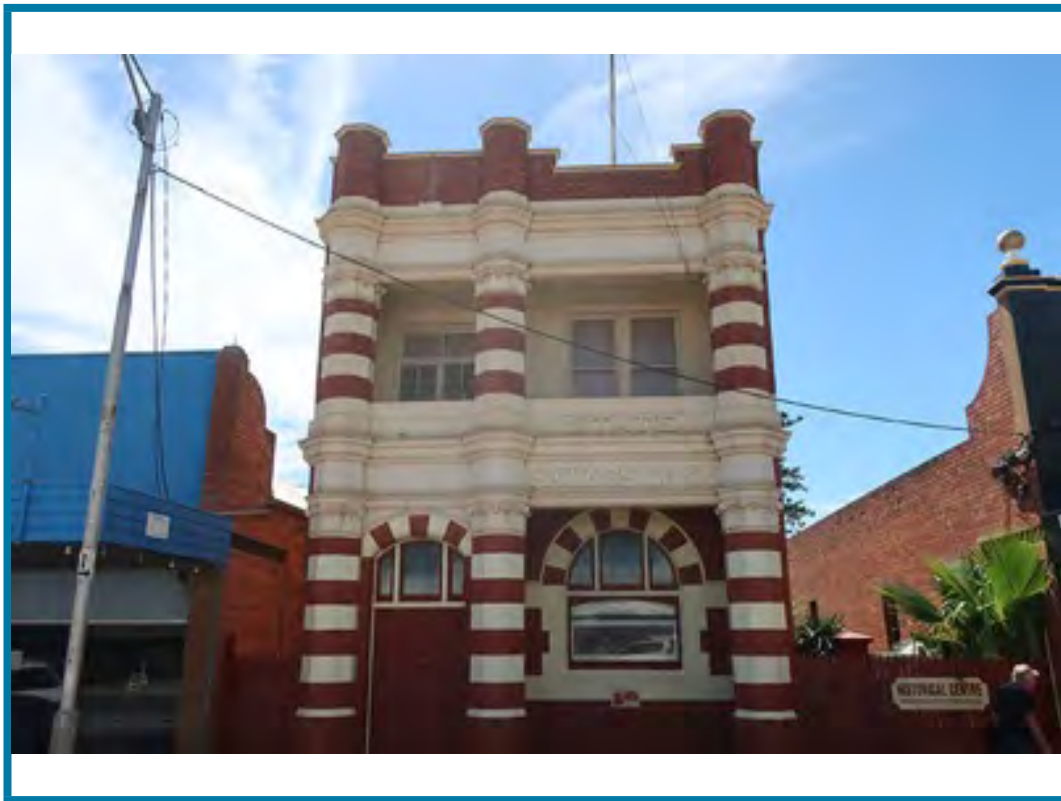
Location	Area	Component Materials	ACM Identified	Type Asbestos Assessment	Condition	Priority	Signage Required
LB15 Historical Centre - entire perimeter of building.		No Asbestos Materials	No	No sample taken - Visual ID

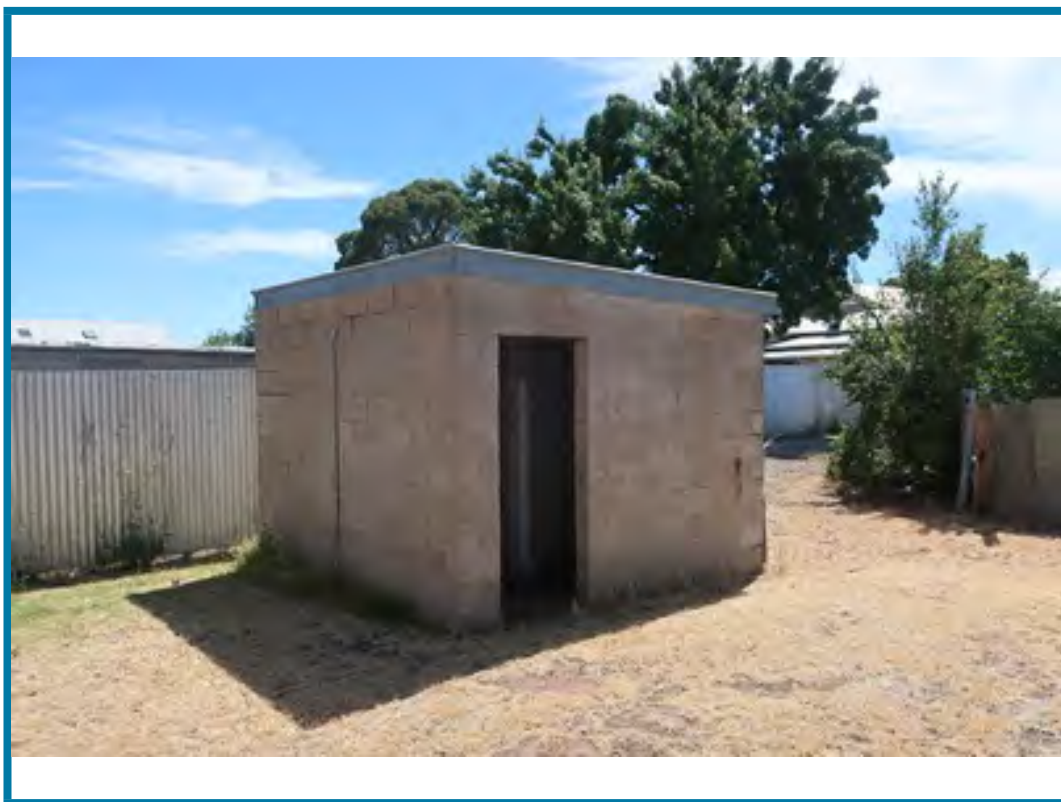
Location	Area	Component Materials	ACM Identified	Type Asbestos Assessment	ConditionPriority	Signage Required
Toilet - entire perimeter of building.		No Asbestos Materials	No	No sample taken - Visual ID
