**Global
Asbestos
Audits**

Asbestos Report

YARRIAMBIACK SHIRE COUNCIL

PROPERTY ADDRESS:
LB1 SHIRE HALL
39 SCOTT STREET
WARRACKNABEAL VIC 3393

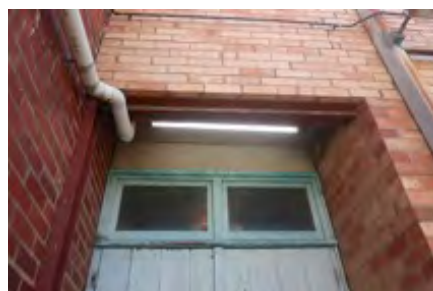
Raw Material

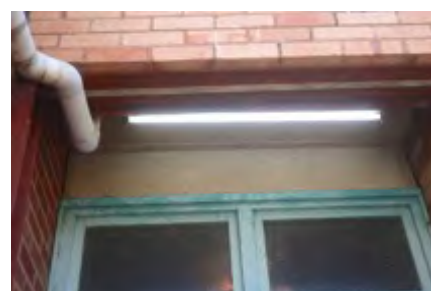
Raw Material

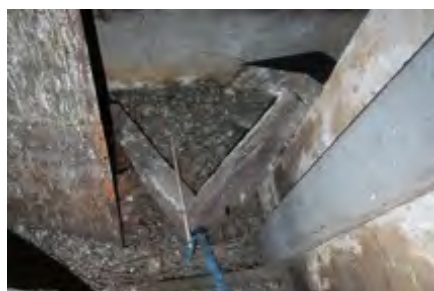
Debris on Surface

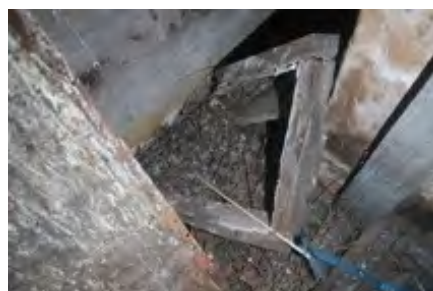
Debris on Surface

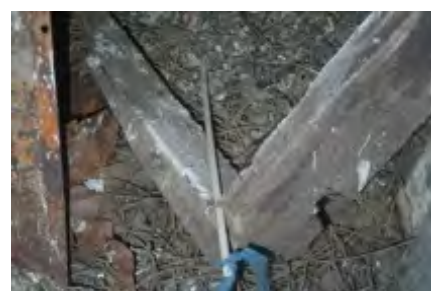
Debris on Surface

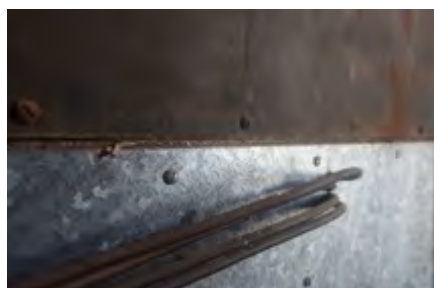
Raw Material

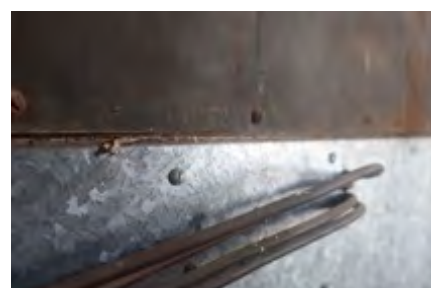
Raw Material

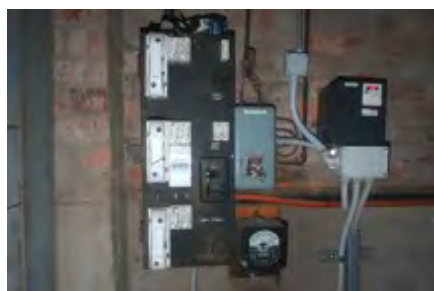
Penetration Holes

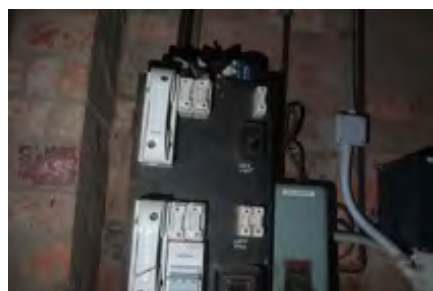
Penetration Holes

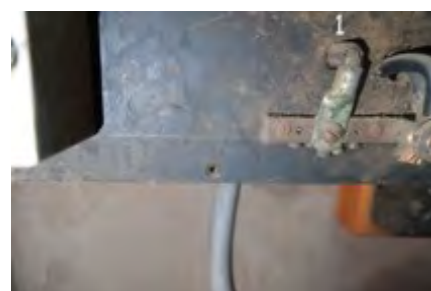
Penetration Holes

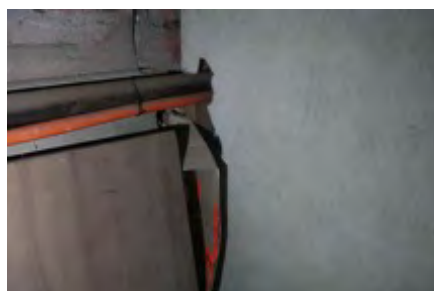
Raw Material

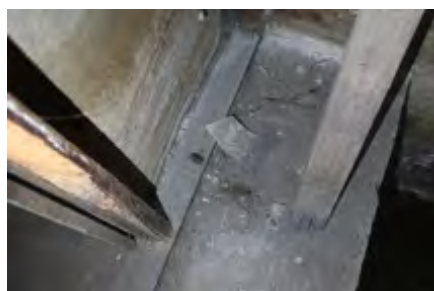
Debris on Surface

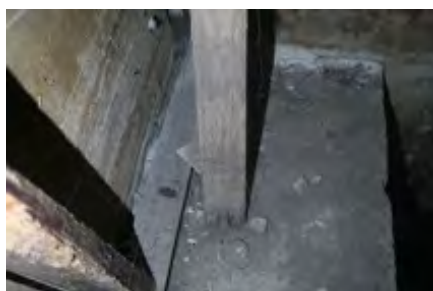
Debris on Surface

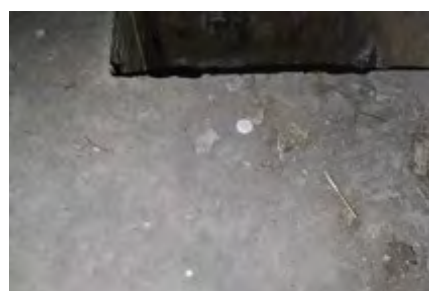
Debris on Surface

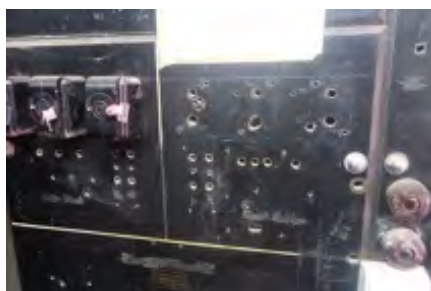
Penetration Holes

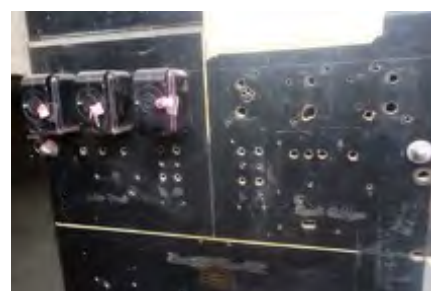
Penetration Holes

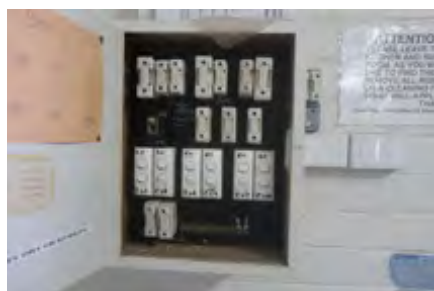
Debris on Surface

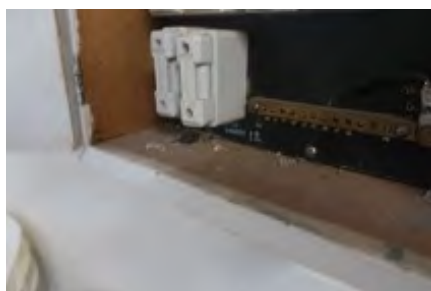
Debris on Surface

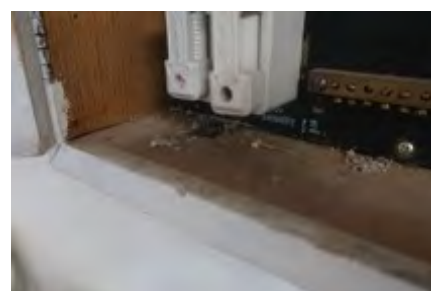
Debris on Surface

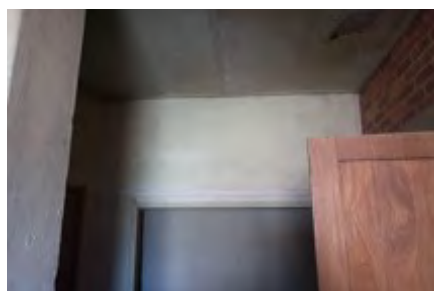
Raw Material

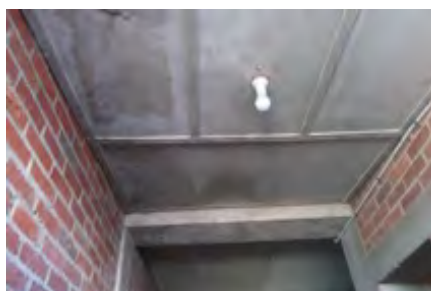
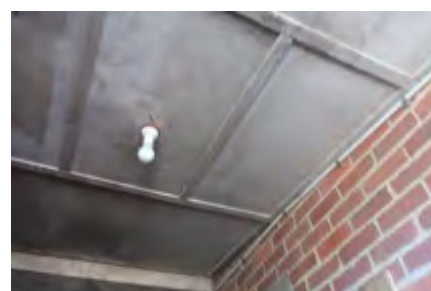
Raw Material

Priority	HIGH	Label Required	Yes	Re- Audit Date	16 Feb 2022
Action	Remedial repairs required - seal raw material / edges				
Recommendation	Raw material sheeting - The area requires immediate remedial repairs. It is recommended the asbestos material be sealed with an approved membrane.				
Legislative Requirements Victorian Regulation 2007	<p>Damaged ACM visible in area. Requires IMMEDIATE ATTENTION. WARNING labels should be affixed. Avoid mechanical damage and abrasion. Remove if refurbishment, structural alteration or demolition is to be carried out in this area. Re-inspect every 12 months or earlier if disturbed or removed in accordance with the Victorian OH&S Regulation 2017.</p> <p>All remedial/removal repairs require a Clearance Inspection & Certificate to be recorded by an approved and competent assessor.</p>

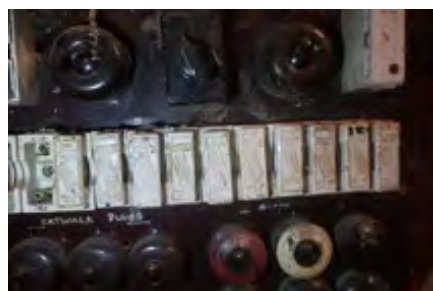
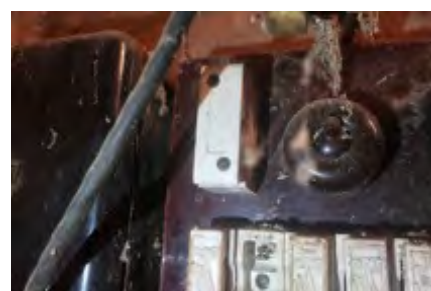
Maintain paint or sealant

Priority	MEDIUM	Label Required	Yes	Re- Audit Date	16 Feb 2022
Action	Remove during normal maintenance or refurbishment				
Recommendation	Do not remove fuses without asbestos controls Maintain paint or sealant to ACM surfaces. Particular attention should be given to side edges, ensure paint/sealant covers ALL exposed ACM surfaces.				
Legislative Requirements Victorian Regulation 2007	Warning labels should be affixed. Avoid mechanical damage and abrasion. Remove if refurbishment, structural alteration or demolition is to be carried out in this area. Re-inspect every 12 months or earlier if disturbed or removed in accordance with the Victorian OH&S Regulation 2017. All remedial/removal repairs require a Clearance Inspection & Certificate to be recorded by an approved and competent assessor.

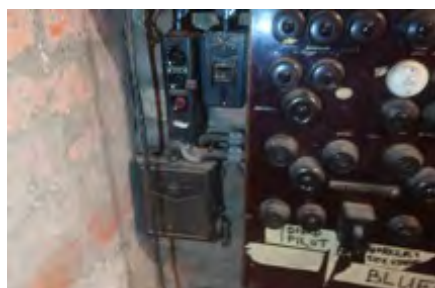
Area 24**LB1 Shire Hall: Ground Floor Stage 10.1. The Electrical switch (Wire - cloth insulation) has Asbestos Containing Material (ACM) present.****RISK ASSESSMENT**

Type of Asbestos or Hazardous Material	Chrysotile	Condition	GOOD	Likelihood of Damage	L (Low) – possible
	Same as Sample - 62141 -007	Activity	Moderate		
		Sealed	Yes	Friability	Bonded (non-friable)
		Labelled	Y	Exposure Risk	Low - Negligible or low risk
		Quantity

Maintain paint or sealant

Priority	MEDIUM	Label Required	Yes	Re- Audit Date	16 Feb 2022
Action	No remedial action required, unless disturbed				
Recommendation	Maintain paint or sealant to ACM surfaces. Particular attention should be given to side edges, ensure paint/sealant covers ALL exposed ACM surfaces.				
Legislative Requirements Victorian Regulation 2007	Warning labels should be affixed. Avoid mechanical damage and abrasion. Remove if refurbishment, structural alteration or demolition is to be carried out in this area. Re-inspect every 12 months or earlier if disturbed or removed in accordance with the Victorian OH&S Regulation 2017. All remedial/removal repairs require a Clearance Inspection & Certificate to be recorded by an approved and competent assessor.

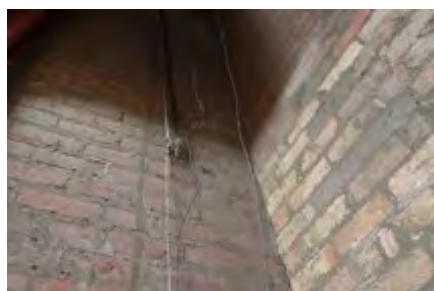
Type of Asbestos or Hazardous Material	Chrysotile	Condition	AVERAGE	Likelihood of Damage	M (Medium) – possible
	Same as Sample - 62141 -007	Activity	Moderate		
		Sealed	No	Friability	Friable
		Labelled	Y	Exposure Risk	Medium - Moderate risk
		Quantity

Exposed ACM Wire cloth

Priority	HIGH	Label Required	Yes	Re- Audit Date	16 Feb 2022
Action	Remedial repairs required - seal raw material / edges				
Recommendation	Unbonded surface (Loose) - The area requires immediate remedial repairs. It is recommended the asbestos material be replaced (preferred) or the material be sealed with an approved membrane.				
Legislative Requirements Victorian Regulation 2007	Damaged ACM visible in area. Requires IMMEDIATE ATTENTION. WARNING labels should be affixed. Avoid mechanical damage and abrasion. Remove if refurbishment, structural alteration or demolition is to be carried out in this area. Re-inspect every 12 months or earlier if disturbed or removed in accordance with the Victorian OH&S Regulation 2017. All remedial/removal repairs require a Clearance Inspection & Certificate to be recorded by an approved and competent assessor.

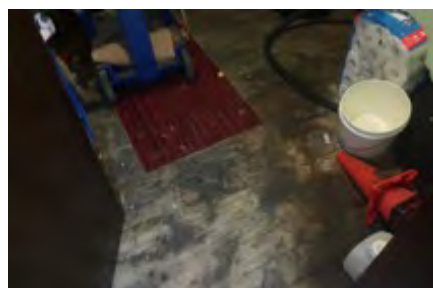
Area 7**LB1 Shire Hall: Ground Floor Cleaners room 11. The Floor (Adhesive (black)) has Asbestos Containing Material (ACM) present.****RISK ASSESSMENT**

Type of Asbestos or Hazardous Material	No sample taken - Visual ID	Condition	AVERAGE	Likelihood of Damage	L (Low) – possible
		Activity	Moderate		
		Sealed	No	Friability	Bonded (non-friable)
		Labelled	Y	Exposure Risk	Medium - Moderate risk
		Quantity

Not Concealed

Priority	HIGH	Label Required	Yes	Re- Audit Date	16 Feb 2022
Action	Remedial repairs required - seal raw material / edges				
Recommendation	Raw material sheeting - The area requires immediate remedial repairs. It is recommended the asbestos material be sealed with an approved membrane.				
Legislative Requirements Victorian Regulation 2007	Damaged ACM visible in area. Requires IMMEDIATE ATTENTION. WARNING labels should be affixed. Avoid mechanical damage and abrasion. Remove if refurbishment, structural alteration or demolition is to be carried out in this area. Re-inspect every 12 months or earlier if disturbed or removed in accordance with the Victorian OH&S Regulation 2017. All remedial/removal repairs require a Clearance Inspection & Certificate to be recorded by an approved and competent assessor.

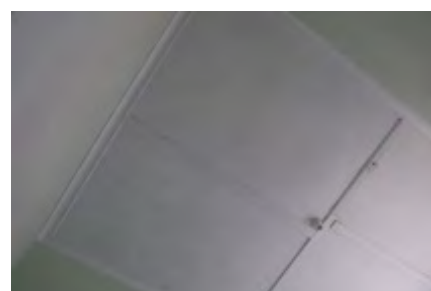
Area 28**LB1 Shire Hall: Level 1 Spare room 15. The Ceiling (F C Sheeting) has Asbestos Containing Material (ACM) present.****RISK ASSESSMENT**

Type of Asbestos or Hazardous Material	No sample taken - Visual ID	Condition	GOOD	Likelihood of Damage	L (Low) – possible
		Activity	Moderate		
		Sealed	Yes	Friability	Bonded (non-friable)
		Labelled	Y	Exposure Risk	Low - Negligible or low risk
		Quantity

Maintain paint or sealant

Priority	MEDIUM	Label Required	Yes	Re- Audit Date	16 Feb 2022
Action	No remedial action required, unless disturbed				
Recommendation	Maintain paint or sealant to ACM surfaces. Particular attention should be given to side edges, ensure paint/sealant covers ALL exposed ACM surfaces.				
Legislative Requirements Victorian Regulation 2007	Warning labels should be affixed. Avoid mechanical damage and abrasion. Remove if refurbishment, structural alteration or demolition is to be carried out in this area. Re-inspect every 12 months or earlier if disturbed or removed in accordance with the Victorian OH&S Regulation 2017. All remedial/removal repairs require a Clearance Inspection & Certificate to be recorded by an approved and competent assessor.

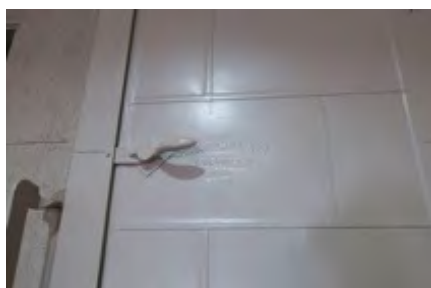
Area 27**LB1 Shire Hall: Level 1 Balcony & Projector room 18 & 19. The Fire Door (Fire Retardant core) has Asbestos Containing Material (ACM) present.****RISK ASSESSMENT**

Type of Asbestos or Hazardous Material	No sample taken - Visual ID	Condition	GOOD	Likelihood of Damage	L (Low) – possible
		Activity	Moderate		
		Sealed	Yes	Friability	Friable
		Labelled	Y	Exposure Risk	Low - Negligible or low risk
		Quantity

Maintain seals

Priority	MEDIUM	Label Required	Yes	Re- Audit Date	16 Feb 2022
Action	No remedial action required, unless disturbed				
Recommendation	Maintain paint or sealant to ACM surfaces. Particular attention should be given to side edges, ensure paint/sealant covers ALL exposed ACM surfaces.				
Legislative Requirements Victorian Regulation 2007	Warning labels should be affixed. Avoid mechanical damage and abrasion. Remove if refurbishment, structural alteration or demolition is to be carried out in this area. Re-inspect every 12 months or earlier if disturbed or removed in accordance with the Victorian OH&S Regulation 2017. All remedial/removal repairs require a Clearance Inspection & Certificate to be recorded by an approved and competent assessor.

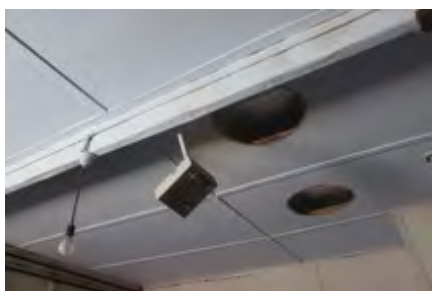
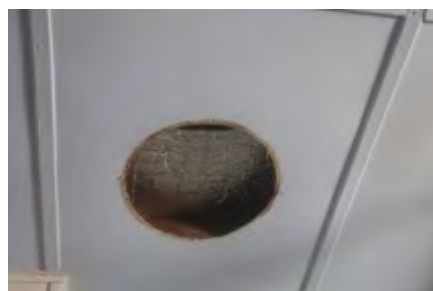
Area 17**LB1 Shire Hall: Level 2 Projector room 19. The Walls and Ceiling (F C Sheeting) has Asbestos Containing Material (ACM) present.****RISK ASSESSMENT**

Type of Asbestos or Hazardous Material	Chrysotile	Condition	AVERAGE	Likelihood of Damage	L (Low) – possible
	Sample taken 62141-006	Activity	Moderate		
		Sealed	No	Friability	Bonded (non-friable)
		Labelled	Y	Exposure Risk	Medium - Moderate risk
		Quantity

Raw Material

Priority	HIGH	Label Required	Yes	Re- Audit Date	16 Feb 2022
Action	Remedial repairs required - seal raw material / edges				
Recommendation	Raw material sheeting - The area requires immediate remedial repairs. It is recommended the asbestos material be sealed with an approved membrane.				
Legislative Requirements Victorian Regulation 2007	Damaged ACM visible in area. Requires IMMEDIATE ATTENTION. WARNING labels should be affixed. Avoid mechanical damage and abrasion. Remove if refurbishment, structural alteration or demolition is to be carried out in this area. Re-inspect every 12 months or earlier if disturbed or removed in accordance with the Victorian OH&S Regulation 2017. All remedial/removal repairs require a Clearance Inspection & Certificate to be recorded by an approved and competent assessor.

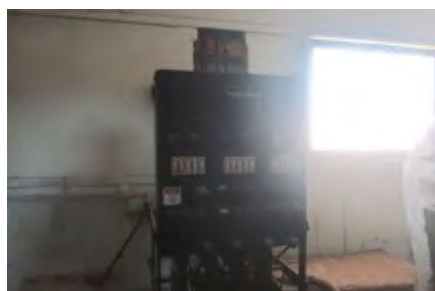
Area 15**LB1 Shire Hall: Level 2 Projector room 19. The A: Electrical board; B: Ceramic Fuses (A: Zelemite; B: Cloth Inserts) has Asbestos Containing Material (ACM) present.****RISK ASSESSMENT**

Type of Asbestos or Hazardous Material	No sample taken - Visual ID	Condition	AVERAGE	Likelihood of Damage	L (Low) – possible
		Activity	Moderate		
		Sealed	Yes	Friability	Exposed Fibres
		Labelled	No	Exposure Risk	Medium - Moderate risk
		Quantity

Penetration Holes

Priority	HIGH	Label Required	Yes	Re- Audit Date	16 Feb 2022
Action	Remedial repairs required - seal raw material / edges				
Recommendation	Penetration Holes - The exposed edges require approved sealant. It is further recommended the gaps be filled with sealant. Do not remove fuses without asbestos controls				
Legislative Requirements Victorian Regulation 2007	Damaged ACM visible in area. Requires IMMEDIATE ATTENTION. WARNING labels should be affixed. Avoid mechanical damage and abrasion. Remove if refurbishment, structural alteration or demolition is to be carried out in this area. Re-inspect every 12 months or earlier if disturbed or removed in accordance with the Victorian OH&S Regulation 2017. All remedial/removal repairs require a Clearance Inspection & Certificate to be recorded by an approved and competent assessor.

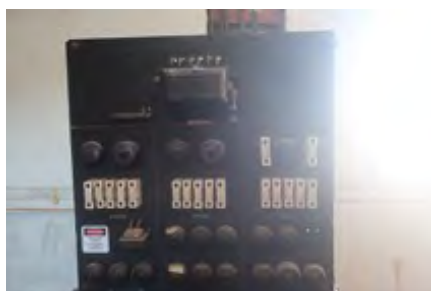
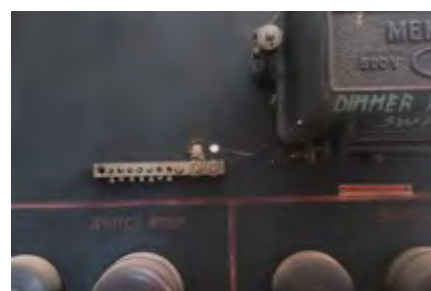
Penetration Holes

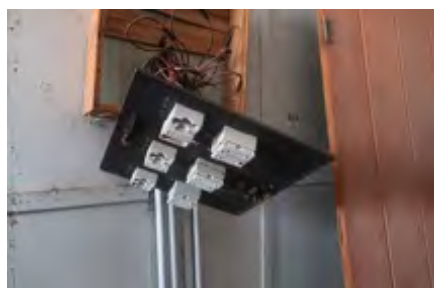
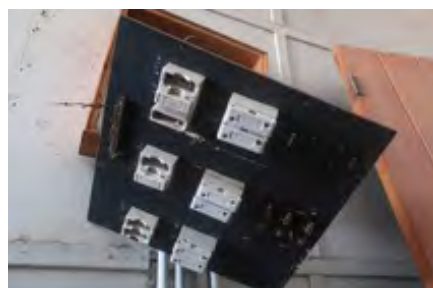
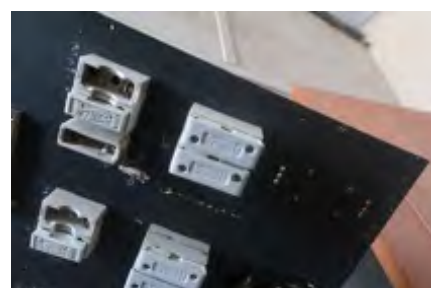
Not Secure

Priority	MEDIUM	Label Required	Yes	Re- Audit Date	16 Feb 2022
Action	Remove during normal maintenance or refurbishment				
Recommendation	Maintain paint or sealant to ACM surfaces. Particular attention should be given to side edges, ensure paint/sealant covers ALL exposed ACM surfaces. Do not remove fuses without asbestos controls				
Legislative Requirements Victorian Regulation 2007	Warning labels should be affixed. Avoid mechanical damage and abrasion. Remove if refurbishment, structural alteration or demolition is to be carried out in this area. Re-inspect every 12 months or earlier if disturbed or removed in accordance with the Victorian OH&S Regulation 2017. All remedial/removal repairs require a Clearance Inspection & Certificate to be recorded by an approved and competent assessor.

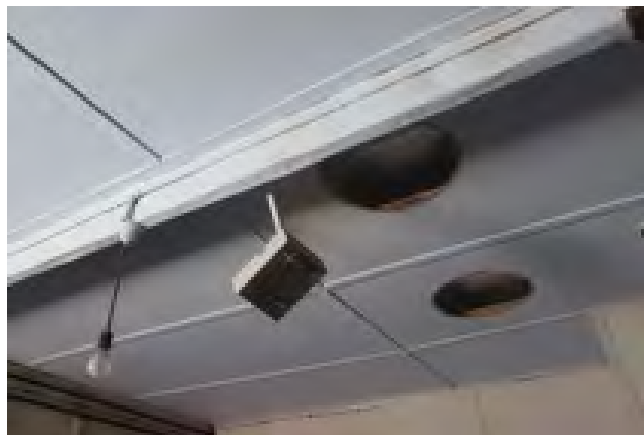
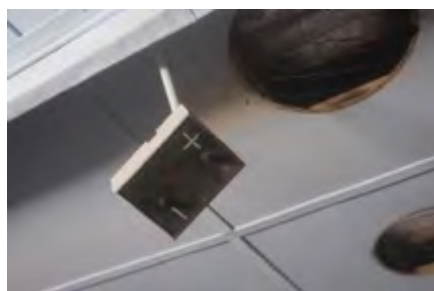
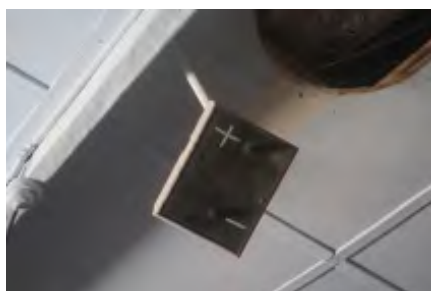
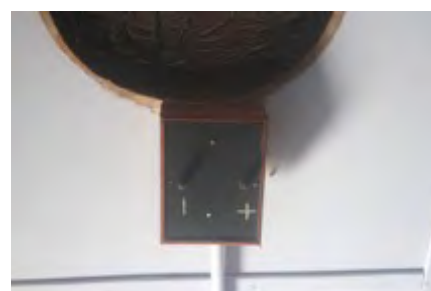
Area 30**LB1 Shire Hall: Level 2 Projector room 19. The Electrical board (Backing Board (Zelemite)) has Asbestos Containing Material (ACM) present.****RISK ASSESSMENT**

Type of Asbestos or Hazardous Material	No sample taken - Visual ID	Condition	GOOD	Likelihood of Damage	L (Low) – possible
		Activity	Moderate		
		Sealed	Yes	Friability	Bonded (non-friable)
		Labelled	Y	Exposure Risk	Low - Negligible or low risk
		Quantity

Maintain paint or sealant

Priority	MEDIUM	Label Required	Yes	Re- Audit Date	16 Feb 2022
Action	No remedial action required, unless disturbed				
Recommendation	Maintain paint or sealant to ACM surfaces. Particular attention should be given to side edges, ensure paint/sealant covers ALL exposed ACM surfaces.				
Legislative Requirements Victorian Regulation 2007	Warning labels should be affixed. Avoid mechanical damage and abrasion. Remove if refurbishment, structural alteration or demolition is to be carried out in this area. Re-inspect every 12 months or earlier if disturbed or removed in accordance with the Victorian OH&S Regulation 2017. All remedial/removal repairs require a Clearance Inspection & Certificate to be recorded by an approved and competent assessor.

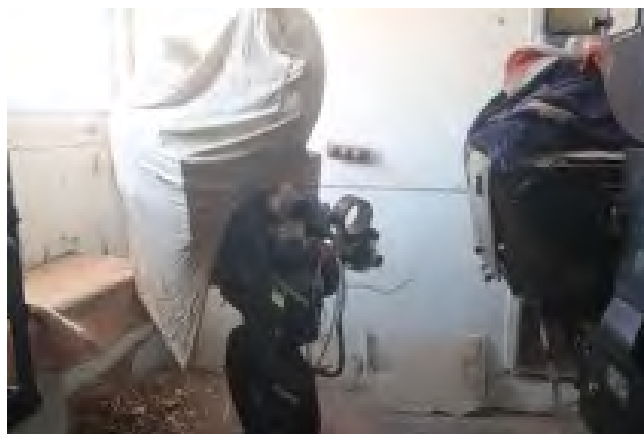
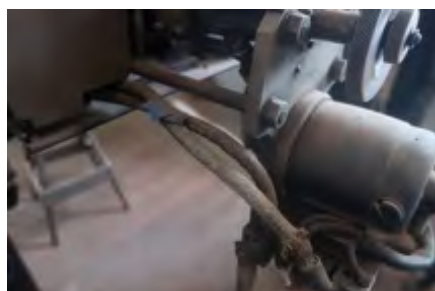
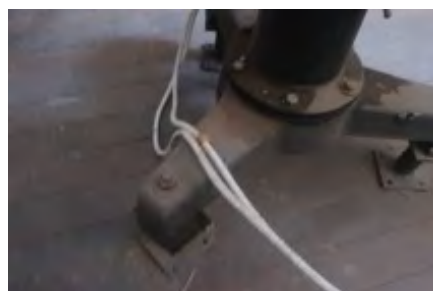
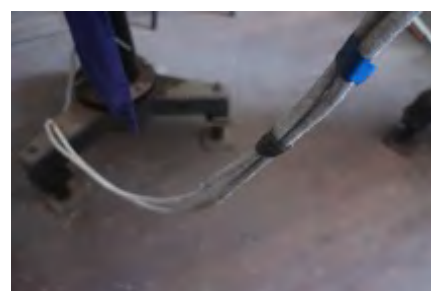
Type of Asbestos or Hazardous Material	Chrysotile	Condition	AVERAGE	Likelihood of Damage	L (Low) – possible
	Sample taken 62141-007	Activity	Moderate		
		Sealed	No	Friability	Friable
		Labelled	Y	Exposure Risk	Medium - Moderate risk
		Quantity

Exposed ACM Wire cloth

Priority	HIGH	Label Required	Yes	Re- Audit Date	16 Feb 2022
Action	Restrict access and enclose or encapsulate or seal				
Recommendation	Exposed asbestos - do not disturb. Unbonded surface (Loose) - The area requires immediate remedial repairs. It is recommended the asbestos material be replaced (preferred) or the material be sealed with an approved membrane.				
Legislative Requirements Victorian Regulation 2007	Damaged ACM visible in area. Requires IMMEDIATE ATTENTION. WARNING labels should be affixed. Avoid mechanical damage and abrasion. Remove if refurbishment, structural alteration or demolition is to be carried out in this area. Re-inspect every 12 months or earlier if disturbed or removed in accordance with the Victorian OH&S Regulation 2017. All remedial/removal repairs require a Clearance Inspection & Certificate to be recorded by an approved and competent assessor.

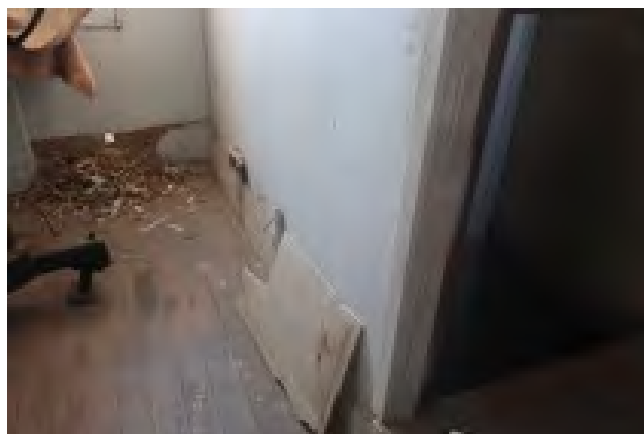
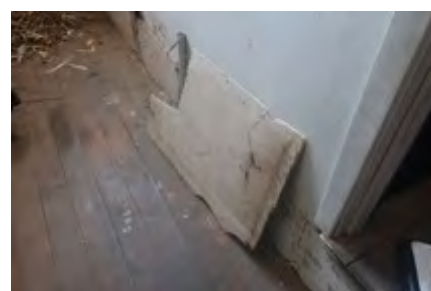
Area 5**LB1 Shire Hall: Level 2 Projector room 19. The Debris - Broken (Debris) has Asbestos Containing Material (ACM) present.****RISK ASSESSMENT**

Type of Asbestos or Hazardous Material	Chrysotile	Condition	POOR	Likelihood of Damage	H (High) - almost certain
	Same as Sample - 62141-006	Activity	Moderate		
		Sealed	No	Friability	Exposed Fibres
		Labelled	Y	Exposure Risk	High - Short term exposure risk
		Quantity

Debris on Surface

Priority	IMMEDIATE	Label Required	Yes	Re- Audit Date	16 Feb 2022
Action	Restrict access and target for imminent removal				
Recommendation	Debris on Surface - The Debris requires immediate cleanup and disposal with specialised equipment and with licensed removalist to safely remove the asbestos debris.				
Legislative Requirements Victorian Regulation 2007	ACM debris visible. Recommend cleanup by licensed Asbestos Removalist. Warning labels should be affixed. Avoid mechanical damage and abrasion. Remove if refurbishment, structural alteration or demolition is to be carried out in this area. Re-inspect every 12 months or earlier if disturbed or removed in accordance with the Victorian OH&S Regulation 2017. All remedial/removal repairs require a Clearance Inspection & Certificate to be recorded by an approved and competent assessor.

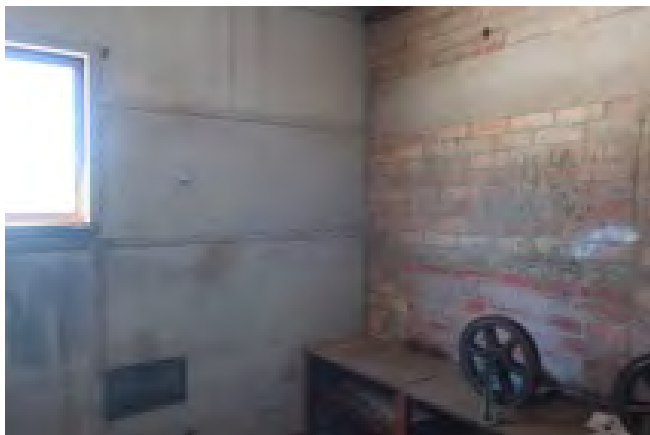
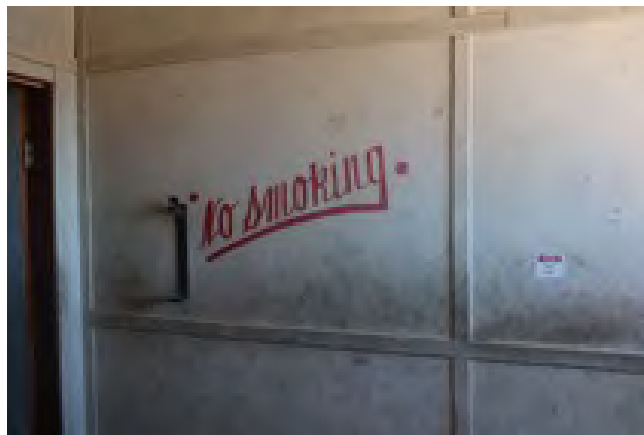
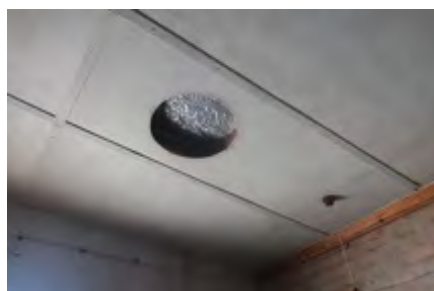
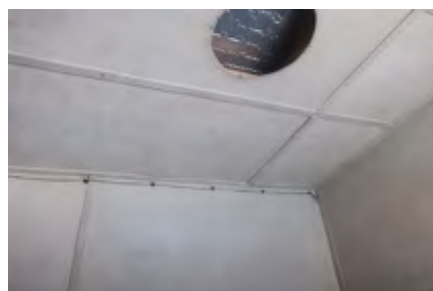
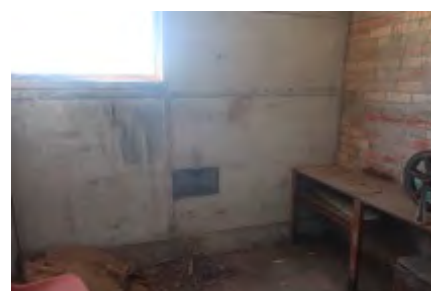
Area 14**LB1 Shire Hall: Level 2 Film room 19. The Walls and Ceiling (F C Sheeting) has Asbestos Containing Material (ACM) present.****RISK ASSESSMENT**

Type of Asbestos or Hazardous Material	Chrysotile	Condition	AVERAGE	Likelihood of Damage	L (Low) – possible
	Same as Sample - 62141 -006	Activity	Moderate		
		Sealed	No	Friability	Bonded (non-friable)
		Labelled	Y	Exposure Risk	Medium - Moderate risk
		Quantity

Raw Material

Priority	HIGH	Label Required	Yes	Re- Audit Date	16 Feb 2022
Action	Remedial repairs required - seal raw material / edges				
Recommendation	Raw material sheeting - The area requires immediate remedial repairs. It is recommended the asbestos material be sealed with an approved membrane.				
Legislative Requirements Victorian Regulation 2007	Damaged ACM visible in area. Requires IMMEDIATE ATTENTION. WARNING labels should be affixed. Avoid mechanical damage and abrasion. Remove if refurbishment, structural alteration or demolition is to be carried out in this area. Re-inspect every 12 months or earlier if disturbed or removed in accordance with the Victorian OH&S Regulation 2017. All remedial/removal repairs require a Clearance Inspection & Certificate to be recorded by an approved and competent assessor.

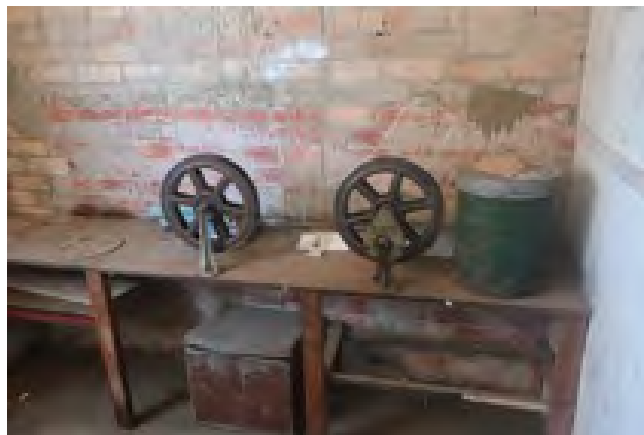
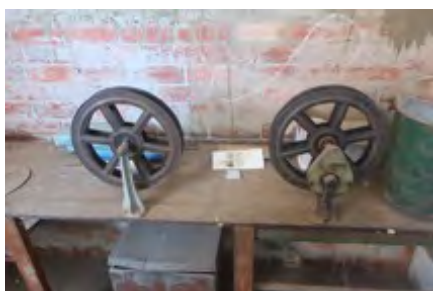
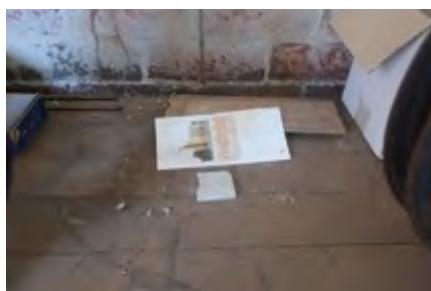
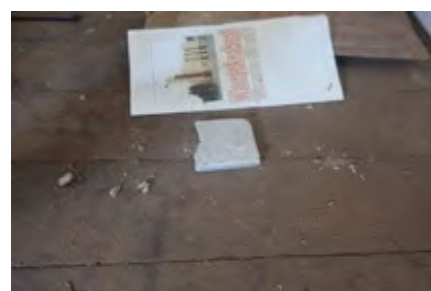
Area 4**LB1 Shire Hall: Level 2 Film room 19.1. The Debris - Broken (Debris) has Asbestos Containing Material (ACM) present.****RISK ASSESSMENT**

Type of Asbestos or Hazardous Material	Chrysotile	Condition	POOR	Likelihood of Damage	H (High) - almost certain
	Same as Sample - 62141 -006	Activity	Moderate		
		Sealed	No	Friability	Exposed Fibres
		Labelled	Y	Exposure Risk	High - Short term exposure risk
		Quantity

Debris on Surface

Priority	IMMEDIATE	Label Required	Yes	Re- Audit Date	16 Feb 2022
Action	Restrict access and target for imminent removal				
Recommendation	Debris on Surface - The Debris requires immediate cleanup and disposal with specialised equipment and with licensed removalist to safely remove the asbestos debris.				
Legislative Requirements Victorian Regulation 2007	ACM debris visible. Recommend cleanup by licensed Asbestos Removalist. Warning labels should be affixed. Avoid mechanical damage and abrasion. Remove if refurbishment, structural alteration or demolition is to be carried out in this area. Re-inspect every 12 months or earlier if disturbed or removed in accordance with the Victorian OH&S Regulation 2017. All remedial/removal repairs require a Clearance Inspection & Certificate to be recorded by an approved and competent assessor.

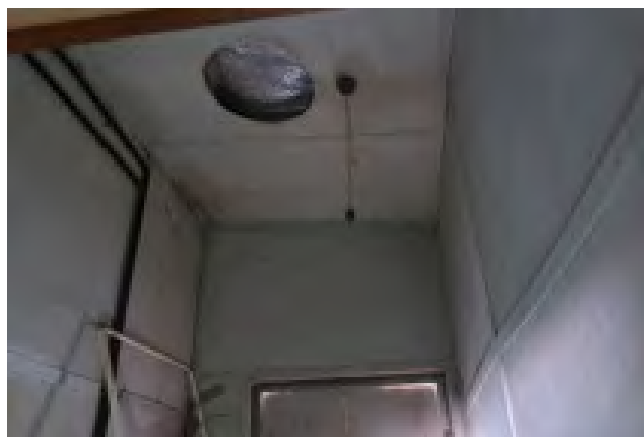
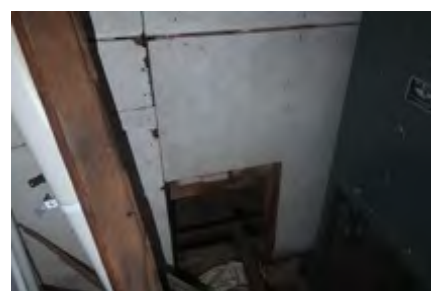
Area 13**LB1 Shire Hall: Level 2 Electrical room 19.2. The Walls and Ceiling (F C Sheeting) has Asbestos Containing Material (ACM) present.****RISK ASSESSMENT**

Type of Asbestos or Hazardous Material	Chrysotile	Condition	AVERAGE	Likelihood of Damage	L (Low) – possible
	Same as Sample - 62141 -006	Activity	Moderate		
		Sealed	No	Friability	Bonded (non-friable)
		Labelled	Y	Exposure Risk	Medium - Moderate risk
		Quantity

Raw Material

Priority	HIGH	Label Required	Yes	Re- Audit Date	16 Feb 2022
Action	Remedial repairs required - seal raw material / edges				
Recommendation	Raw material sheeting - The area requires immediate remedial repairs. It is recommended the asbestos material be sealed with an approved membrane.				
Legislative Requirements Victorian Regulation 2007	<p>Damaged ACM visible in area. Requires IMMEDIATE ATTENTION. WARNING labels should be affixed. Avoid mechanical damage and abrasion. Remove if refurbishment, structural alteration or demolition is to be carried out in this area. Re-inspect every 12 months or earlier if disturbed or removed in accordance with the Victorian OH&S Regulation 2017.</p> <p>All remedial/removal repairs require a Clearance Inspection & Certificate to be recorded by an approved and competent assessor.</p>
